DRAFT
GROUT-IN-PLACE CULVERT LINING INVESTIGATION REPORT

4018-E-0001 ASSIGNMENT #5

Ministry of Transportation Ontario
c/o WSP Canada Group Limited

October 2020
Thurber File No.: 28182

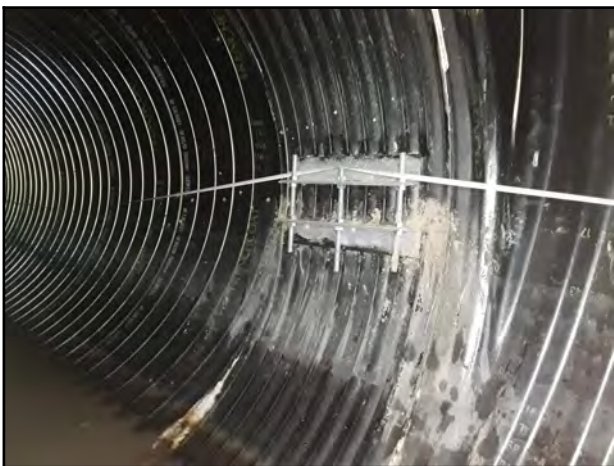
Photo 23 - V-4: Joint with visible expansion foam.

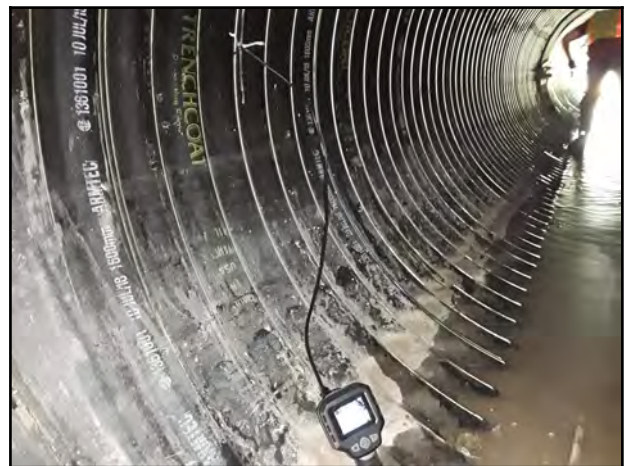
Photo 24 - V-5: Endoscope camera showing visible void.

Based on the findings, it is recommended that the areas with confirmed annular voids between the existing CMP and the sliplined CMP be injected with grouting material approved by the design engineer. This will ensure the supporting soil structure remains stable when the host CMP fully deteriorates. This can be accomplished by injecting grout directly in the center of the specific area and drilling overflow ports to ensure the product has reached the desired location. Locations of the captured BCT scan images are indicated by the distance from the inlet, as well as the clock position, and should be referenced during the injections. The BCT images should also be utilized to help estimate the material volumes required to complete the repair. Please refer to the soilsight™ Pipe Map and segment views for the exact locations of the voids.

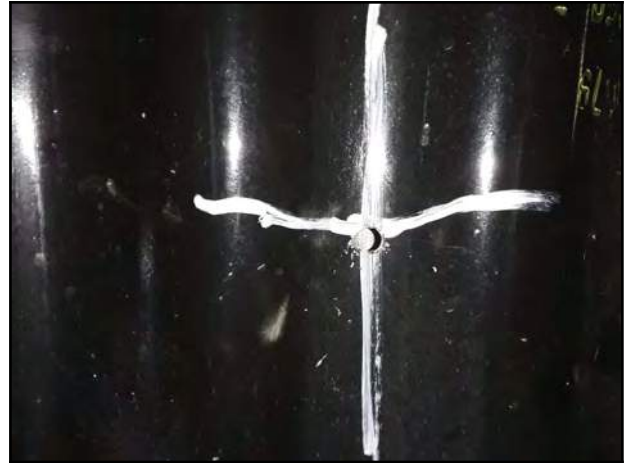
Photo 26 - V-5: Endoscope camera showing visible void.

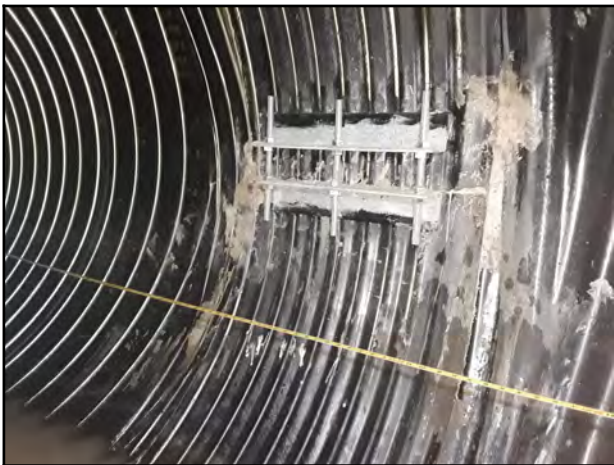
Photo 27 - V-6: Joint with visible expansion foam.

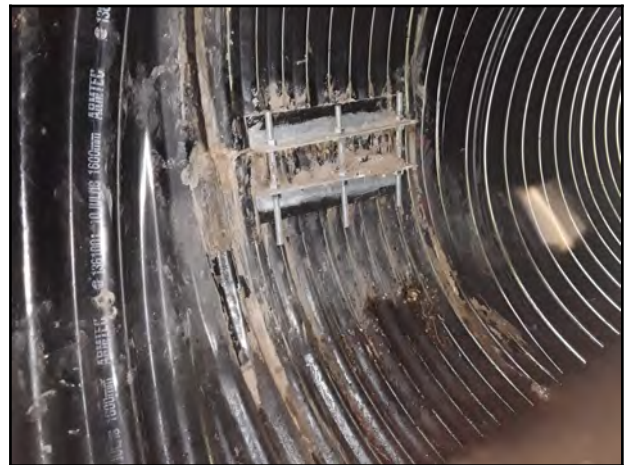
Photo 28 - V-6: Joint with visible expansion foam.

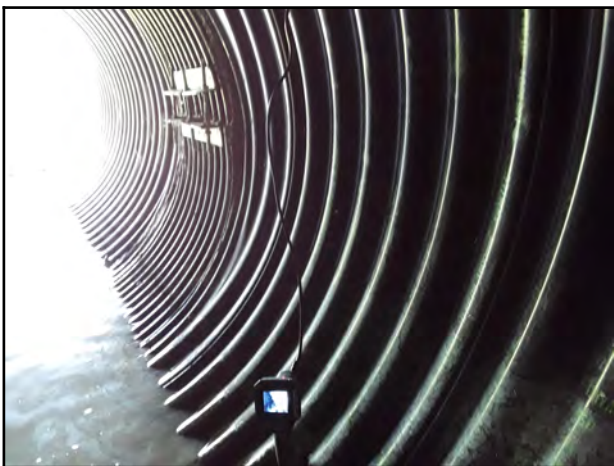
Photo 29 - V-7: Endoscope camera showing visible void.

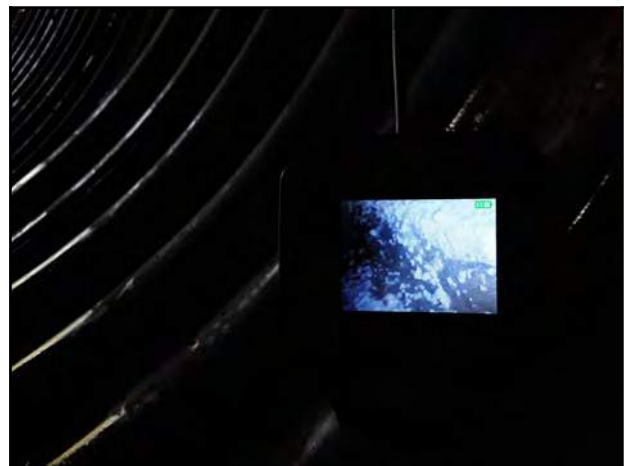
Photo 30 - V-7: Endoscope camera showing visible void.

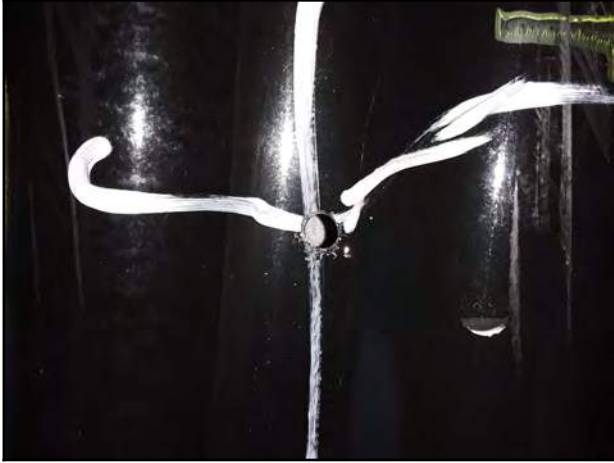
Photo 31 - V-7: Endoscope camera showing visible void.

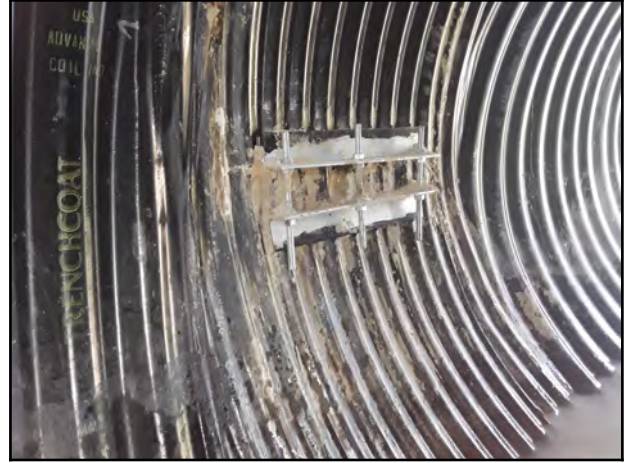
Photo 32 - V-8: Joint with visible expansion foam.

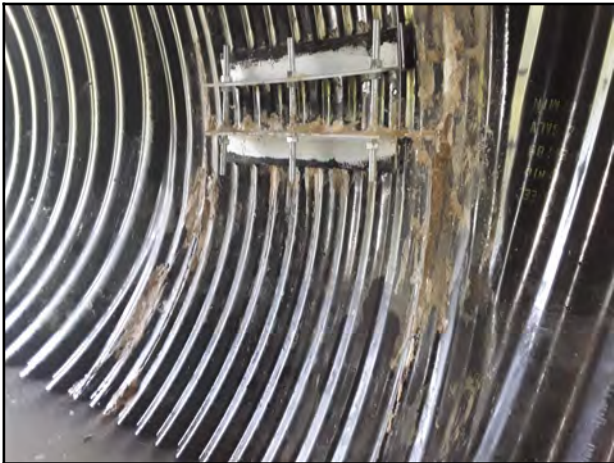
Photo 33 - V-8: Joint with visible expansion foam.

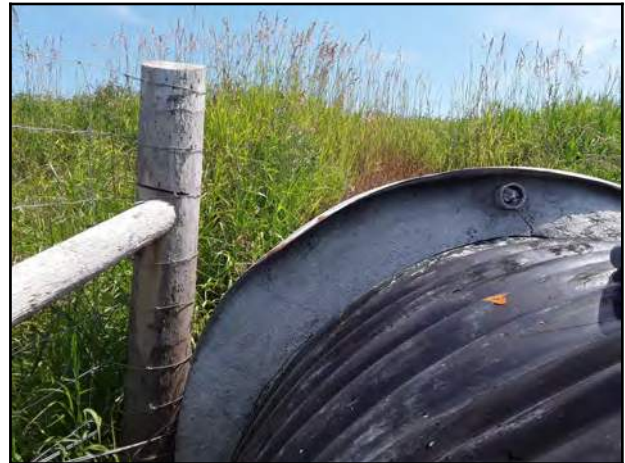
Photo 34 - Annular space of 240 mm between existing pipe and sliplined culvert at outlet.

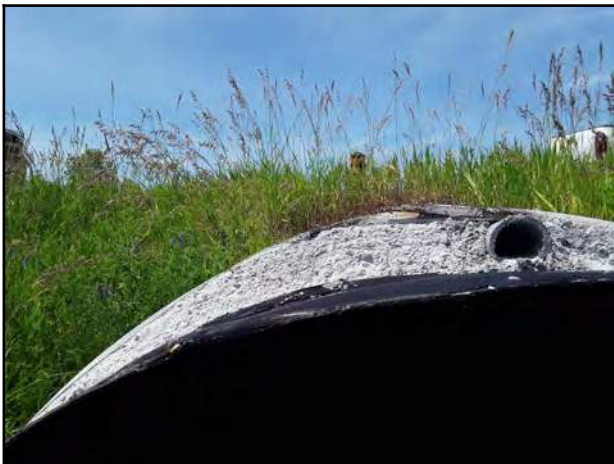
Photo 35 - Annular space of 80 mm between existing pipe and sliplined culvert at inlet.

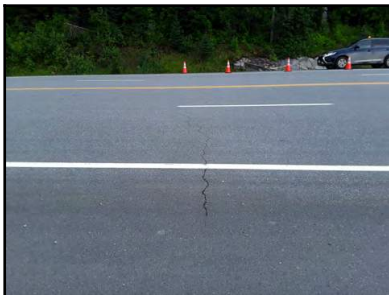
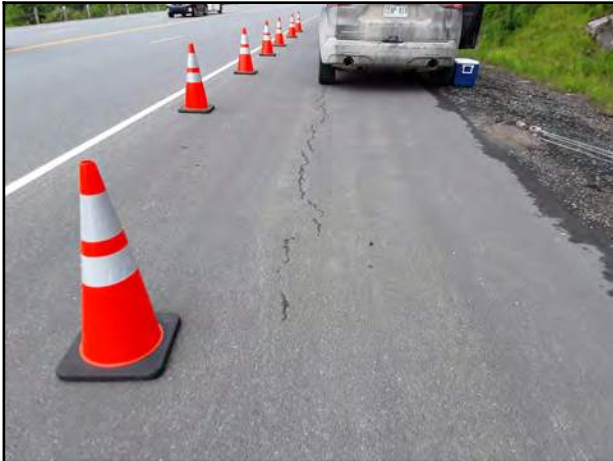
Pavement	Rank 2	
Pavement in good condition.		
Cracks		
<ul style="list-style-type: none">• Longitudinal cracks: Frequency: Medium (2 - 5 cracks); Severity: Light (< 5 mm (0.2 in) Width)• Transverse cracks present: Frequency: Medium (2 - 5 cracks); Severity: Light (< 5 mm (0.2 in) Width)

Photo 2 - Transverse crack.	Photo 1 - Longitudinal crack.	Photo 3 - Highway 60 facing north.

Photo 1 - Longitudinal crack.

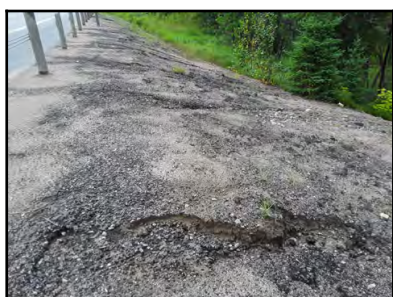
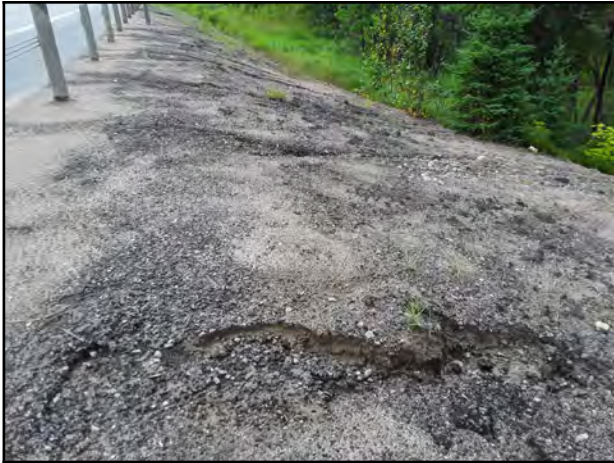
- Erosion channel(s) present: **Frequency:** > 5 channels; **Severity:** Very severe (> 300 mm (12 in) Width).
- Vegetation present: **Size:** Small vegetation present (< 3.0 m (10 ft) in height).

Photo 7 - Multiple erosion channels on the outlet embankment with the most severe measuring approximately 400 mm in width.

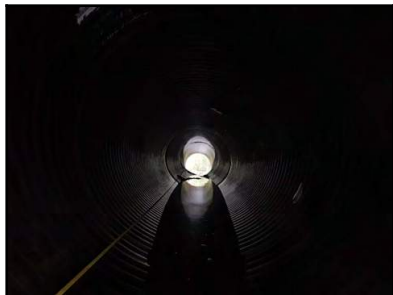
- Pipe misalignment present: **Condition:** Vertical misalignment.

Photo 13 - Pooling of approximately 100 mm evident within pipe due to the vertical misalignment at the outlet end.

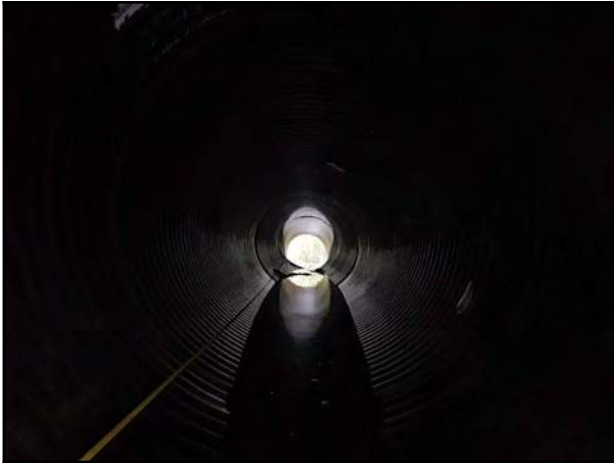
Photo 13 - Pooling of approximately 100 mm evident within pipe due to the vertical misalignment at the outlet end.

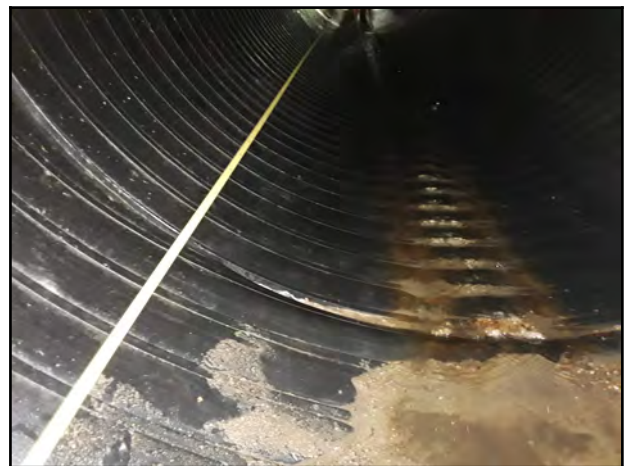
Photo 18 - V-2: Pipe sections overlapping at joint.

Based on the findings, the annular space between the existing and Sliplined culverts was found to be well grouted. However, the outlet embankment was found to have multiple erosion channels. It is therefore recommended that the outlet embankment be repaired and stabilized to prevent further deterioration and/or potential failure. Following the maintenance of the outlet embankment, it is recommended that the asset continues to be monitored at its current inspection intervals. Subsequent inspections should emphasize monitoring the identified overlapping joints for signs of further movement.

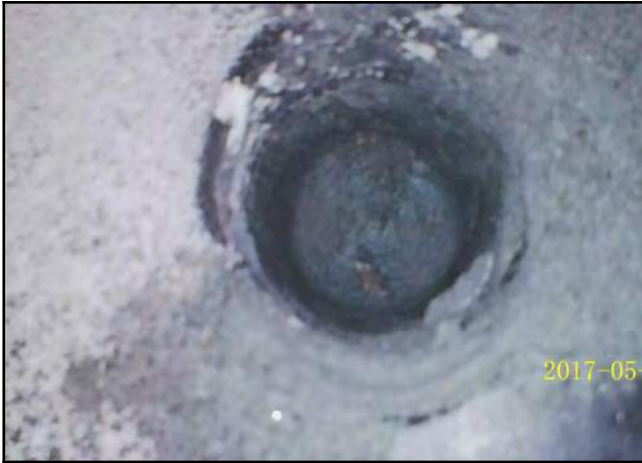
Photo 19 - V-3: Endoscope camera placed in the probe hole showing no void.

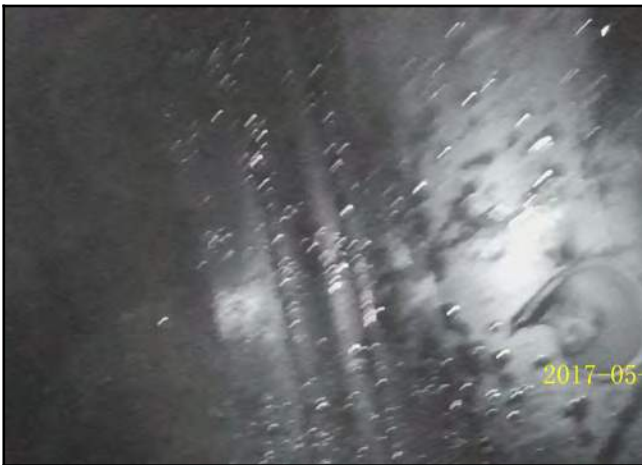
Photo 21 - V-4: Endoscope camera placed in the probe hole showing no void.

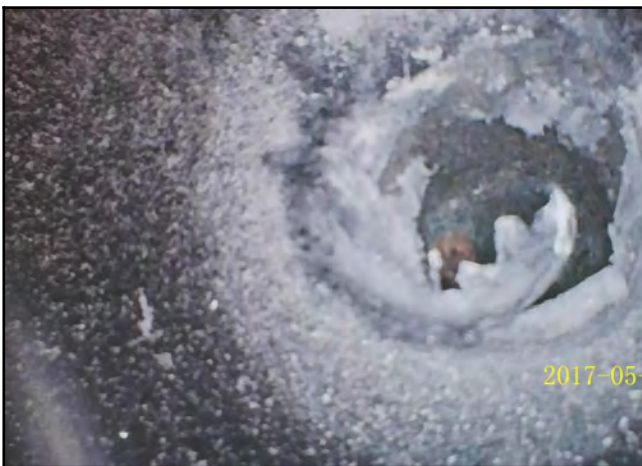
Photo 23 - V-5: Endoscope camera placed in the probe hole showing no void.

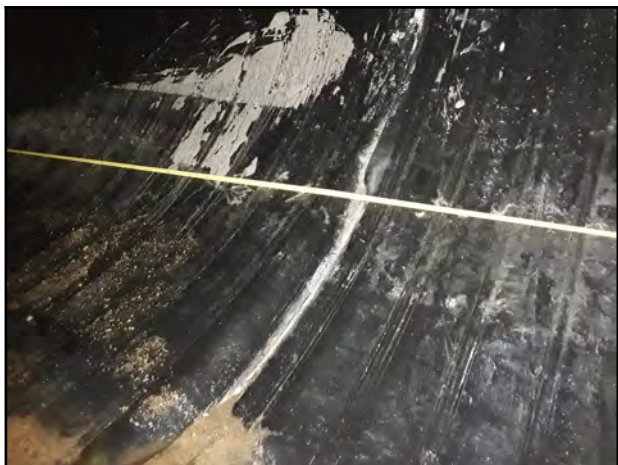
Photo 25 - V-6: Pipe sections overlapping at joint with foam evident.

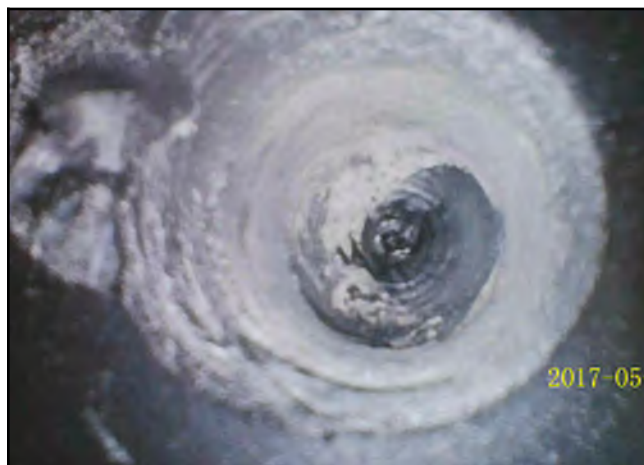
Photo 28 - V-7: Endoscope camera placed in the probe hole showing no void.

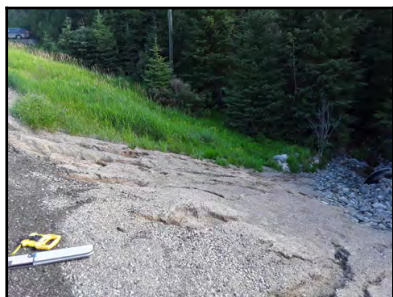
- Erosion channel(s) present: **Frequency:** > 5 channels; **Severity:** Very severe (> 300 mm (12 in) Width).
- Rip-Rap stabilizing embankment present.

Photo 4 - Multiple erosion channels on the outlet embankment, most severe measuring approximately 800 mm in width.

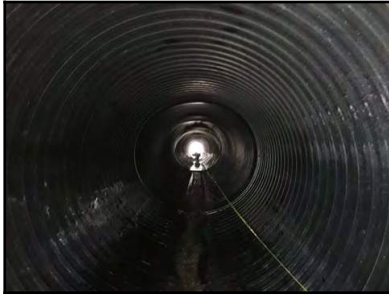
Slight horizontal misalignment at the outlet end.

Photo 11 - Upstream pipe alignment and shape.

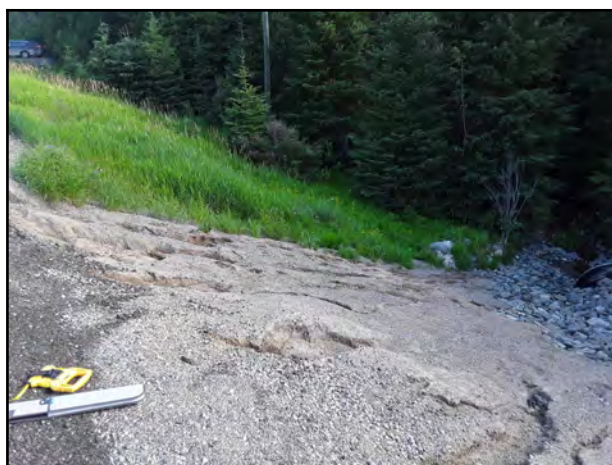
Photo 4 - Multiple erosion channels on the outlet embankment, most severe measuring approximately 800 mm in width.

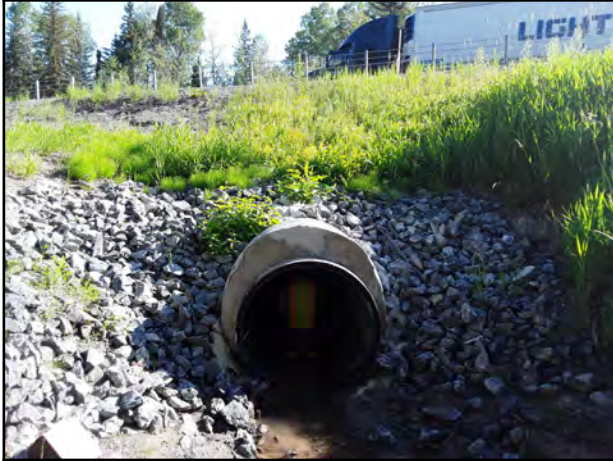
Photo 7 - Inlet overview.

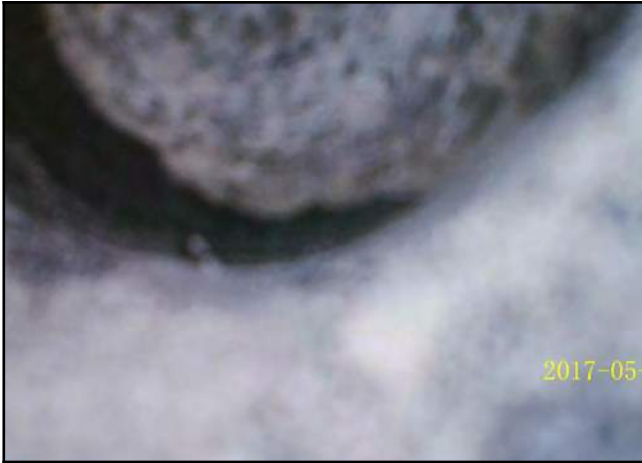
Photo 13 - V-1: Endoscope camera placed in the probe hole showing no void.

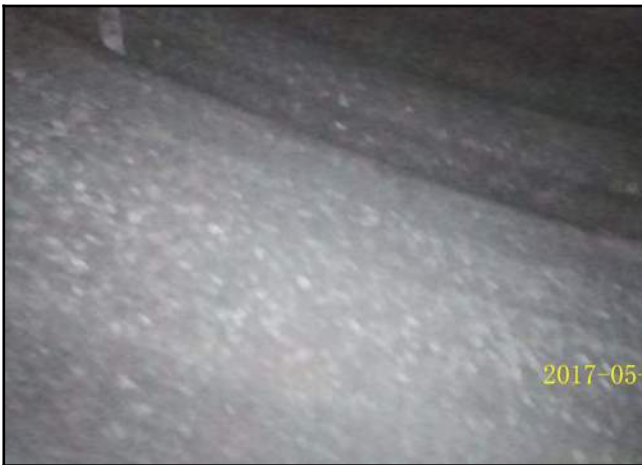
Photo 15 - V-2: Endoscope camera placed in the probe hole showing void.

As noted in V-2 and V-3, visible annular voids between the existing culvert and the Sliplined HDPE were recorded at each probe hole location, confirming the inSight™ Lite anomalous regions at these locations. V-1, and V-8 were identified as locations of no void. A control point was also taken and recorded as V-6 to ensure the accuracy of the inSight™ Lite assessment. Following the inspection, each hole was sealed with a silicone sealant.

Based on the findings, it is recommended the outlet embankment be repaired and stabilized to prevent further deterioration and/or potential failure. Additionally, it is recommended that the areas with confirmed annular voids between the existing culvert and the sliplined HDPE be injected with grouting material approved by the design engineer. This will ensure the supporting soil structure remains stable when the host culvert fully deteriorates. This can be accomplished by injecting grout directly in the center of the specific area and drilling overflow ports to ensure the product has reached the desired location. Locations of the captured probe holes are indicated by the distance from the inlet, as well as the clock position, and should be referenced during the injections. The SoilSight™ Pipe Map should also be utilized to help estimate the material volumes required to complete the repair. Please refer to the SoilSight™ Pipe Map and segment views for the exact locations of the probe holes.

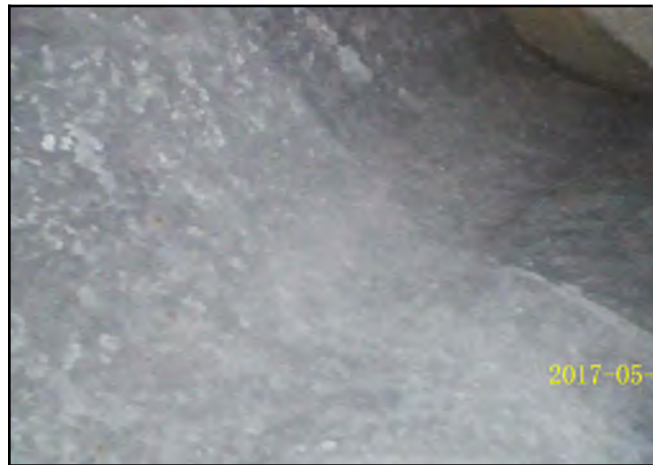
Photo 16 - V-2: Endoscope camera placed in the probe hole showing void.

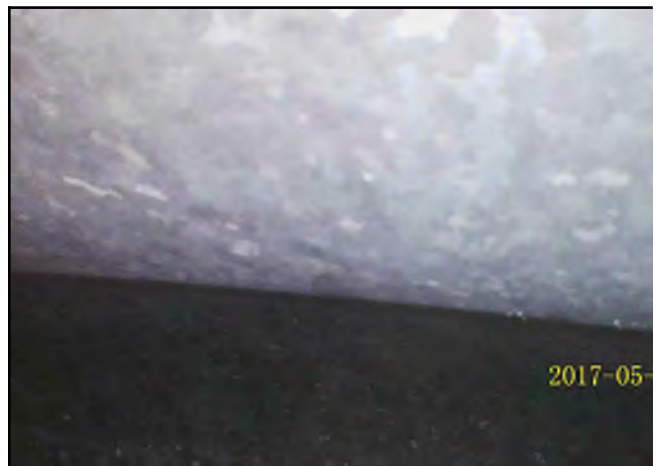
Photo 18 - V-3: Endoscope camera placed in the probe hole showing void.

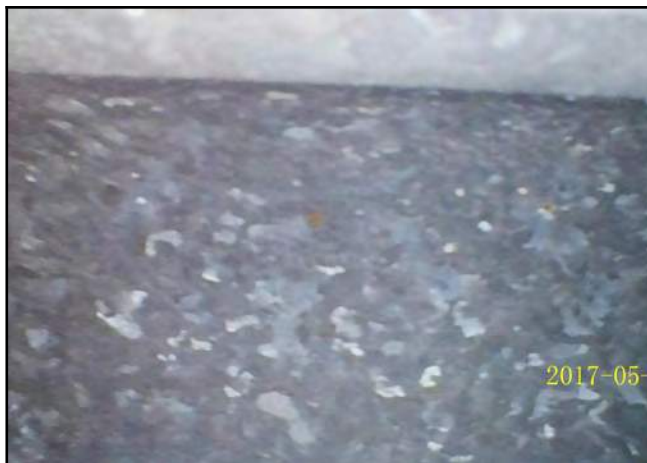
Photo 19 - V-3: Endoscope camera placed in the probe hole showing void.

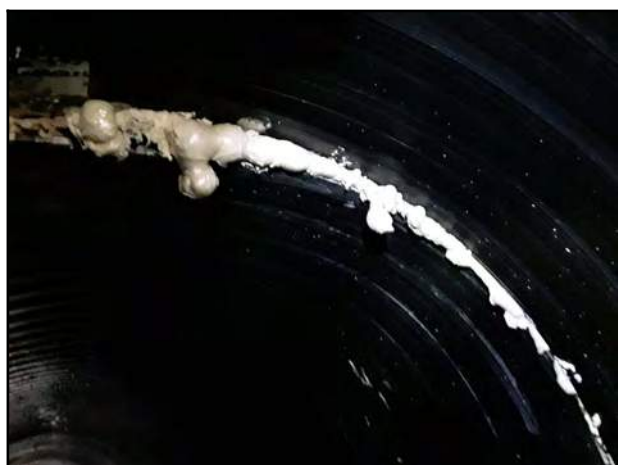
Photo 21 - V-5: Offset joint by approximately 40 mm with visible grouting and foam.

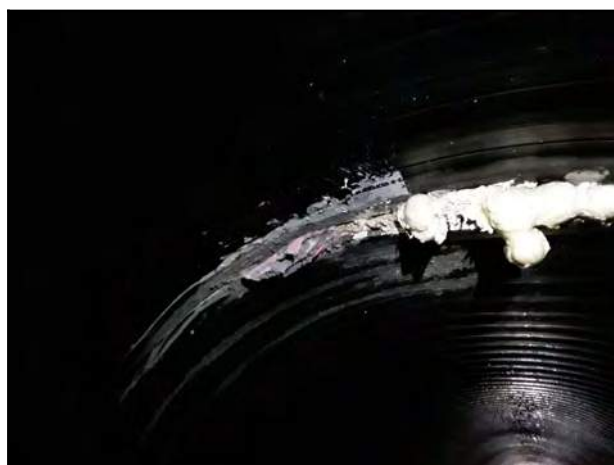
Photo 22 - V-5: Offset joint by approximately 40 mm with visible grouting and foam.

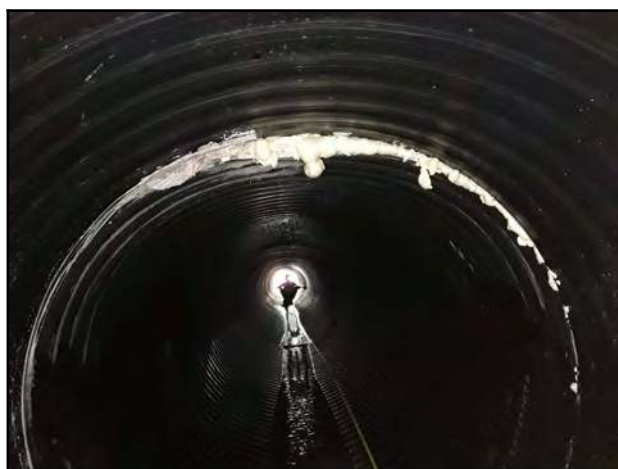
Photo 23 - V-5: Offset joint by approximately 40 mm with visible grouting and foam.

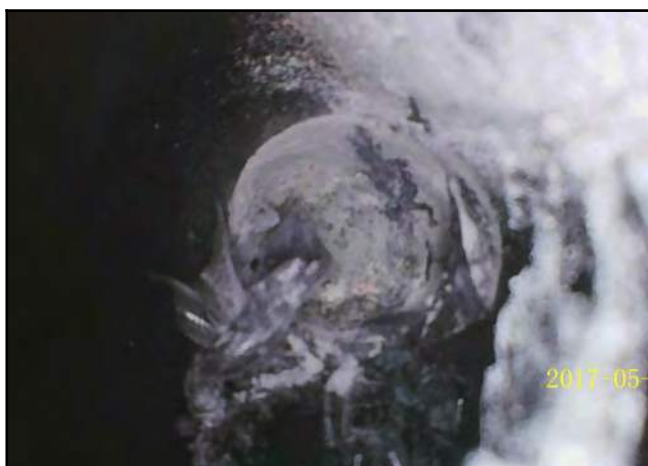
Photo 29 - V-8: Endoscope camera placed in the probe hole showing no void.

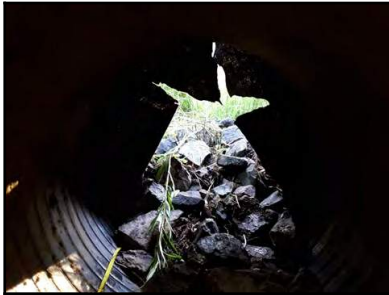
- Streambed material present: **Location:** Within pipe barrel.; X1: 24.00 m; X2: 31.60 m
Extent of blockage.: Equal to or less than 20%.

Photo 8 - Upstream channel view.

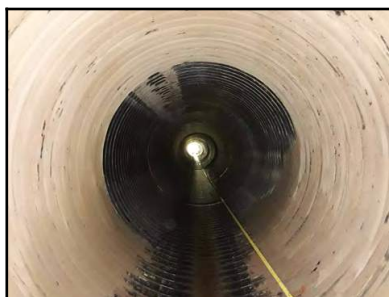
Slight horizontal misalignment at the outlet end.

Photo 11 - Downstream pipe alignment and shape.

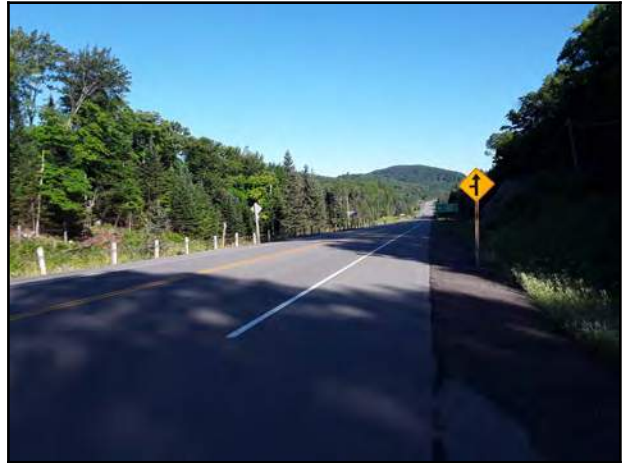
Photo 2 - Highway 17 facing west.

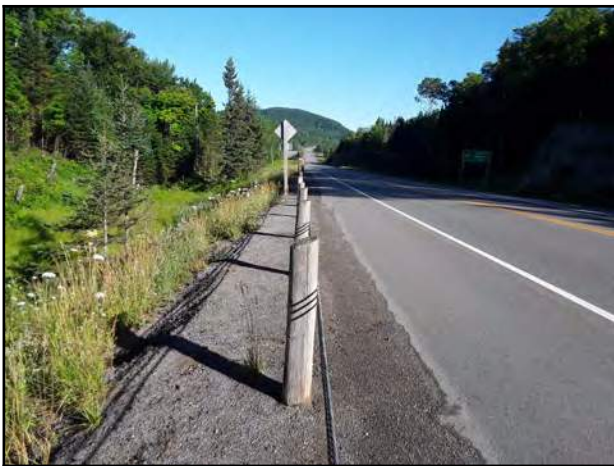
Photo 3 - Outlet guardrail.

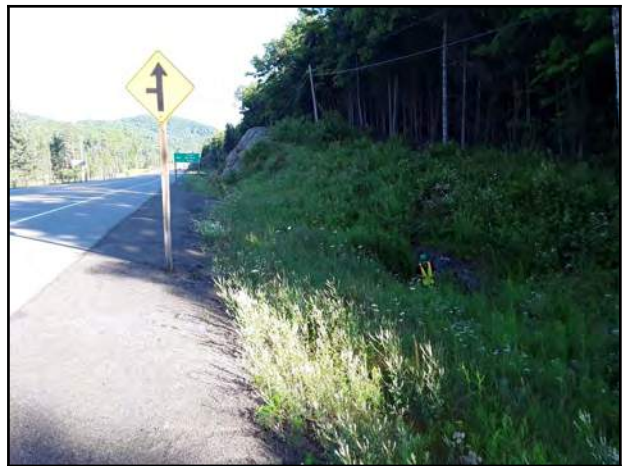
Photo 4 - Inlet embankment.

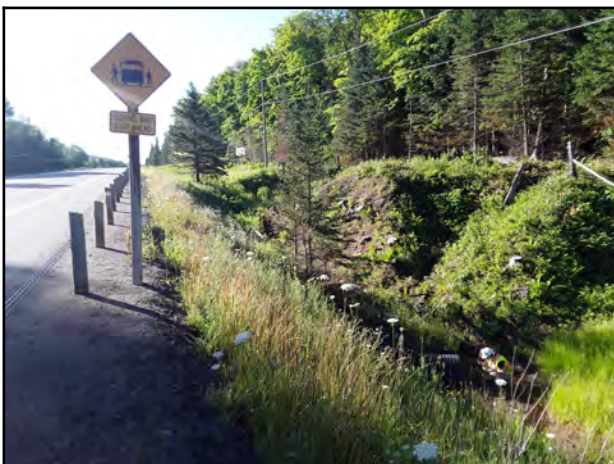
Photo 5 - Outlet embankment.

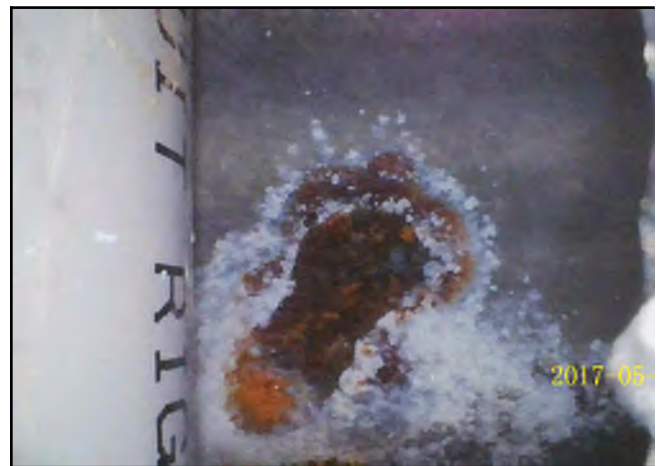
Photo 12 - V-1: Endoscope camera placed in the probe hole showing void.

As noted in V-1, V-2, and V-5, visible annular voids between the existing and sliplined culverts were recorded at each probe hole location, confirming the inSight™ Lite anomalous regions at these locations. V-3 and V-7 were identified as locations of no void. Following the inspection, each hole was sealed with a silicone sealant.

Based on the findings, it is recommended that the areas with confirmed annular voids between the existing culvert and the Sliplined HDPE be injected with grouting material approved by the design engineer. This will ensure the supporting soil structure remains stable when the host culvert fully deteriorates. This can be accomplished by injecting grout directly in the center of the specific area and drilling overflow ports to ensure the product has reached the desired location. Locations of the captured probe holes are indicated by the distance from the inlet, as well as the clock position, and should be referenced during the injections. The SoilSight™ Pipe Map should also be utilized to help estimate the material volumes required to complete the repair. Please refer to the SoilSight™ Pipe Map and segment views for the exact locations of the probe holes.

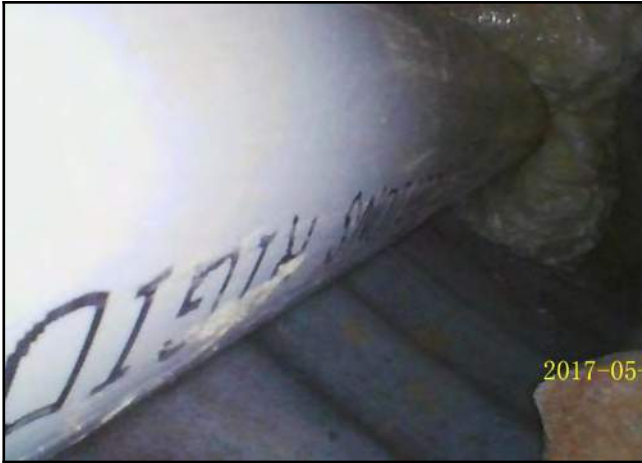
Photo 13 - V-1: Endoscope camera placed in the probe hole showing void.

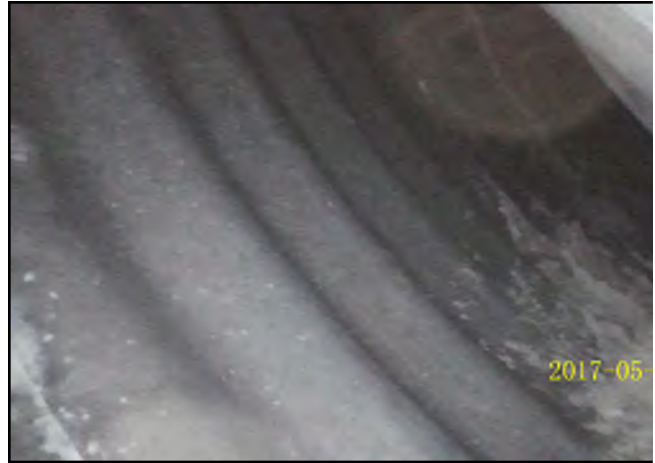
Photo 14 - V-1: Endoscope camera placed in the probe hole showing void.

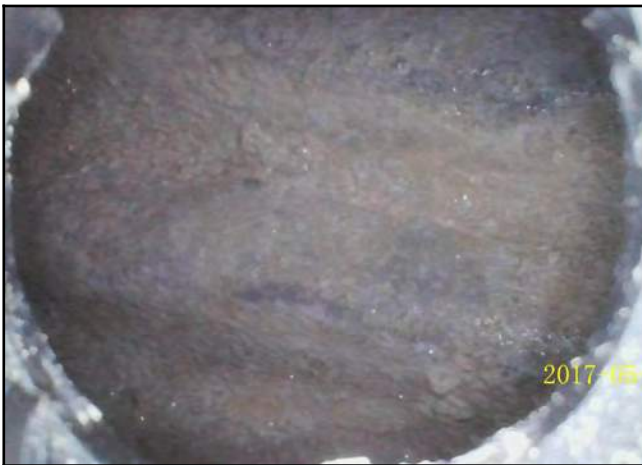
Photo 15 - V-2: Endoscope camera placed in the probe hole showing void.

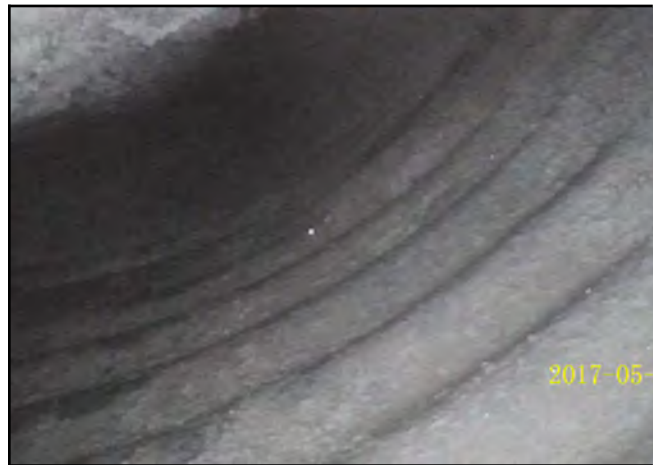
Photo 16 - V-2: Endoscope camera placed in the probe hole showing void.

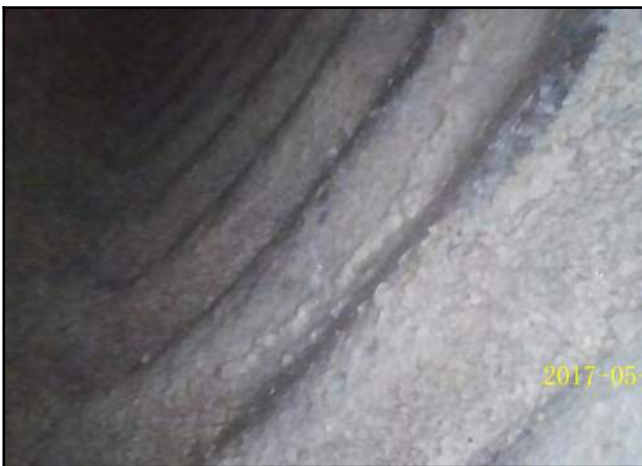
Photo 17 - V-2: Endoscope camera placed in the probe hole showing void.

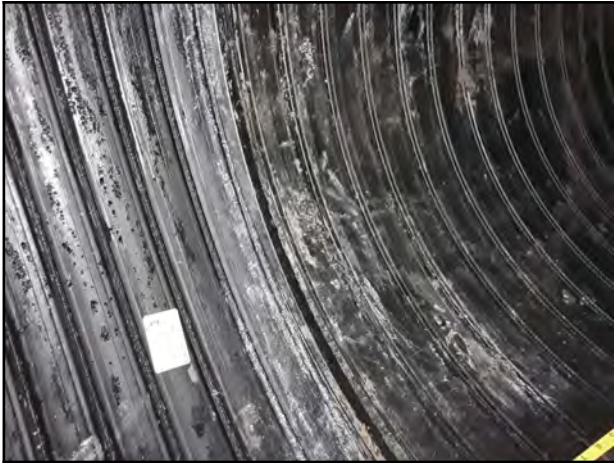
Photo 19 - V-4: Separated joint by approximately 40 mm.

The culvert was found to be in fair condition and performing as designed, however, a few deficiencies were noted. The visual assessment identified two (2) visual indicators, V-4 and V-6, which consisted of separated joints of approximately 40 mm. Visual indicator V-2 also had minor localized damage evident.

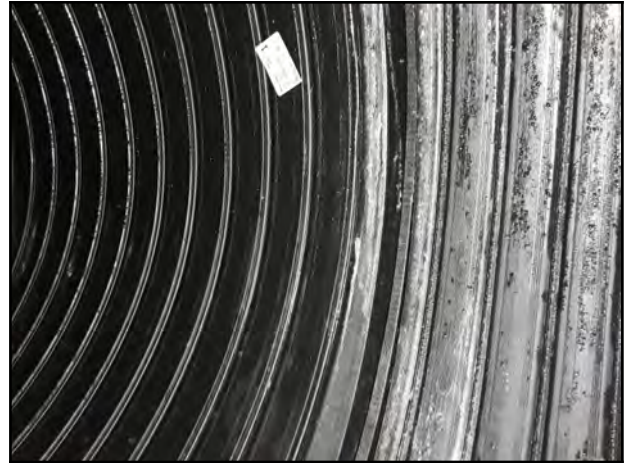
Photo 20 - V-4: Separated joint by approximately 40 mm.

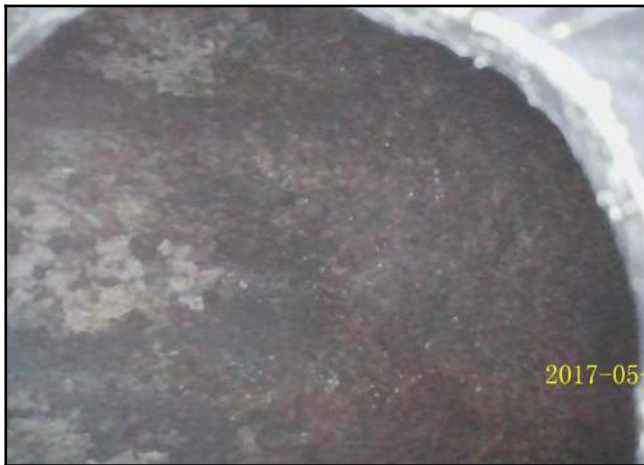
Photo 21 - V-5: Endoscope camera placed in the probe hole showing void.

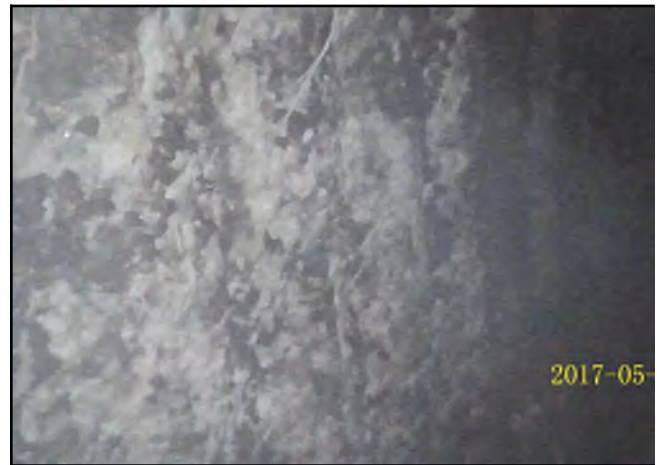
Photo 22 - V-5: Endoscope camera placed in the probe hole showing void.

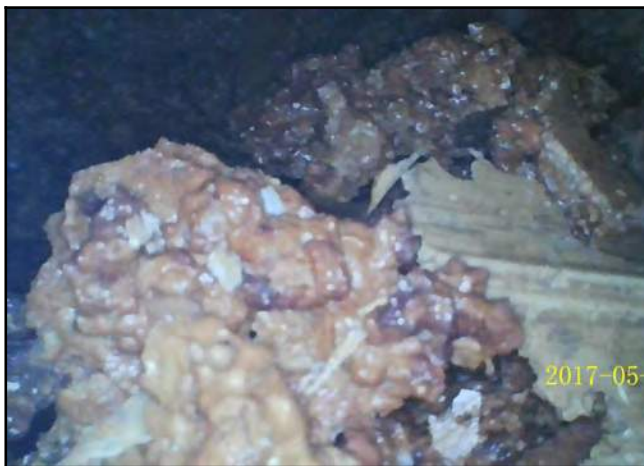
Photo 23 - V-5: Endoscope camera placed in the probe hole showing void.

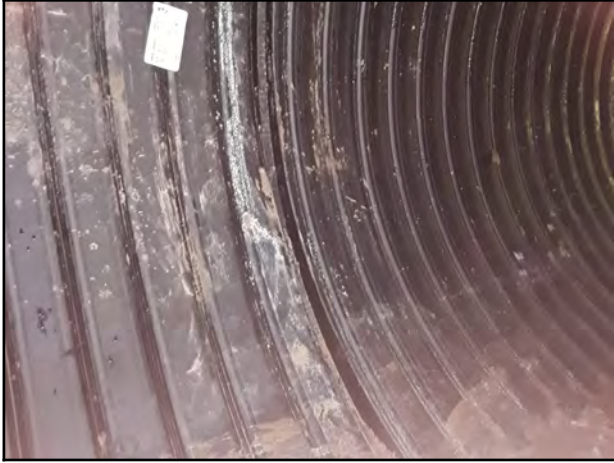
Photo 25 - V-6: Separated joint by approximately 40 mm with minor localized damage evident.

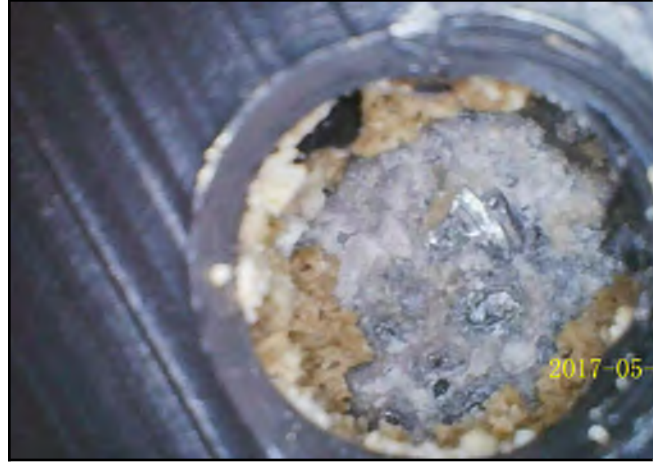
Photo 26 - V-7: Endoscope camera placed in the probe hole showing no void.

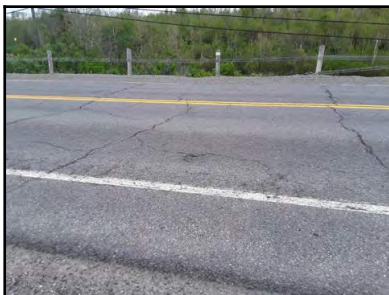
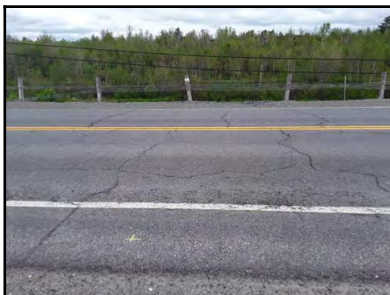
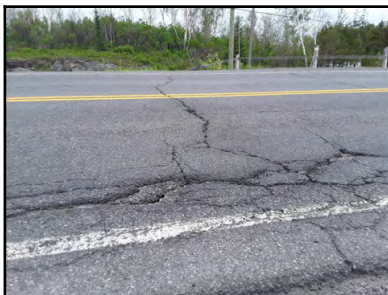
Pavement		Rank 5
<ul style="list-style-type: none">Vehicle track rutting present: Severity: Severe (21 - 40 mm (0.9 - 1.6 in) Depth).		
Cracks		
<ul style="list-style-type: none">Longitudinal cracks: Frequency: Frequent (more than 5 cracks); Severity: Severe (> 15 mm (0.6 in) Width)Transverse cracks present: Frequency: Frequent (more than 5 cracks); Severity: Severe (> 15 mm (0.6 in) Width)		
Potholes		
<ul style="list-style-type: none">Pothole(s) present: Frequency: Medium (2 - 5 potholes); Severity: Very severe (> 40 mm (1.5 in) Depth)

Photo 2 - Minor pothole measuring approximately 20 mm in-depth.	Photo 1 - Multiple severe transverse and longitudinal cracks directly above the pipe.	Photo 3 - Pothole measuring approximately 100 mm in-depth not directly over pipe.

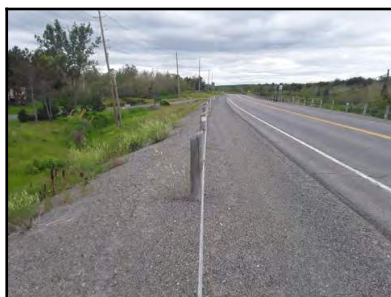
- Corrosion present: **Severity:** Light surface corrosion.
- Horizontal misalignment present.

Photo 6 - Inlet guardrail.

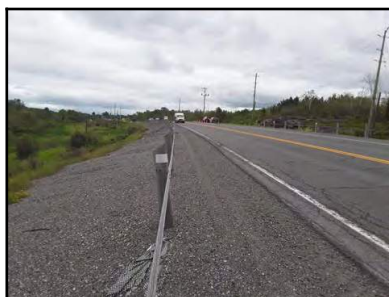
- Corrosion present: **Severity:** Light surface corrosion.

Photo 7 - Outlet guardrail.

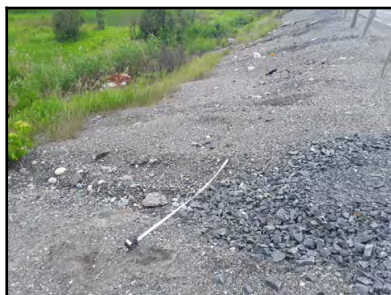
- Erosion channel(s) present: **Frequency:** > 5 channels; **Severity:** Very severe (> 300 mm (12 in) Width).
- Vegetation present: **Size:** Small vegetation present (< 3.0 m (10 ft) in height).

Photo 8 - Multiple erosion channels on the outlet, most severe measuring approximately 1500 mm in width.

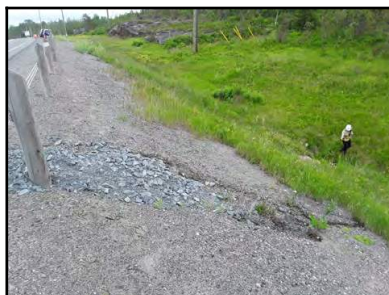
Photo 9 - Poorly repaired erosion channel on the inlet embankment.

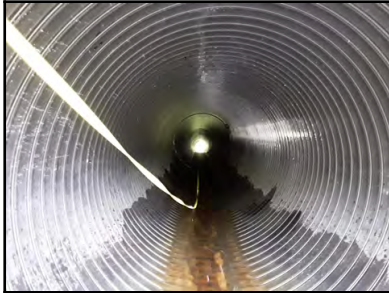
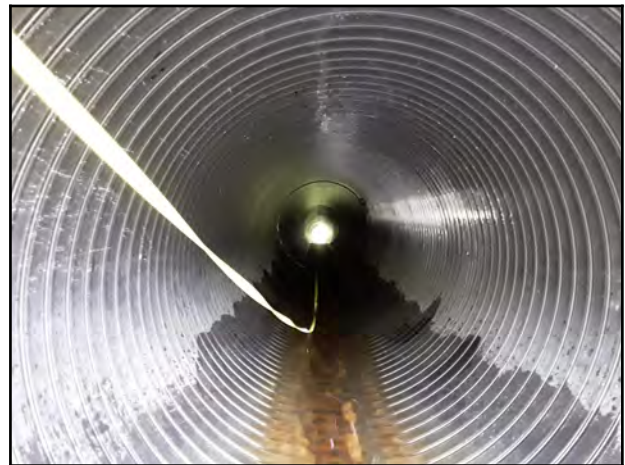
- Vertical misalignment of terminal pipe ends present.

Photo 16 - Upstream pipe alignment and shape.

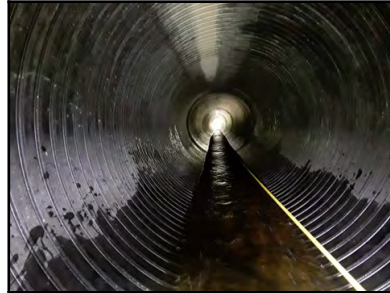
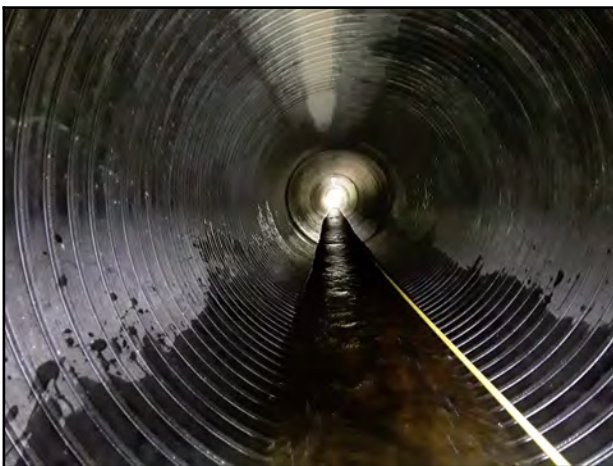
Photo 17 - Downstream pipe alignment and shape.

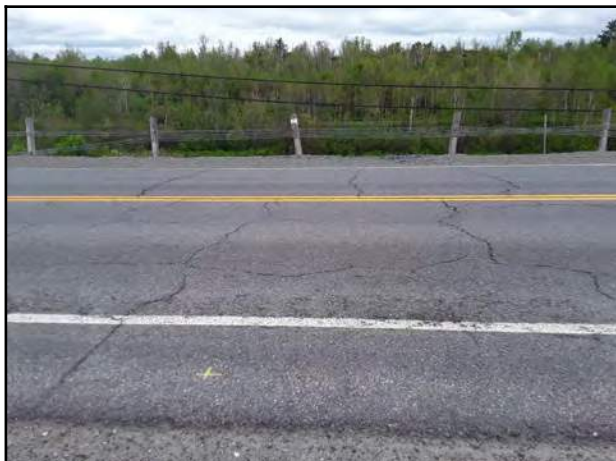
Photo 1 - Multiple severe transverse and longitudinal cracks directly above the pipe.

The culvert was found to be in fair condition and performing as designed, however, several deficiencies were noted. The visual inspection revealed the roadway above the asset was in poor condition with severe transverse and longitudinal cracks directly above the pipe. Additionally, two (2) potholes were identified near the asset measuring approximately 20 mm and 100 mm in-depth. Both the inlet and outlet guardrails had light surface corrosion and the inlet guardrail had visible horizontal misalignment. The outlet embankment had multiple erosion channels with the most severe measuring approximately 1500 mm in width, as shown in Photo 8.

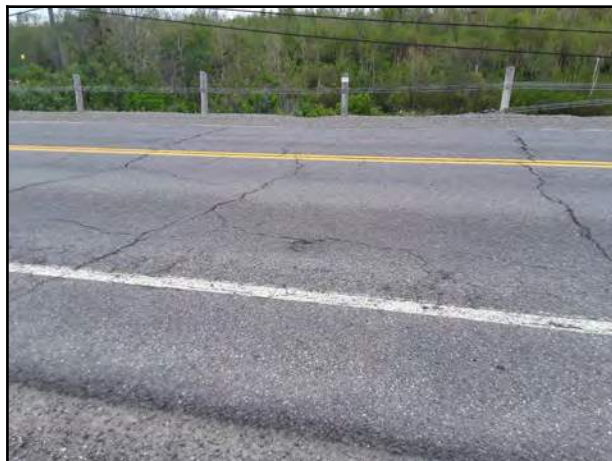
Photo 2 - Minor pothole measuring approximately 20 mm in-depth.

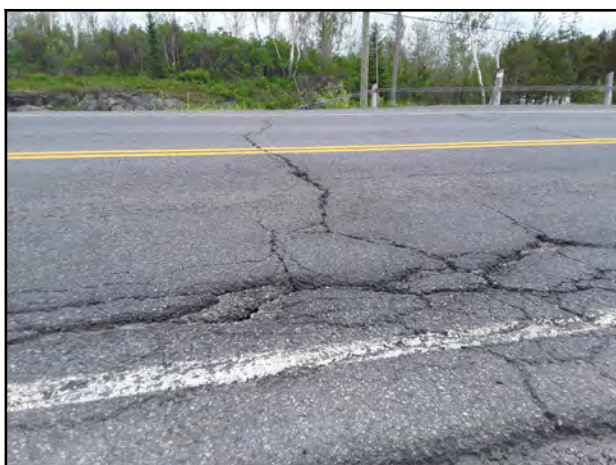
Photo 3 - Pothole measuring approximately 100 mm in-depth not directly over pipe.

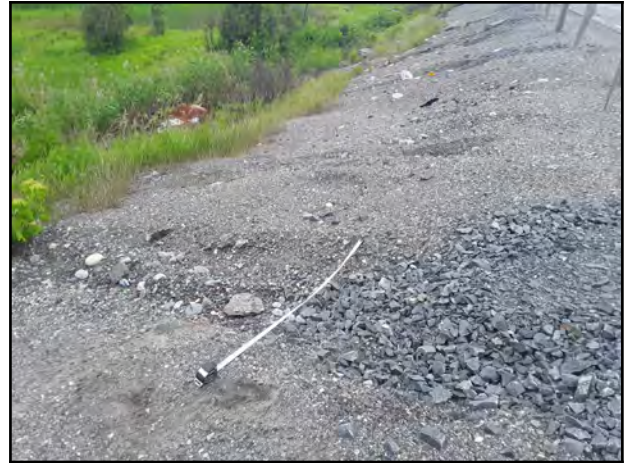
Photo 8 - Multiple erosion channels on the outlet, most severe measuring approximately 1500 mm in width.

Based on the findings, it is recommended the outlet embankment be repaired and stabilized to prevent further deterioration and/or potential failure. Additionally, it is recommended that the areas with confirmed annular voids between the existing culvert and the sliplined HDPE be injected with grouting material approved by the design engineer. This will ensure the supporting soil structure remains stable when the host culvert fully deteriorates. This can be accomplished by injecting grout directly in the center of the specific area and drilling overflow ports to ensure the product has reached the desired location. Locations of the captured probe holes are indicated by the distance from the inlet, as well as the clock position, and should be referenced during the injections. The SoilSight™ Pipe Map should also be utilized to help estimate the material volumes required to complete the repair. Please refer to the SoilSight™ Pipe Map and segment views for the exact locations of the probe holes.

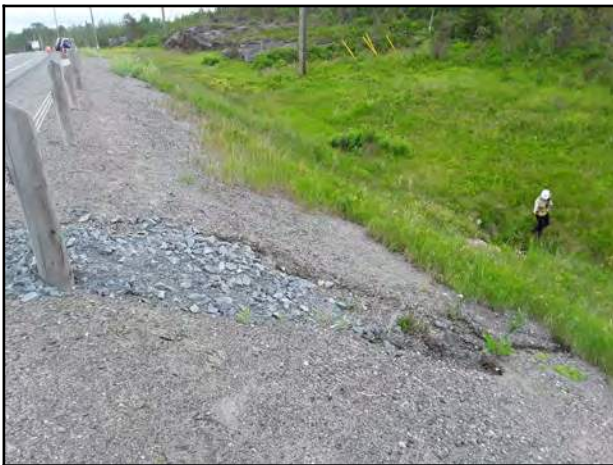
Photo 9 - Poorly repaired erosion channel on the inlet embankment.

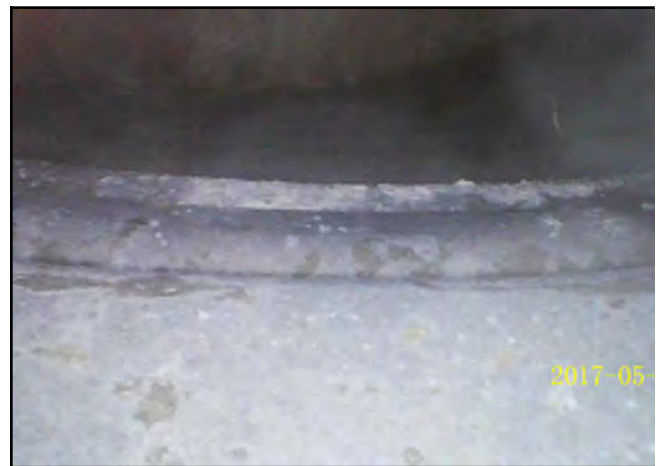
Photo 18 - V-1: Endoscope camera placed in the probe hole showing void.

As noted in V-1, V-2, V-3, and V-4, visible annular voids between the existing culvert and the sliplined HDPE were recorded at each probe hole location, confirming the inSight™ Lite anomalous regions at all locations. Following the inspection, each hole was sealed with a silicone sealant.

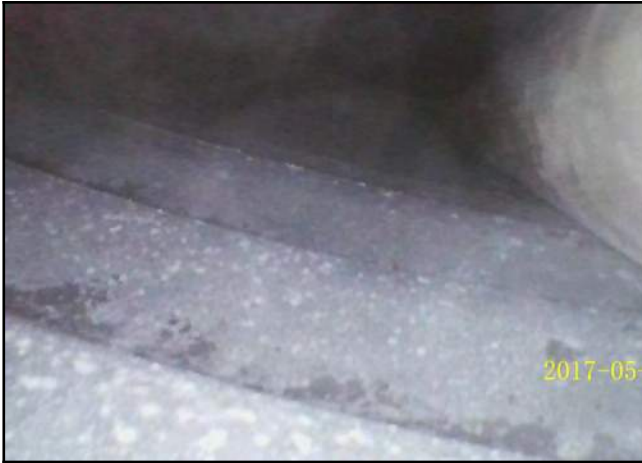
Photo 19 - V-1: Endoscope camera placed in the probe hole showing void.
