DRAFT
GROUT-IN-PLACE CULVERT LINING INVESTIGATION REPORT

4018-E-0001 ASSIGNMENT #5

Ministry of Transportation Ontario
c/o WSP Canada Group Limited

October 2020
Thurber File No.: 28182

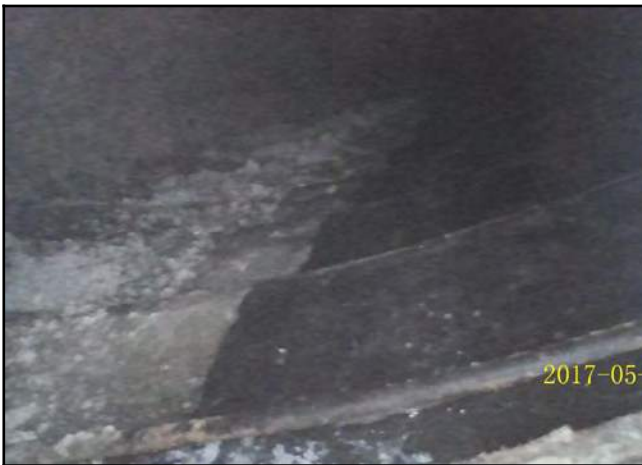
Photo 21 - V-2: Endoscope camera placed in the probe hole showing void.

As noted in V-1, V-2, V-3, and V-4, visible annular voids between the existing culvert and the sliplined HDPE were recorded at each probe hole location, confirming the inSight™ Lite anomalous regions at all locations. Following the inspection, each hole was sealed with a silicone sealant.

Based on the findings, it is recommended the outlet embankment be repaired and stabilized to prevent further deterioration and/or potential failure. Additionally, it is recommended that the areas with confirmed annular voids between the existing culvert and the sliplined HDPE be injected with grouting material approved by the design engineer. This will ensure the supporting soil structure remains stable when the host culvert fully deteriorates. This can be accomplished by injecting grout directly in the center of the specific area and drilling overflow ports to ensure the product has reached the desired location. Locations of the captured probe holes are indicated by the distance from the inlet, as well as the clock position, and should be referenced during the injections. The SoilSight™ Pipe Map should also be utilized to help estimate the material volumes required to complete the repair. Please refer to the SoilSight™ Pipe Map and segment views for the exact locations of the probe holes.

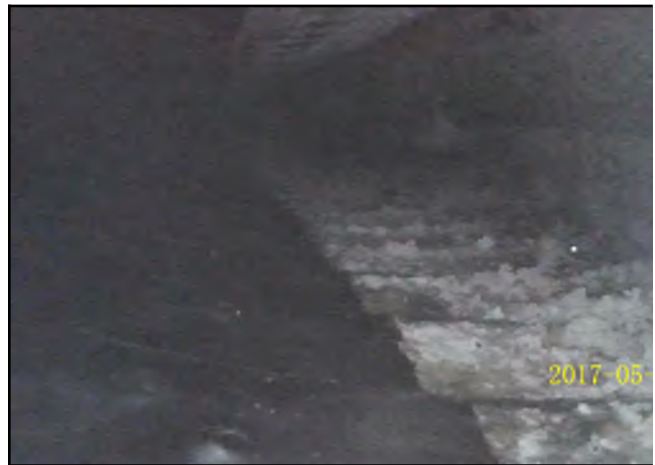
Photo 22 - V-2: Endoscope camera placed in the probe hole showing void.

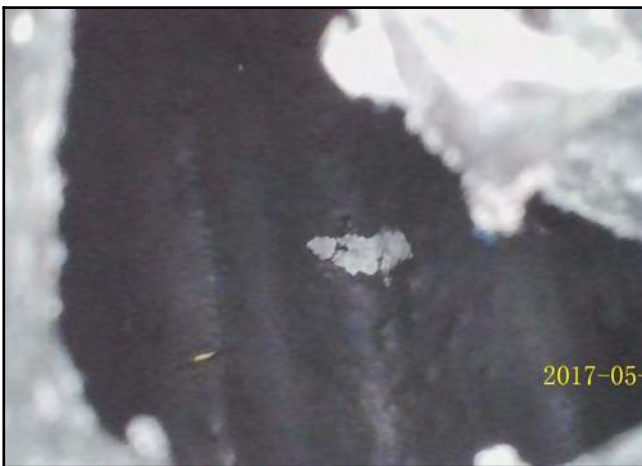
Photo 23 - V-2: Endoscope camera placed in the probe hole showing void.

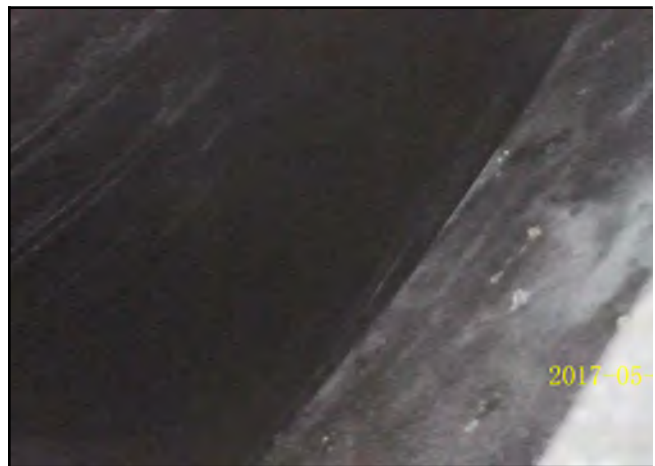
Photo 24 - V-3: Endoscope camera placed in the probe hole showing void.

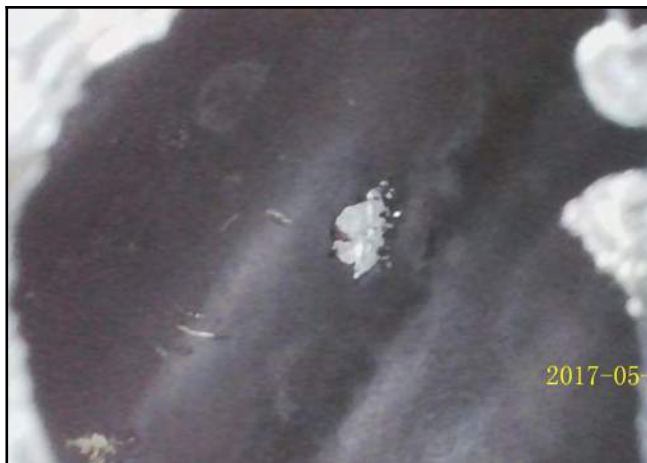
Photo 25 - V-3: Endoscope camera placed in the probe hole showing void.

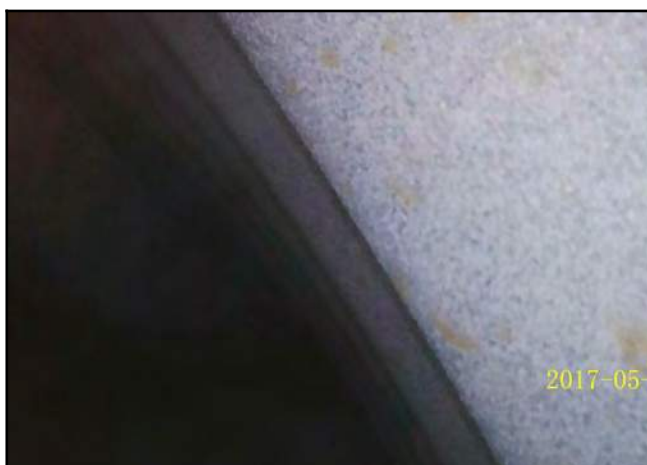
Photo 27 - V-4: Endoscope camera placed in the probe hole showing void.

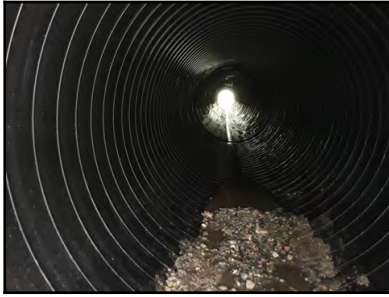
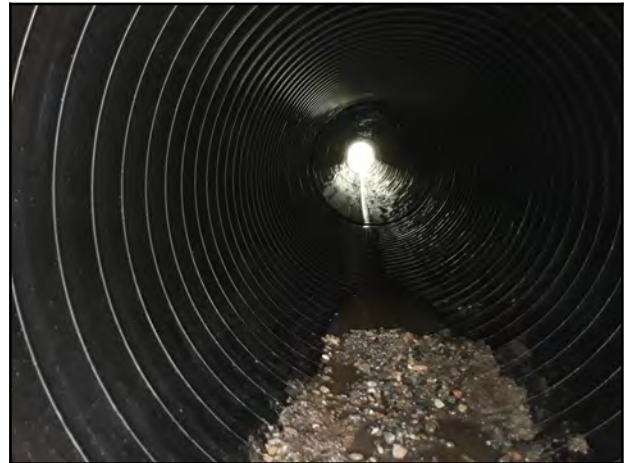
Pipe well aligned.

Photo 10 - Upstream pipe alignment and shape.

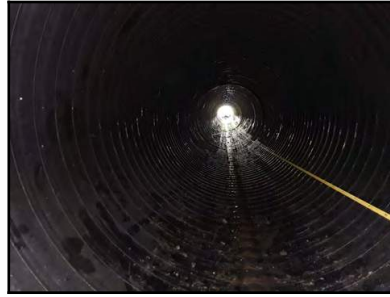
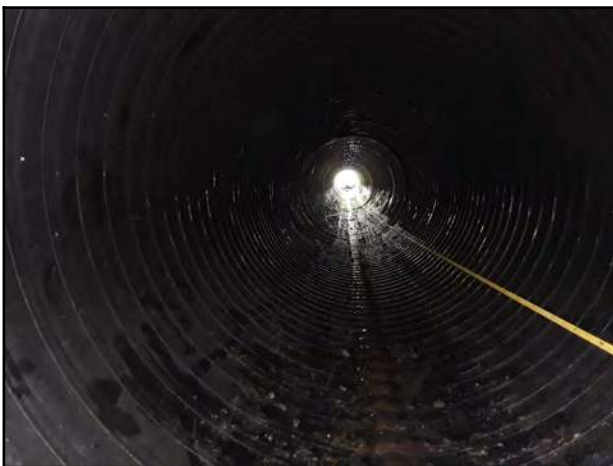
Photo 11 - Downstream pipe alignment and shape.

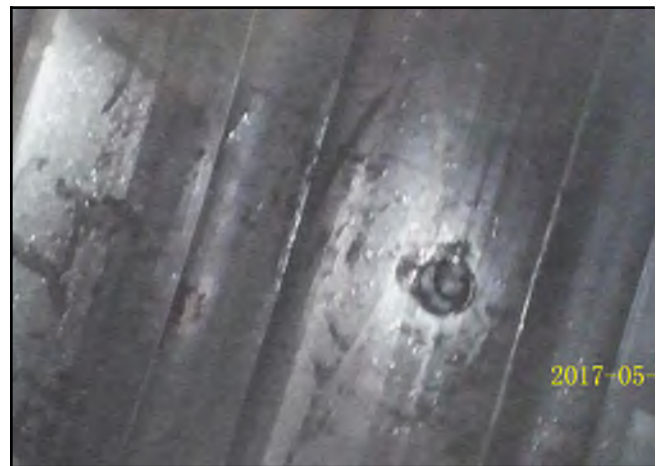
Photo 12 - V-1: Endoscope camera placed in the probe hole showing void.

Photo 13 - V-1: Endoscope camera placed in the probe hole showing void.

Photo 14 - V-1: Endoscope camera placed in the probe hole showing void.

As noted in V-1, V-2, V-3, and V-4, visible annular voids between the existing culvert and the sliplined HDPE were recorded at each probe hole location, confirming the inSight™ Lite anomalous regions at all locations. Following the inspection, each hole was sealed with a silicone sealant.

Based on the findings, it is recommended that the areas with confirmed annular voids between the existing culvert and the Sliplined HDPE be injected with grouting material approved by the design engineer. This will ensure the supporting soil structure remains stable when the host culvert fully deteriorates. This can be accomplished by injecting grout directly in the center of the specific area and drilling overflow ports to ensure the product has reached the desired location. Locations of the captured probe holes are indicated by the distance from the inlet, as well as the clock position, and should be referenced during the injections. The SoilSight™ Pipe Map should also be utilized to help estimate the material volumes required to complete the repair. Please refer to the SoilSight™ Pipe Map and segment views for the exact locations of the probe holes.

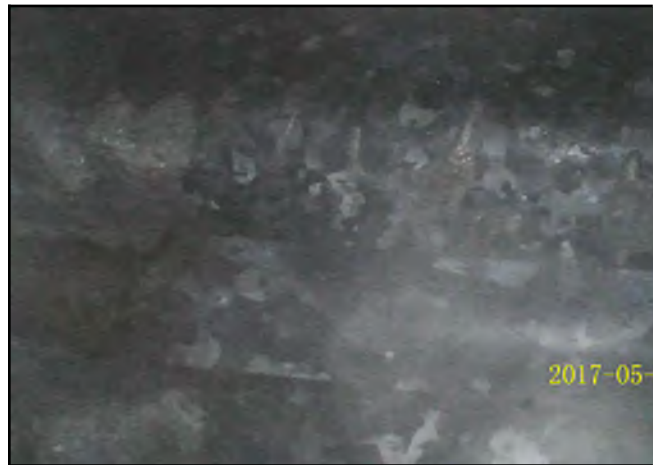
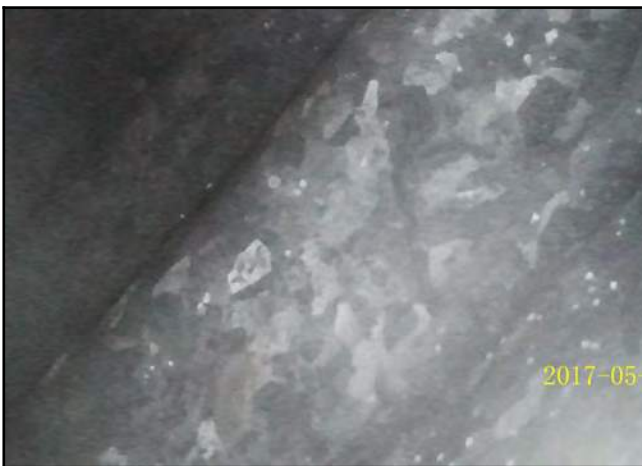
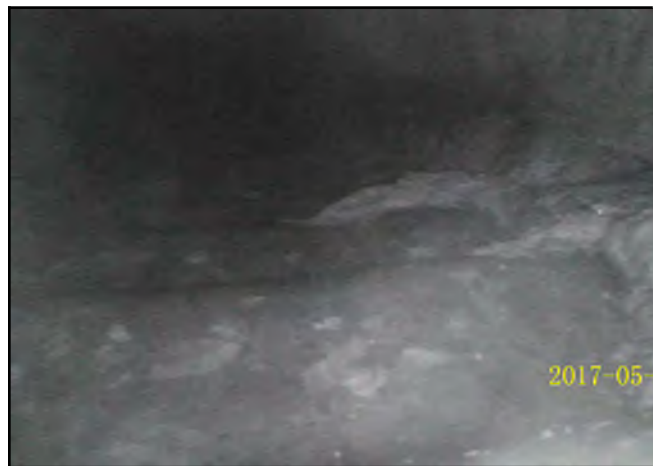
Photo 15 - V-2: Endoscope camera placed in the probe hole showing void.

Photo 16 - V-2: Endoscope camera placed in the probe hole showing void.

Photo 17 - V-2: Endoscope camera placed in the probe hole showing void.

Photo 18 - V-2: Endoscope camera placed in the probe hole showing void.

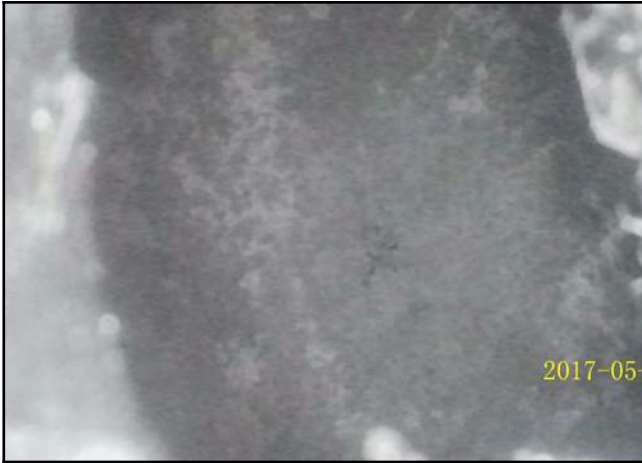
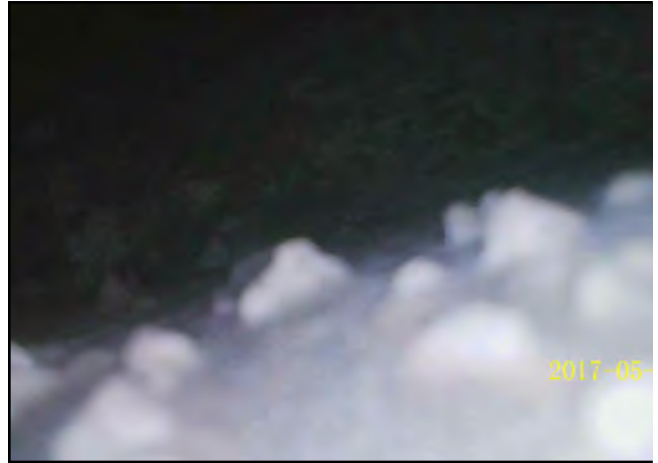
Photo 19 - V-3: Endoscope camera placed in the probe hole showing void.

Photo 20 - V-3: Endoscope camera placed in the probe hole showing void.

Photo 21 - V-3: Endoscope camera placed in the probe hole showing void.

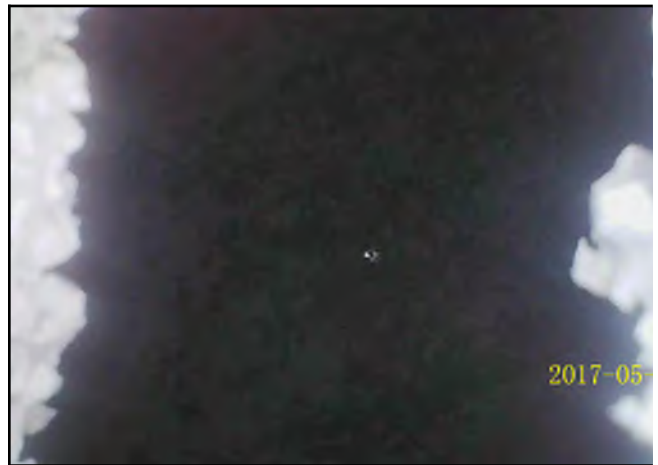
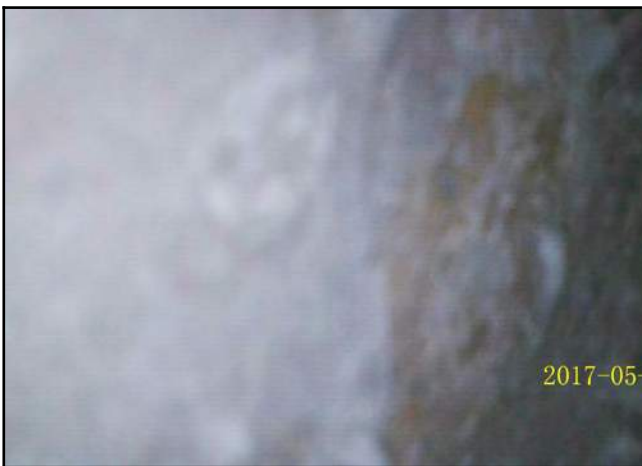
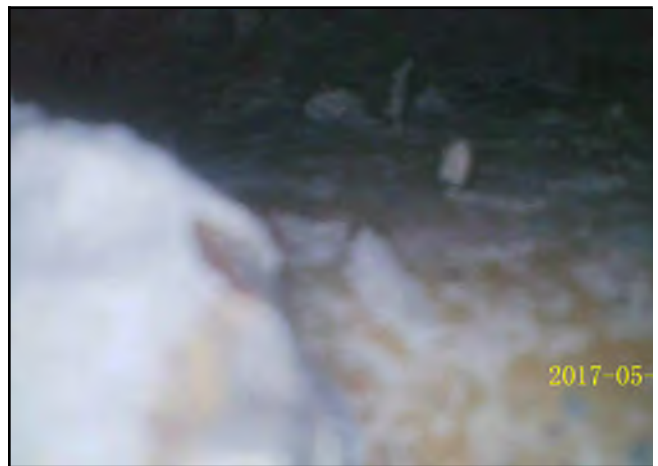
Photo 22 - V-4: Endoscope camera placed in the probe hole showing void.

Photo 23 - V-4: Endoscope camera placed in the probe hole showing void.

Photo 24 - V-4: Endoscope camera placed in the probe hole showing void.

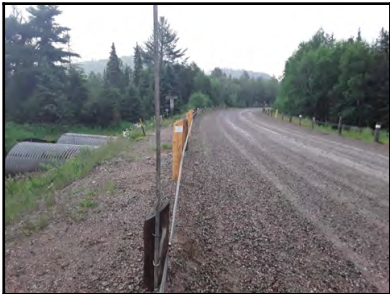
Guardrail	Rank 2
Inlet guardrail has minor slack in wire.	
Inlet guardrail.: Present.	
Outlet guardrail.: Present.

Photo 3 - Inlet guardrail.	Photo 4 - Outlet guardrail.

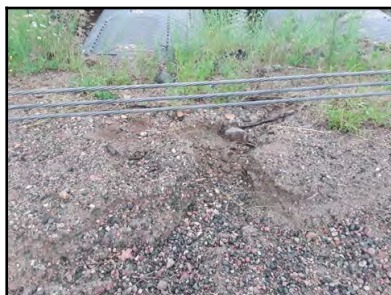
- Erosion channel(s) present: **Frequency:** 1 channel; **Severity:** Very severe (> 300 mm (12 in) Width).
- Rip-Rap stabilizing embankment present.

Photo 5 - Erosion channel on the outlet embankment measuring approximately 430 mm in width.

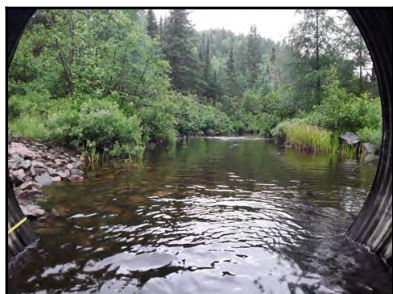
Some large boulders found throughout the pipe invert.

- Streambed material present: **Location:** Within pipe barrel.; X1: 5.00 m; X2: 20.00 m

Extent of blockage.: Equal to or less than 20%.

Photo 10 - Upstream channel view.

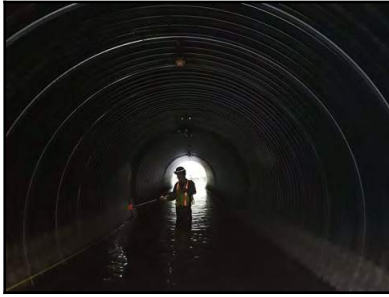
Pipe well aligned.

Photo 12 - Upstream pipe alignment and shape.

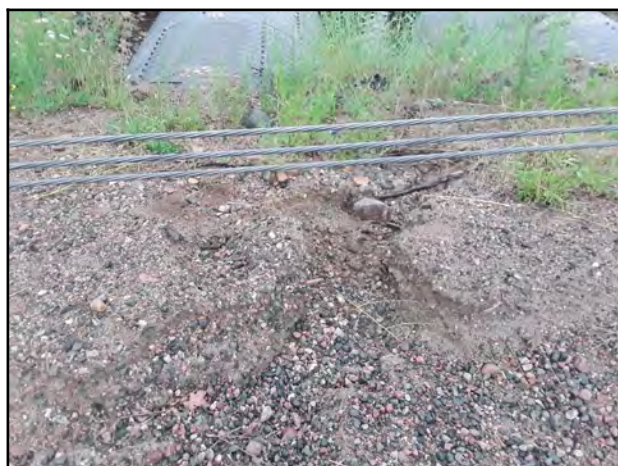
Photo 5 - Erosion channel on the outlet embankment measuring approximately 430 mm in width.

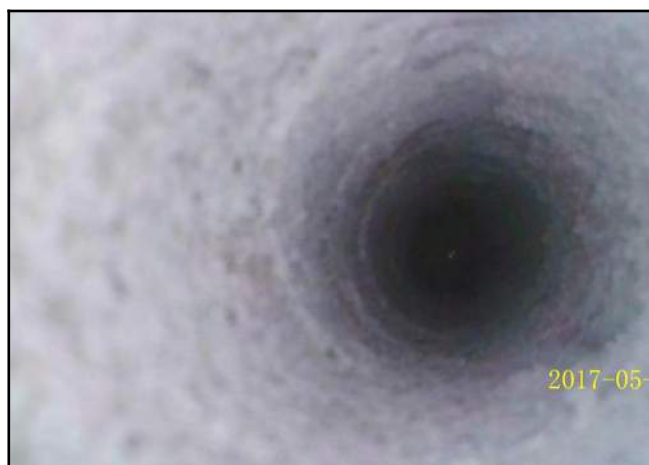
Photo 15 - V-1: Endoscope camera placed in the probe hole showing no void.

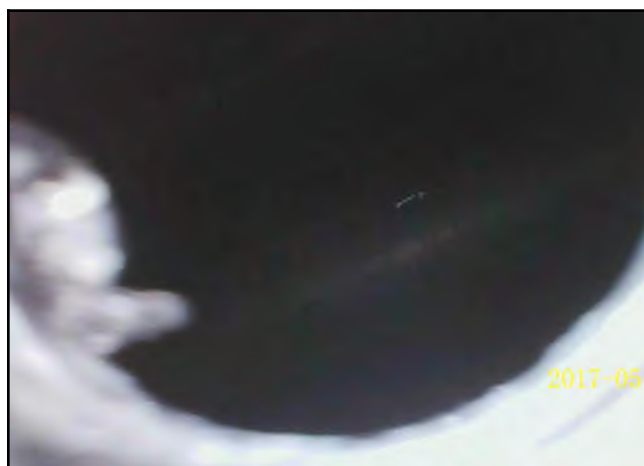
Photo 18 - V-3: Endoscope camera placed in the probe hole showing void.

As noted in V-2, V-3, and V-4, visible annular voids between the existing and sliplined culverts were recorded at each probe hole location, confirming the inSight™ Lite anomalous regions at all locations. V-1 was recorded as a location of no void (control point). Following the inspection, each hole was sealed with a silicone sealant.

Based on the findings, it is recommended that the areas with confirmed annular voids between the existing culvert and the Sliplined HDPE be injected with grouting material approved by the design engineer. This will ensure the supporting soil structure remains stable when the host culvert fully deteriorates. This can be accomplished by injecting grout directly in the center of the specific area and drilling overflow ports to ensure the product has reached the desired location. Locations of the captured probe holes are indicated by the distance from the inlet, as well as the clock position, and should be referenced during the injections. The SoilSight™ Pipe Map should also be utilized to help estimate the material volumes required to complete the repair. Please refer to the SoilSight™ Pipe Map and segment views for the exact locations of the probe holes.

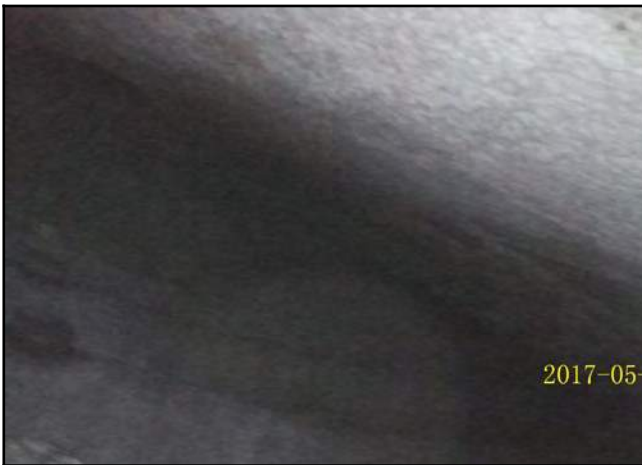
Photo 21 - V-4: Endoscope camera placed in the probe hole showing void.

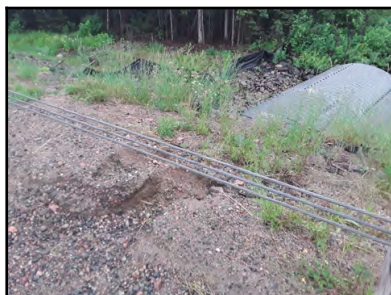
- Erosion channel(s) present: **Frequency:** 1 channel; **Severity:** Very severe (> 300 mm (12 in) Width).
- Rip-Rap stabilizing embankment present.

Photo 5 - Erosion channel on the outlet embankment measuring approximately 430 mm in width.

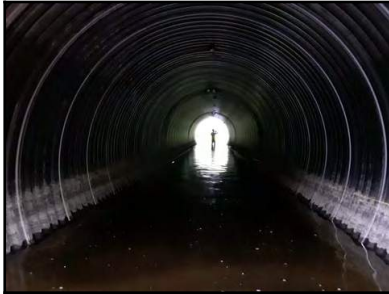
Pipe well aligned.

Photo 12 - Upstream pipe alignment and shape.

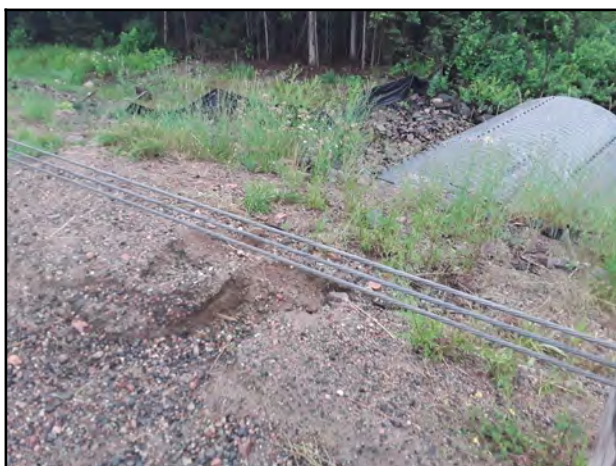
Photo 5 - Erosion channel on the outlet embankment measuring approximately 430 mm in width.

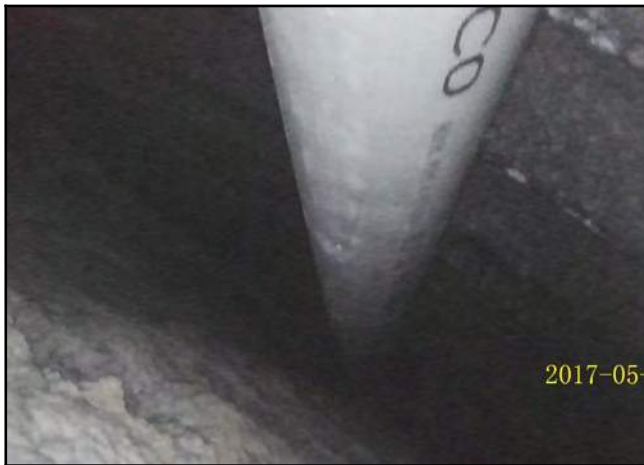
Photo 15 - V-1: Endoscope camera placed in the probe hole showing void.

Based on the findings, it is recommended that the areas with confirmed annular voids between the existing culvert and the sliplined HDPE be injected with grouting material approved by the design engineer. This will ensure the supporting soil structure remains stable when the host culvert fully deteriorates. This can be accomplished by injecting grout directly in the center of the specific area and drilling overflow ports to ensure the product has reached the desired location. Locations of the captured probe holes are indicated by the distance from the inlet, as well as the clock position, and should be referenced during the injections. The SoilSight™ Pipe Map should also be utilized to help estimate the material volumes required to complete the repair. Please refer to the SoilSight™ Pipe Map and segment views for the exact locations of the probe holes.

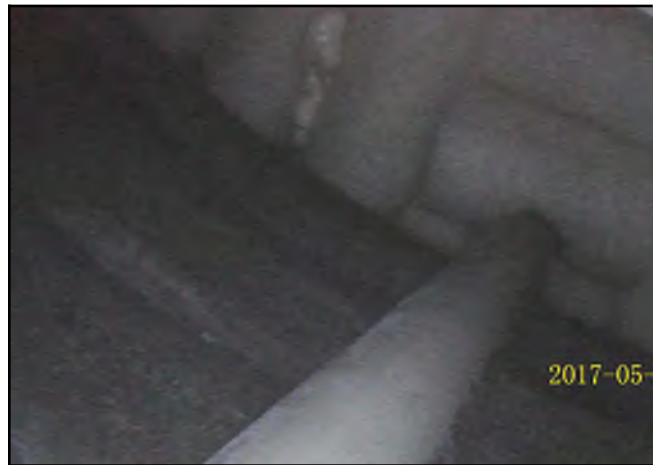
Photo 16 - V-1: Endoscope camera placed in the probe hole showing void.

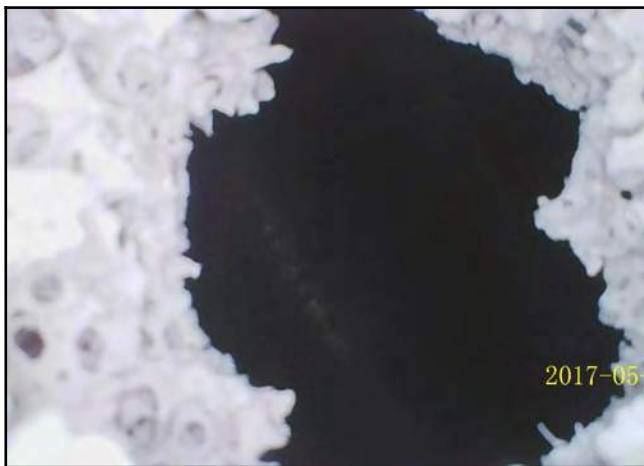
Photo 17 - V-2: Endoscope camera placed in the probe hole showing void.

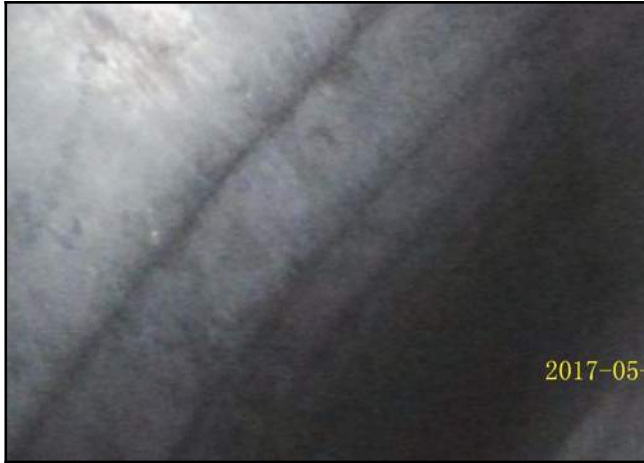
Photo 19 - V-2: Endoscope camera placed in the probe hole showing void.

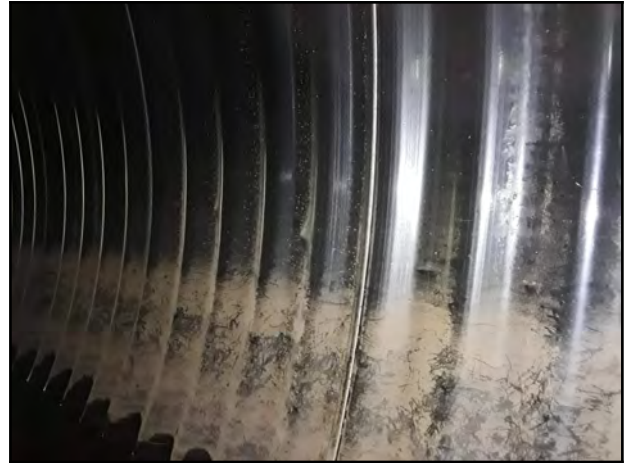
Photo 20 - V-3: Minor dents protruding approximately 15 mm.

The culvert was found to be in fair condition and performing as designed, however, one deficiency was noted. The visual inspection identified one (1) visual indicator, V-3, which consisted of minor dents protruding approximately 15 mm.

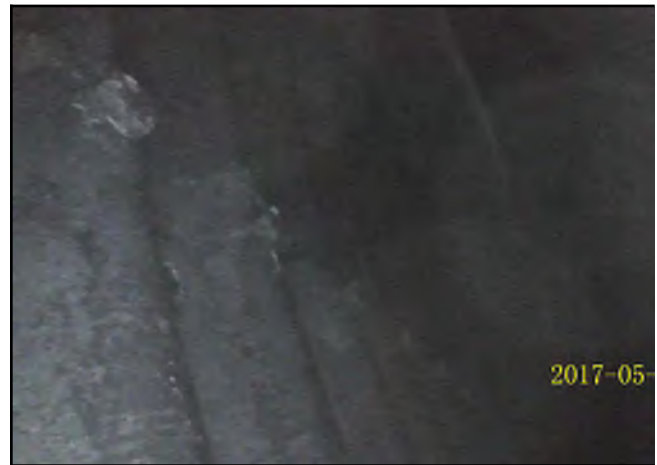
Photo 22 - V-4: Endoscope camera placed in the probe hole showing void.

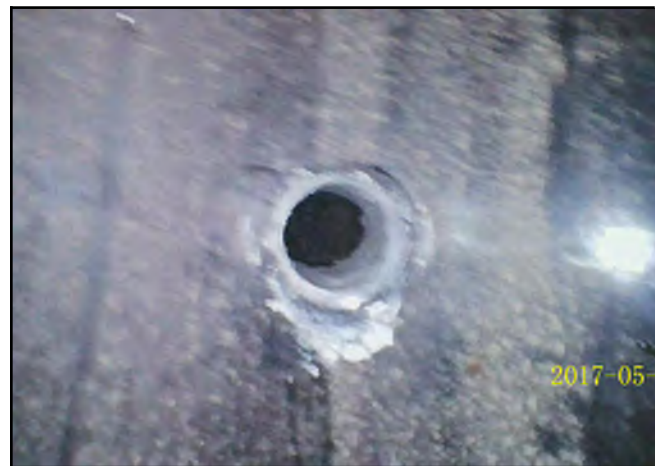
Photo 24 - V-5: Endoscope camera placed in the probe hole showing minor void.

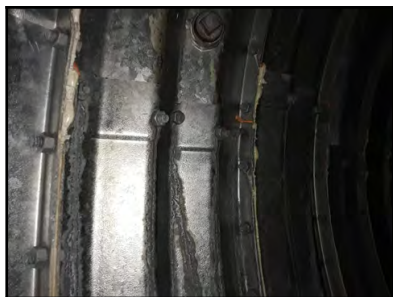
- Water intrusion present.
- Water intrusion at seam(s) present.

Photo 5 - Level 1 water infiltration evident at seam bolt hole locations throughout the entire culvert.

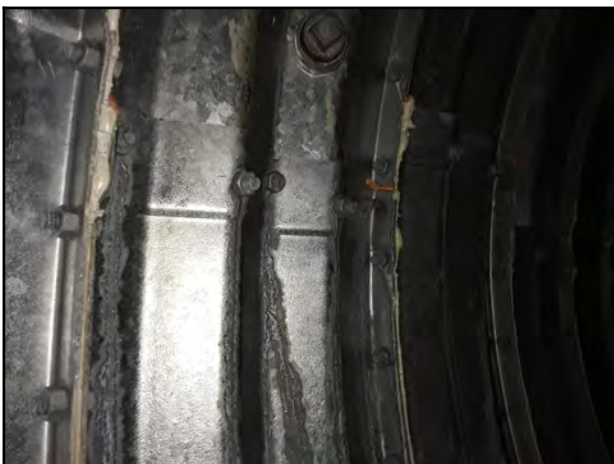
Photo 5 - Level 1 water infiltration evident at seam bolt hole locations throughout the entire culvert.

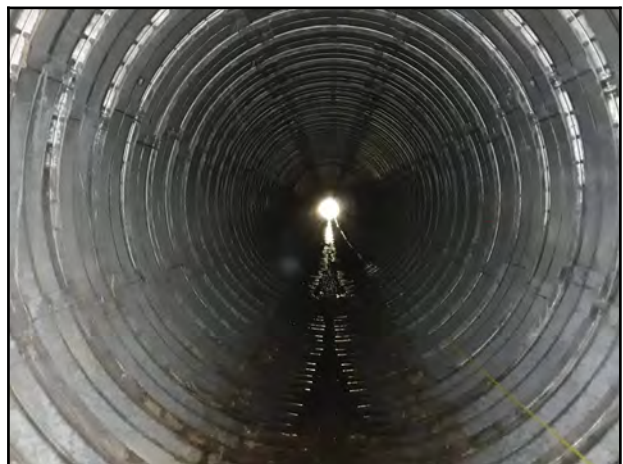
Photo 6 - Upstream pipe alignment and shape.

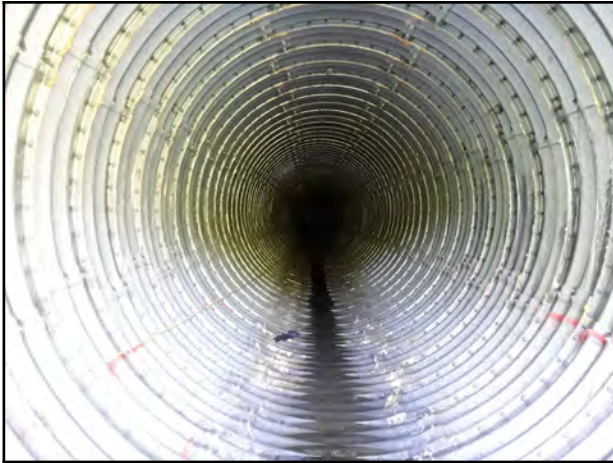
Photo 7 - Downstream pipe alignment and shape.

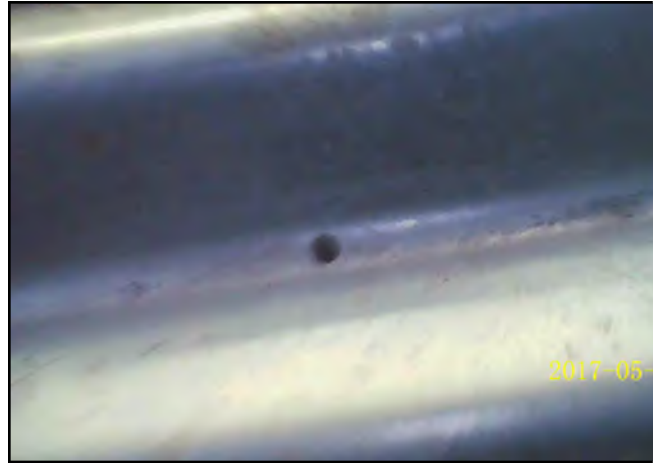
Photo 8 - V-1: Endoscope camera placed in the probe hole showing no void.

As noted in V-1, V-2, V-3 and V-4, no visible annular voids between the existing and Sliplined culverts. were recorded at each probe hole location, confirming the inSight™ Lite regions at these locations. Following the inspection, each hole was sealed with a silicone sealant.

Based on the findings, the annular space between the existing and Sliplined culverts was found to be well grouted. It is therefore recommended that the asset continues to be monitored at its current inspection intervals.

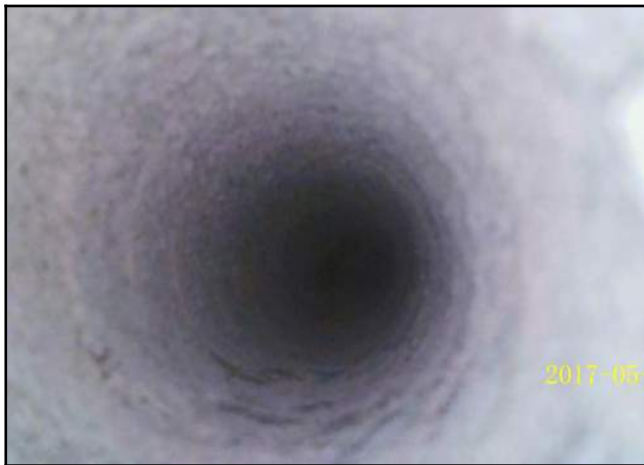
Photo 9 - V-1: Endoscope camera placed in the probe hole showing no void.

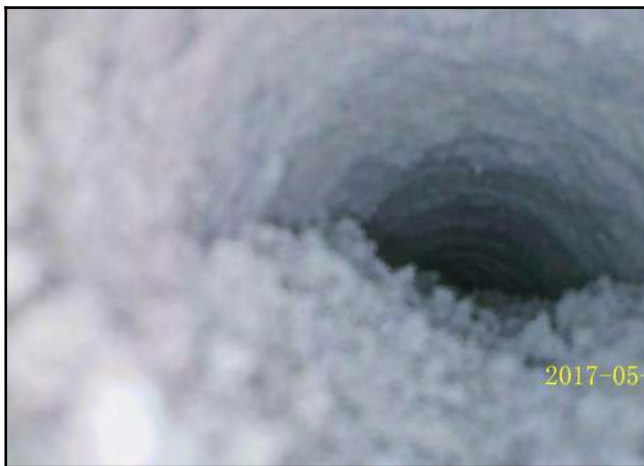
Photo 11 - V-3: Endoscope camera placed in the probe hole showing no void.

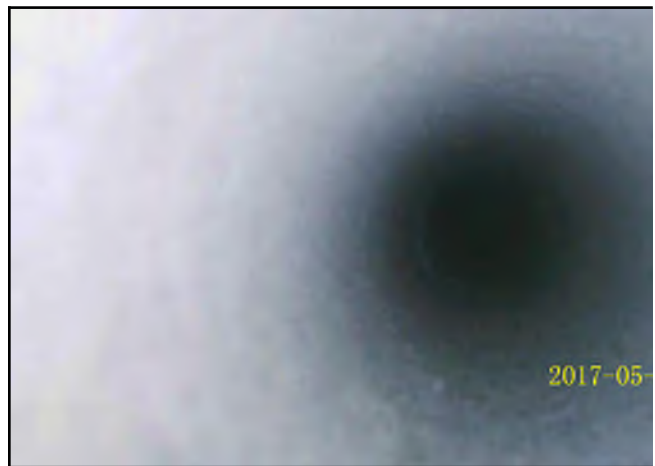
Photo 12 - V-4: Endoscope camera placed in the probe hole showing no void.
