**CONDITION SURVEY REPORT  
3892 HIGHWAY 26 - DRAINAGE DITCH IMPROVEMENT  
AGREEMENT NO. 2013-E-0039  
TOWN OF EDENVALE, ONTARIO  
FOR  
MINISTRY OF TRANSPORTATION**

PML Ref.: 14TF007  
Index No.: 017CSR  
GEOCRES No.: 31D-579  
September 16, 2014

**Condition Survey Report**  
**Highway 26 – Edenvale, 3892 Highway 26,**  
**Personal Residence and Detached Structures**  
**Agreement No. 2013-E-0039**  
**Edenvale, Ontario**

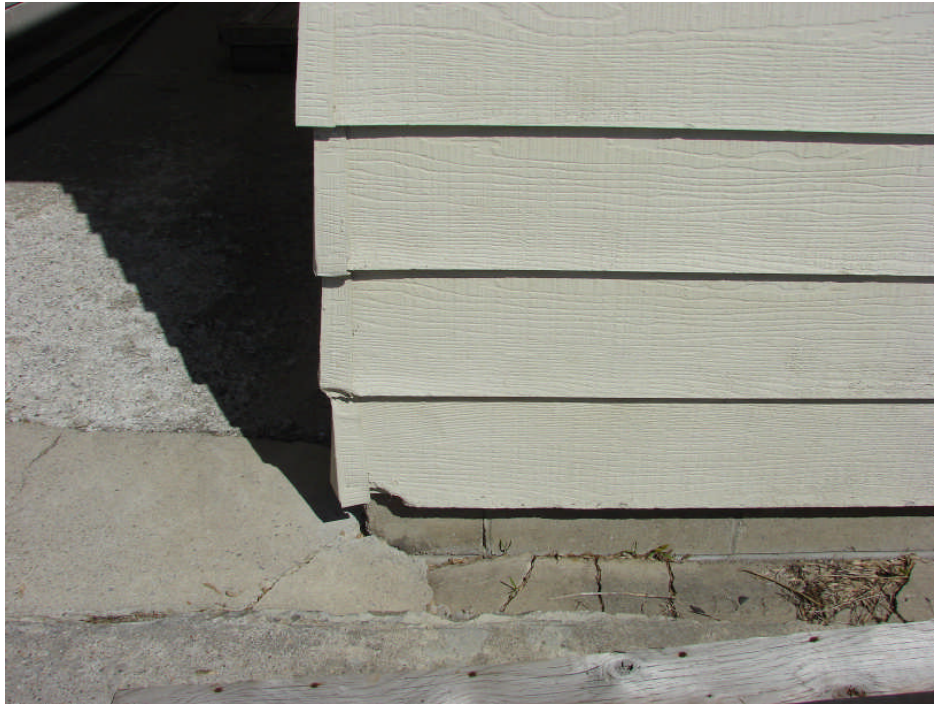
**Photograph 3:** Residence south elevation – impact damaged to siding and cracking slab-on-grade concrete at west end.

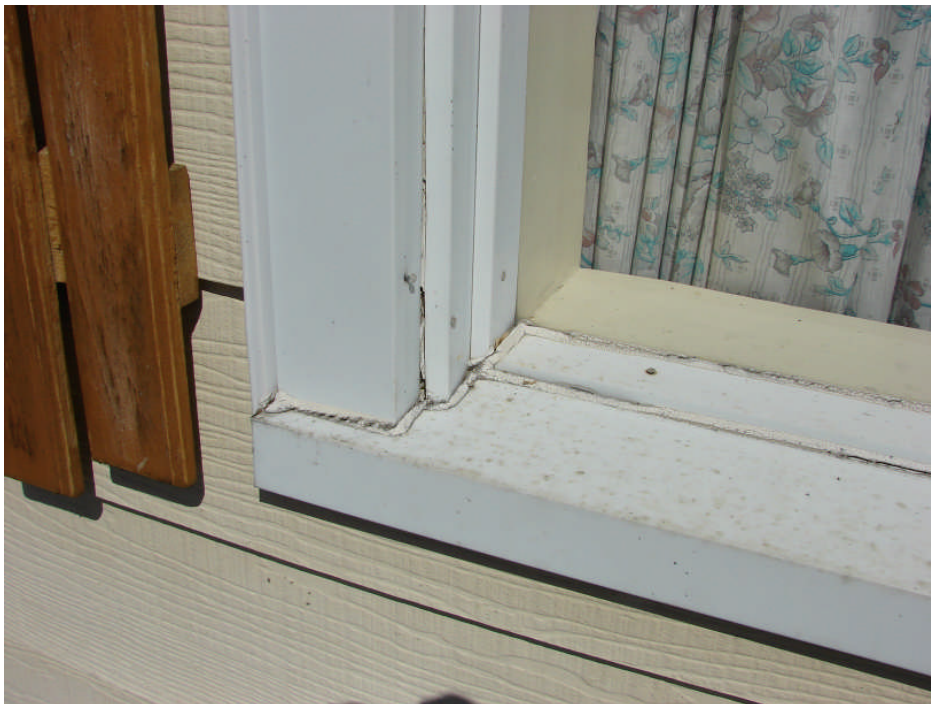
**Photograph 4:** Residence south elevation – Aged and deteriorated windows caulking, typical.

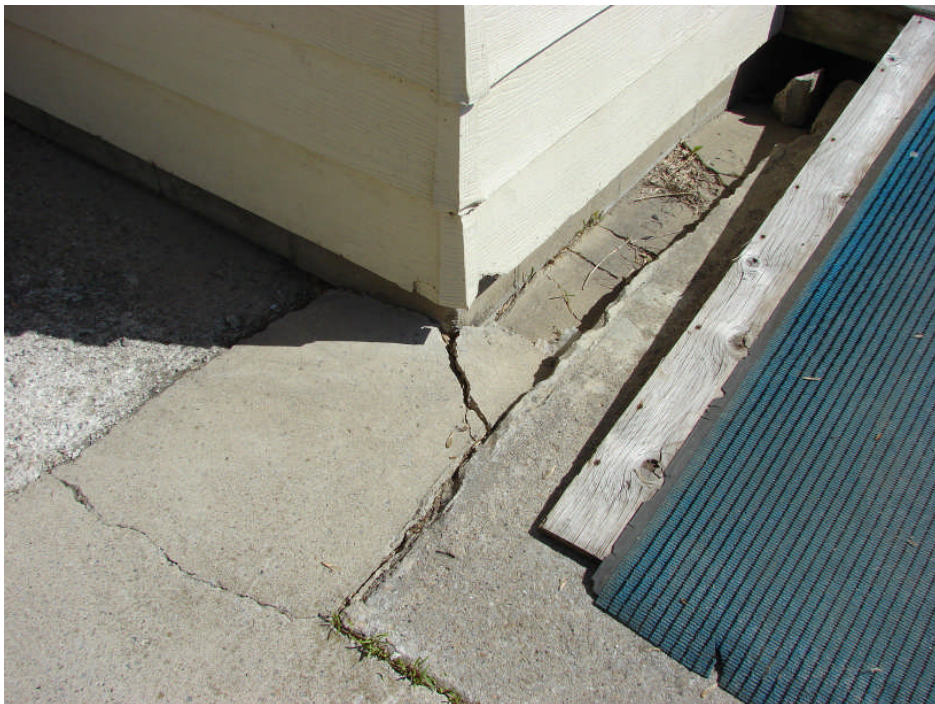
**Photograph 10:** Residence West elevation – severely deteriorated slab-on-grade concrete with extensive cracking, typical.

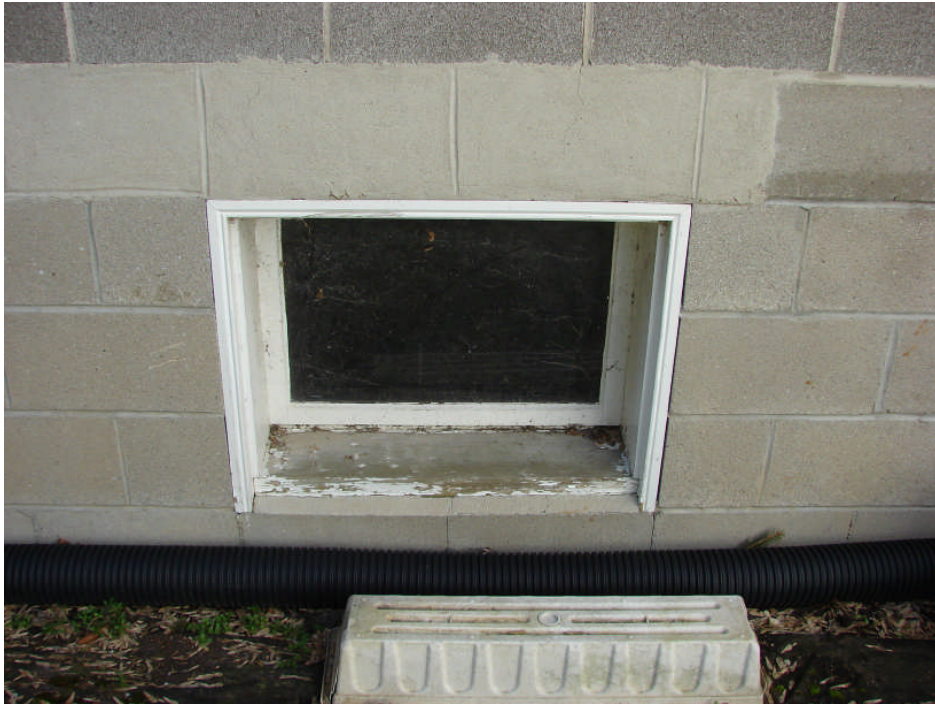
**Photograph 13:** Residence north elevation – Basement window paint peeling/blistering, also repaired window lintel and wall cracks near west end, typical.

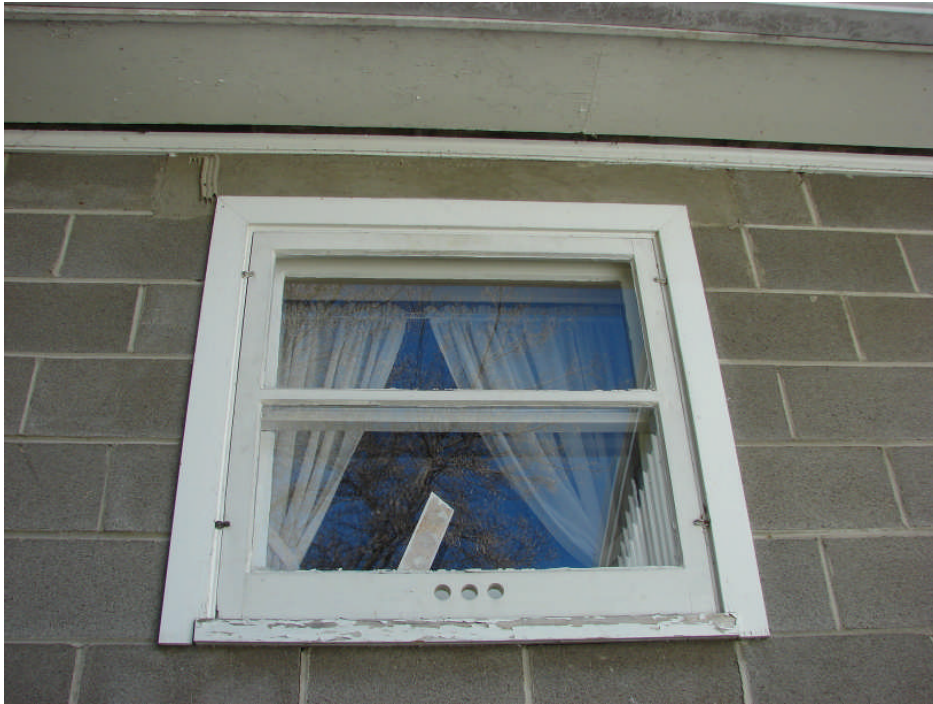
**Photograph 15:** Residence north elevation – soffit paint peeling, repaired window lintels, typical.

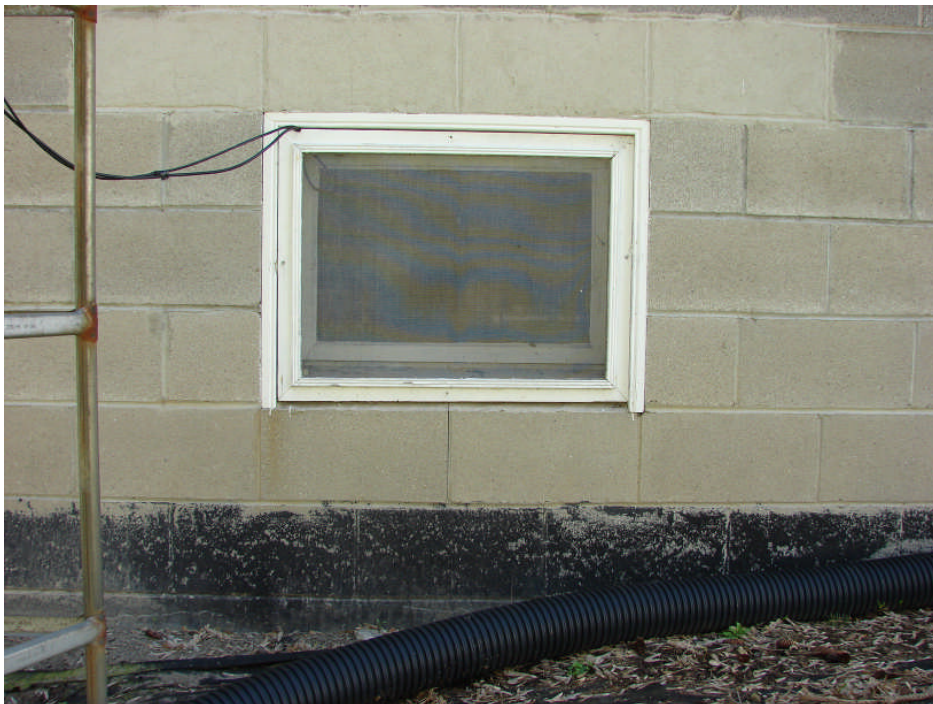
**Photograph 16:** Residence north elevation – Basement window paint peeling/blistering, also repaired window lintel and wall cracks near east end, typical.

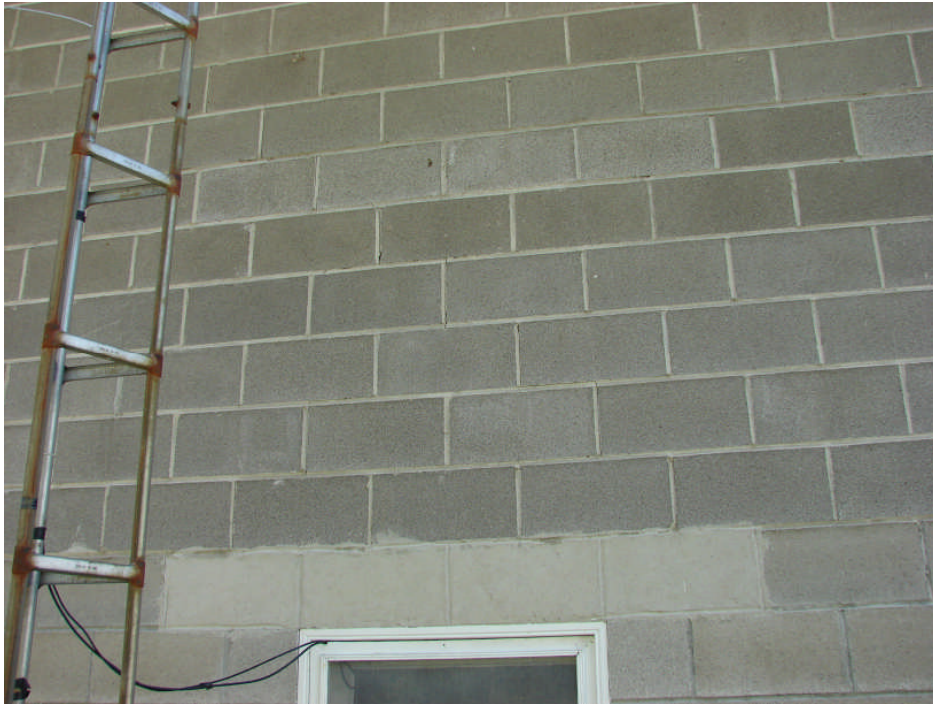
**Photograph 17:** Residence north elevation – Basement and main floor concrete block step cracking near east end, typical.

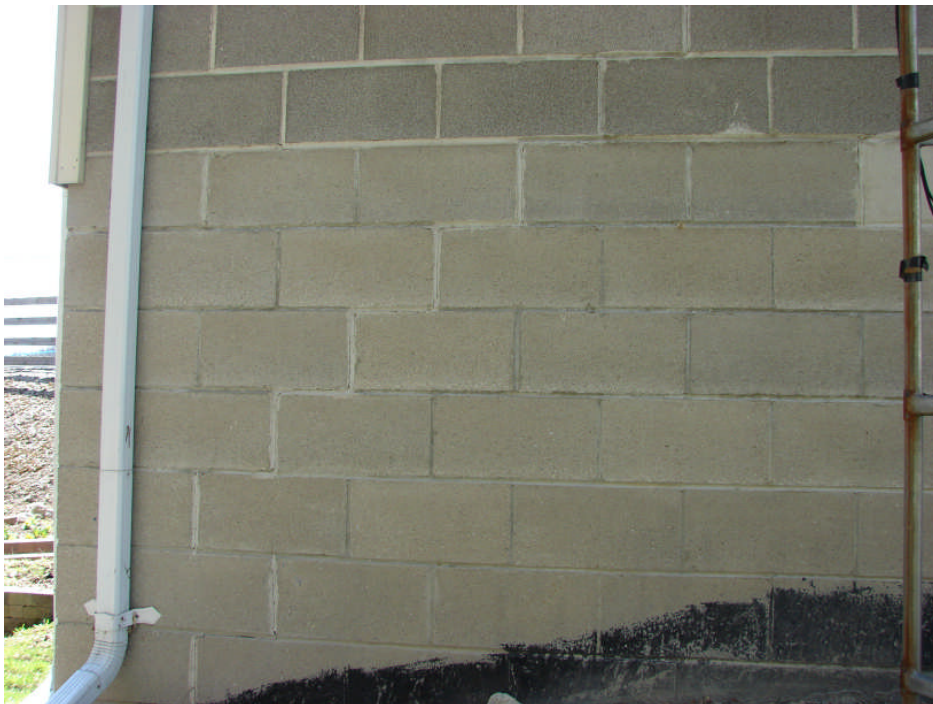
**Photograph 18:** Residence north elevation – repaired wall step cracks at east end.

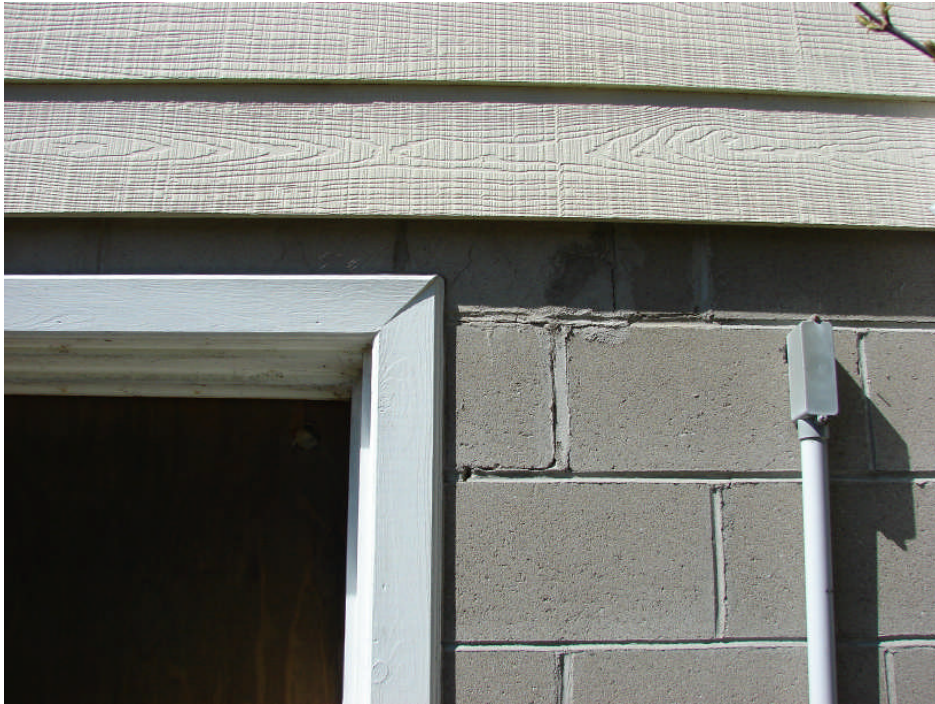
**Photograph 21:** Residence east elevation – concrete block wall step cracking at north end of basement lintel door frame.

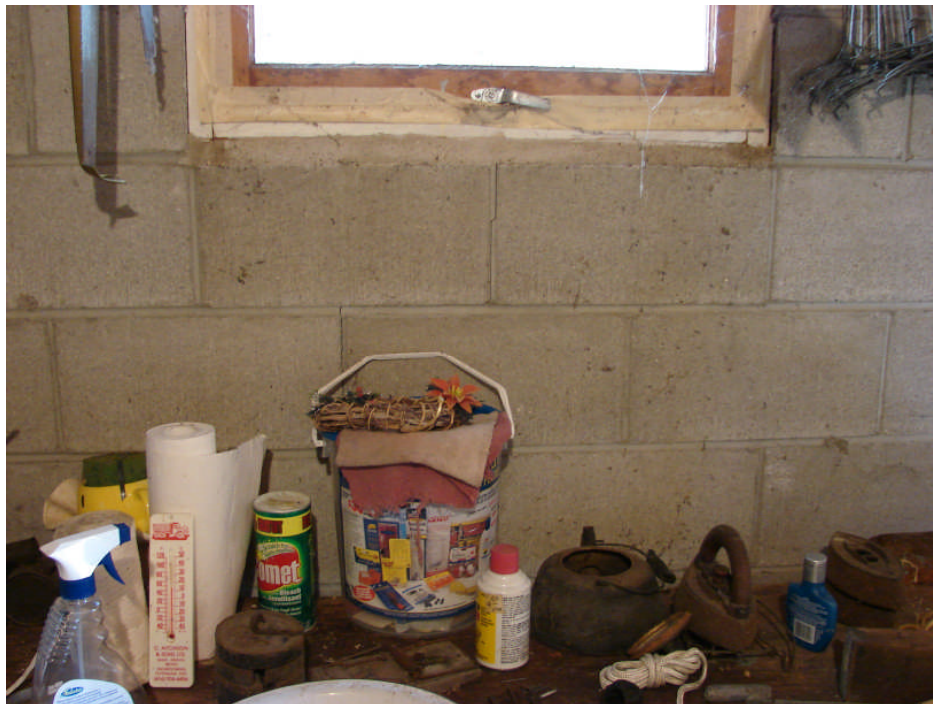
**Photograph 28:** Residence basement level north wall – concrete block step cracking and taped window perimeter, typical.

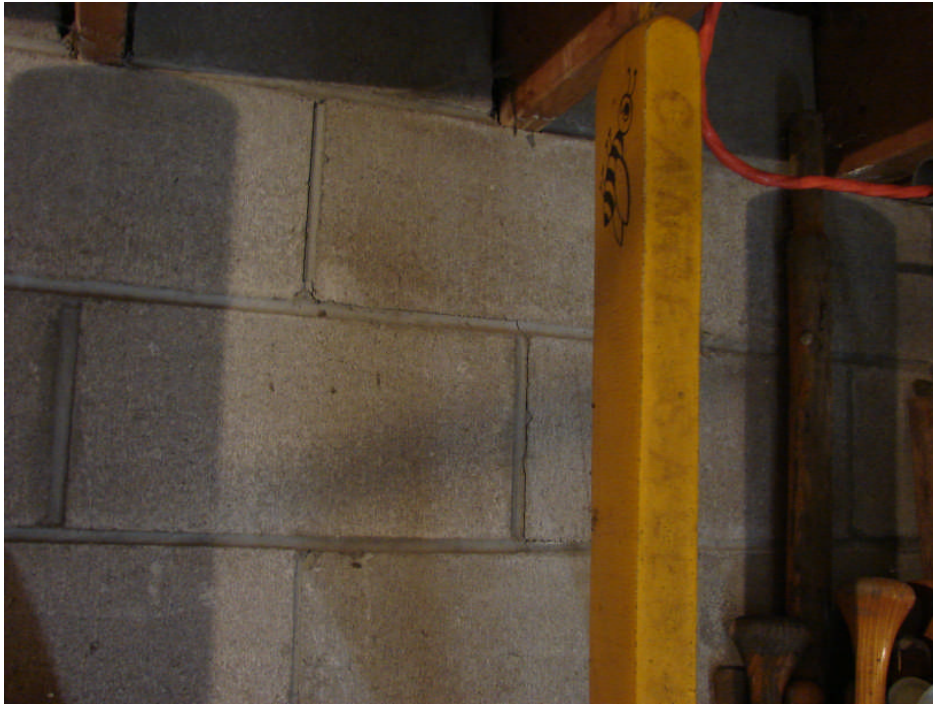
**Photograph 33:** Residence basement level east wall – concrete block step cracking, typical.

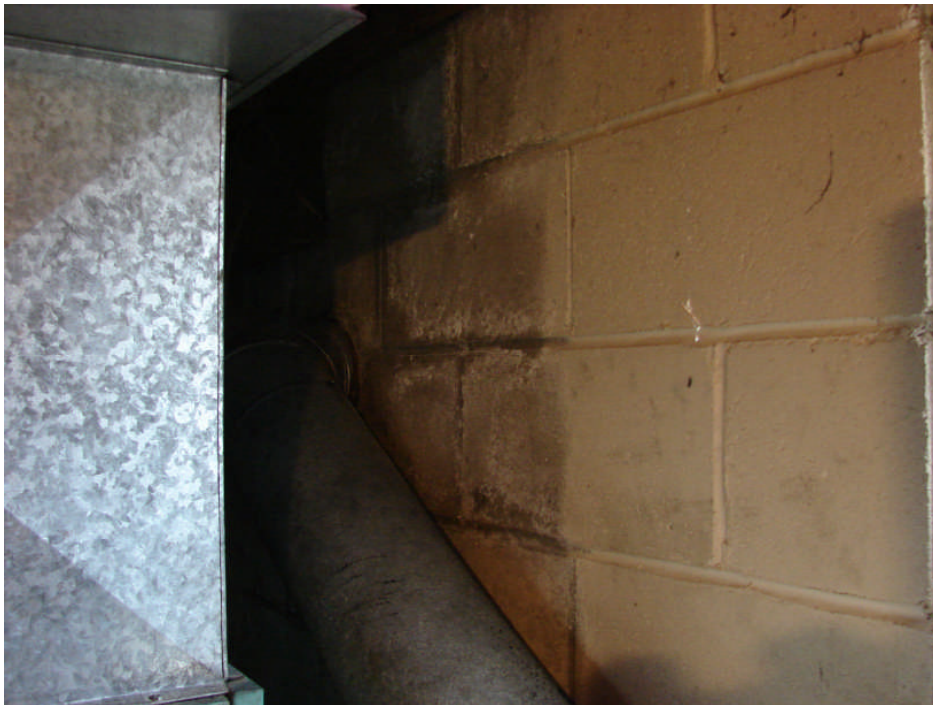
**Photograph 34:** Residence basement level east wall – moisture staining and efflorescence behind heating system.

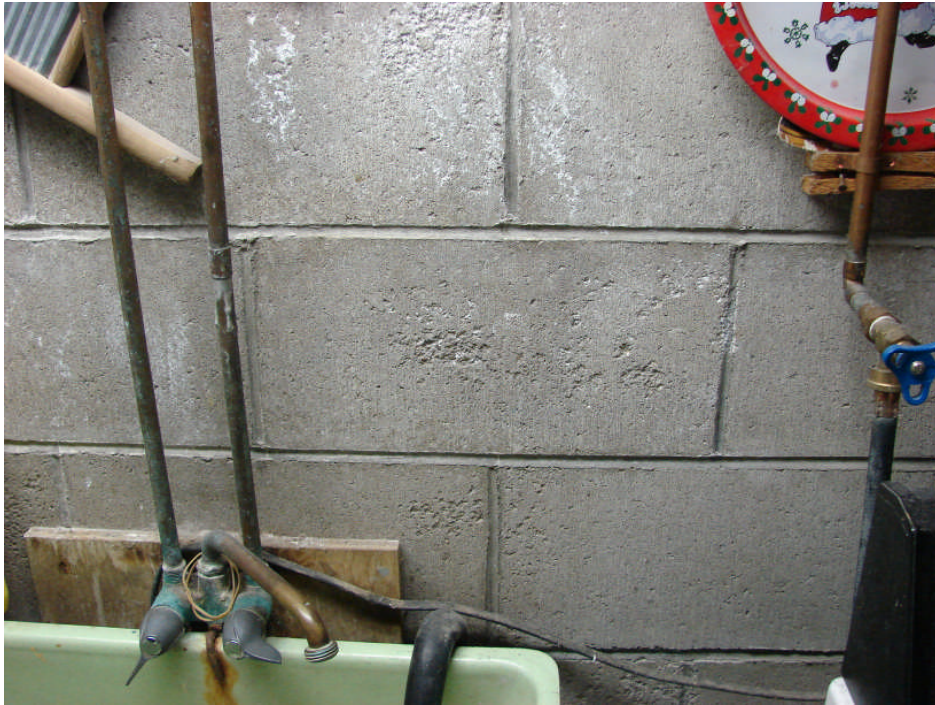
**Photograph 39:** Residence basement level south wall – extensive efflorescence and wall pitting of concrete block, typical.

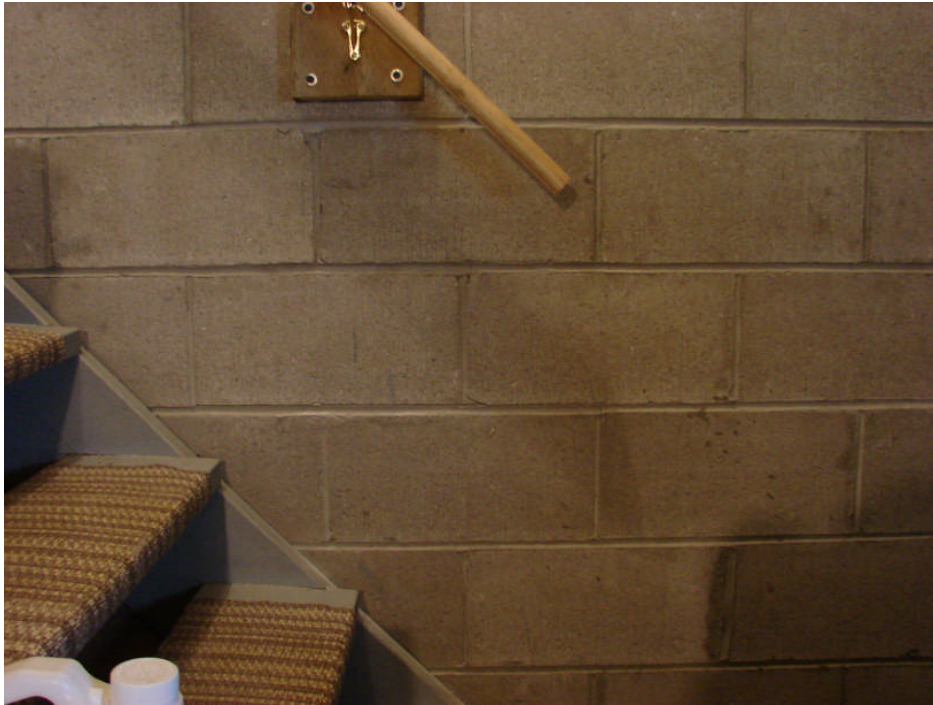
**Photograph 41:** Residence basement level west wall – concrete block wall step cracking near north end, typical.

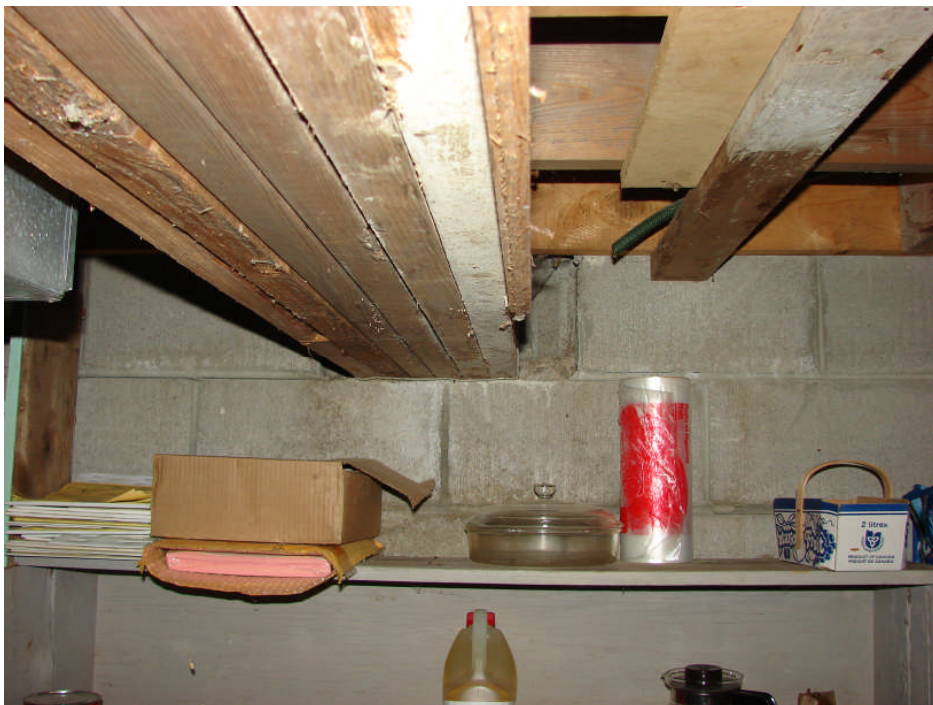
- Residence basement level east wall – unsealed wall penetration through concrete block
- Residence basement level west wall – concrete block wall joint cracking at beam pocket

**Photograph 42:** Residence basement level west wall – concrete block wall joint cracking at beam pocket.

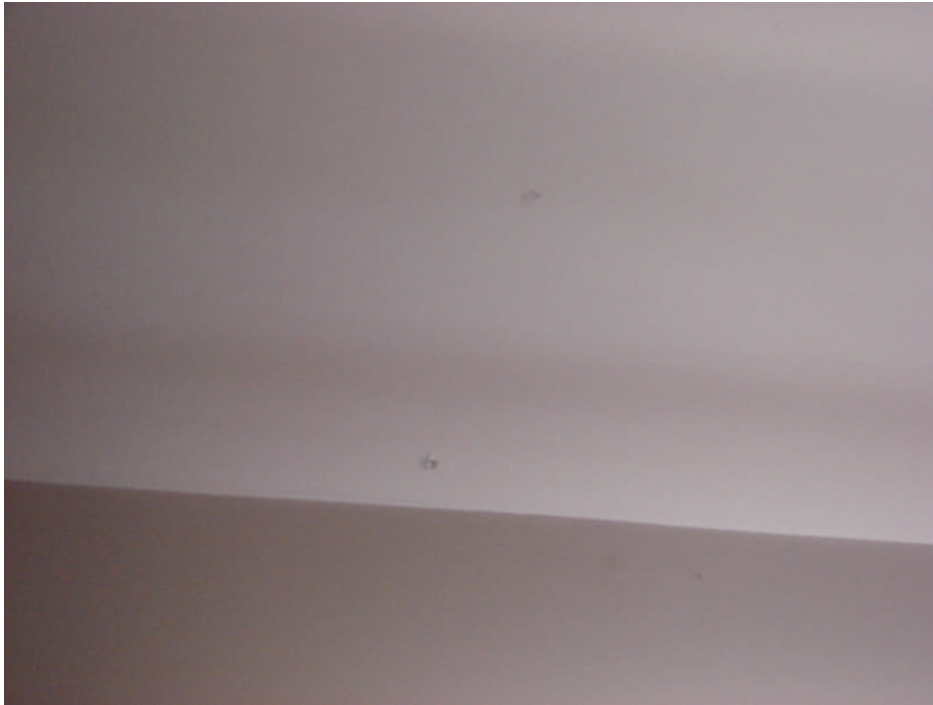
**Photograph 47:** Residence main floor level – ceiling drywall popped nails at north end of northwest bedroom.

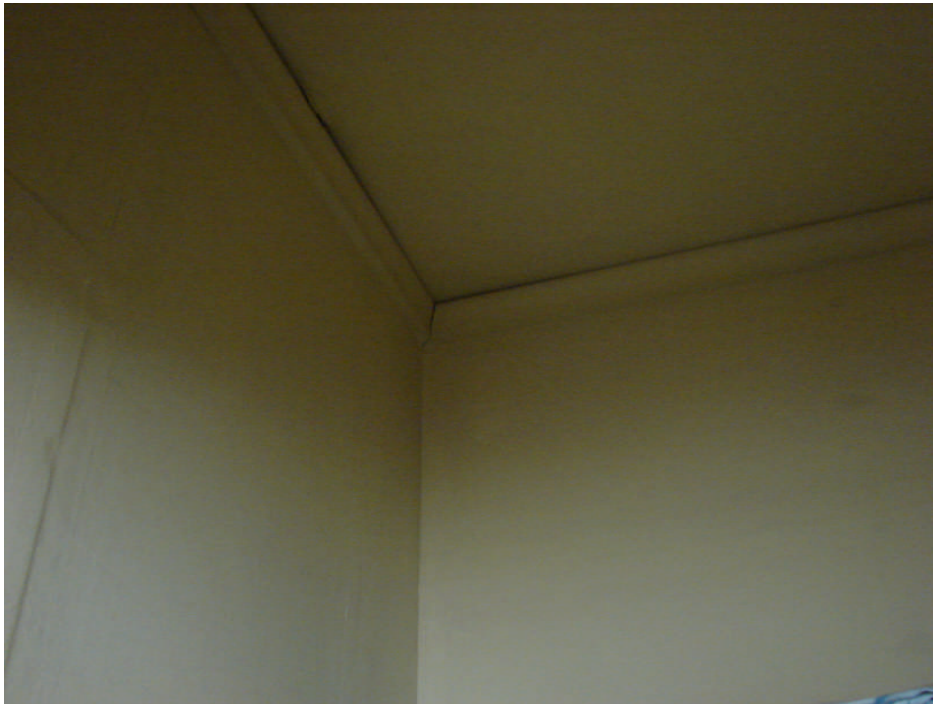
**Photograph 48:** Residence main floor level – moulding joint cracks at northeast corner of northwest bedroom, typical.

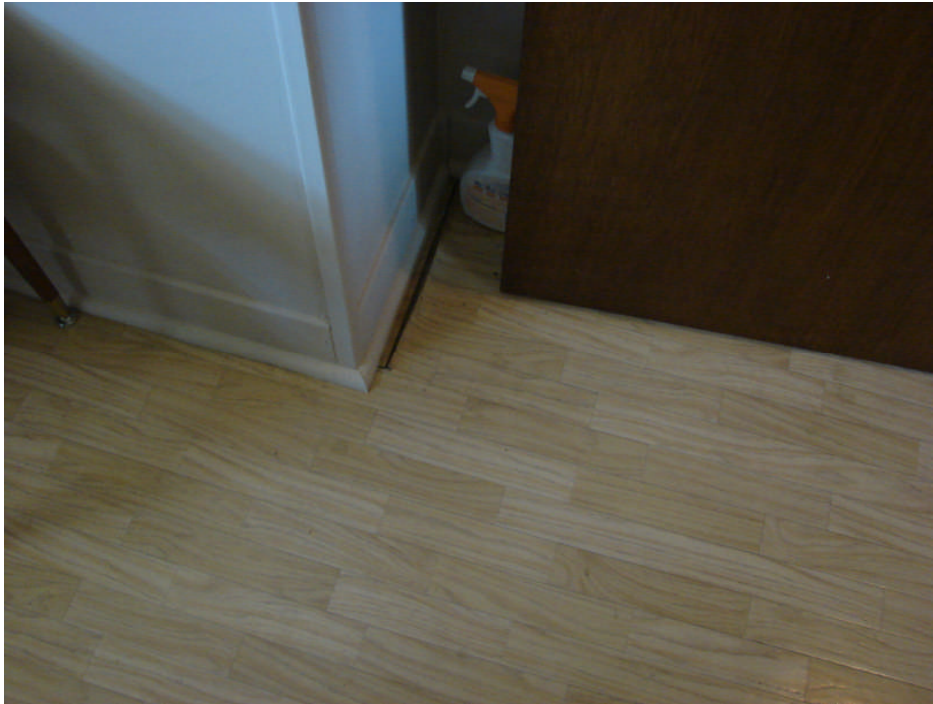
**Photograph 51:** Residence main floor level – vinyl sheet flooring / open seam along baseboard at centre bedroom on north side, typical.

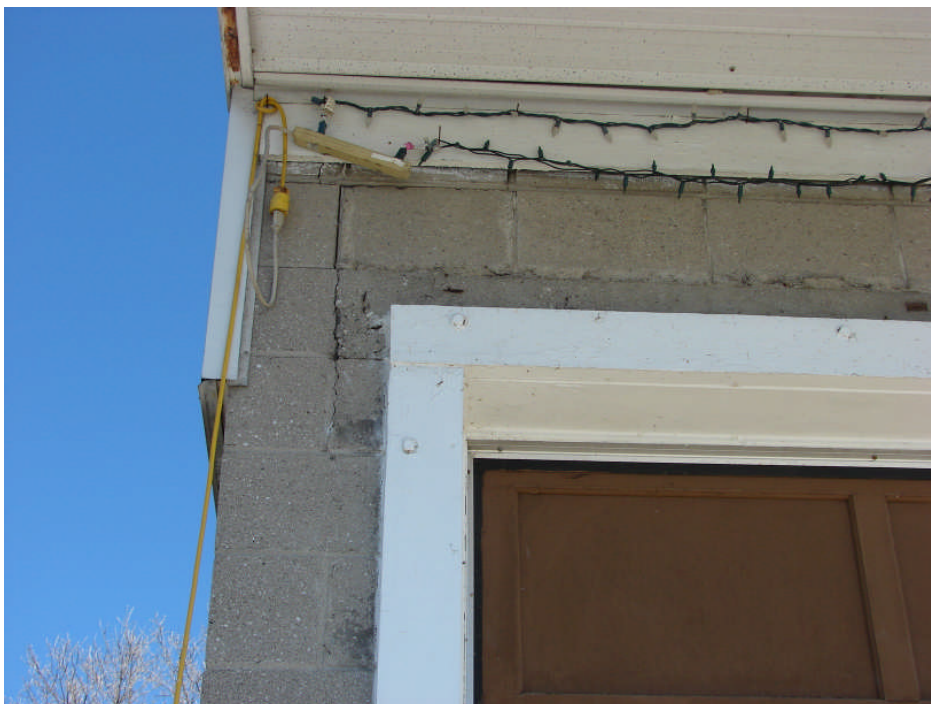
**Photograph 3:** Garage Building south elevation – concrete block wall step cracking at west end adjacent overhead door, typical.

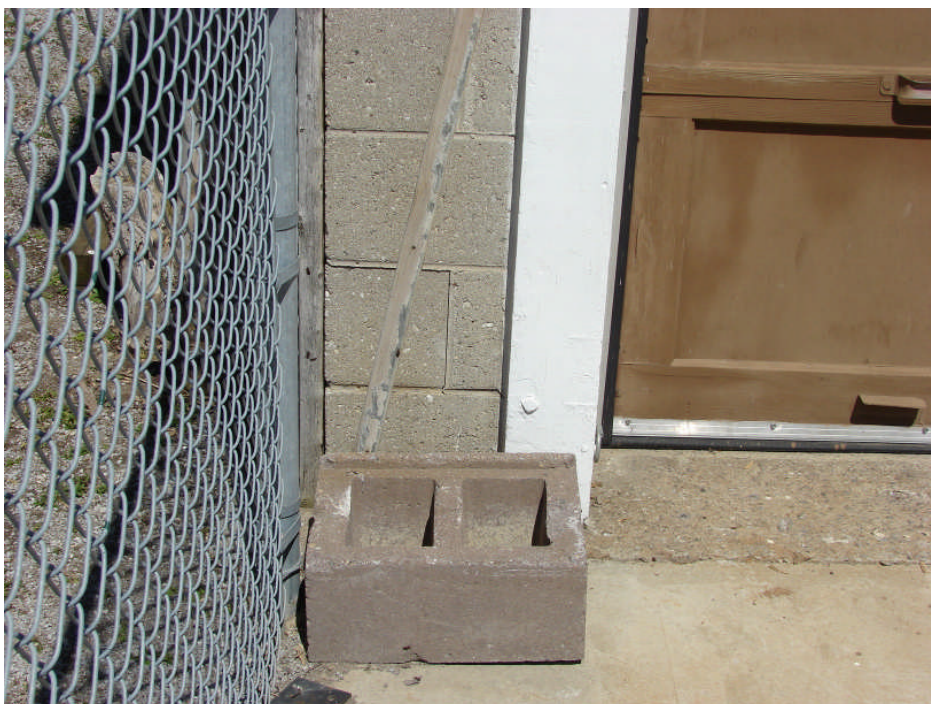
**Photograph 4:** Garage Building south elevation – concrete block wall step cracking at west end adjacent overhead door, typical.

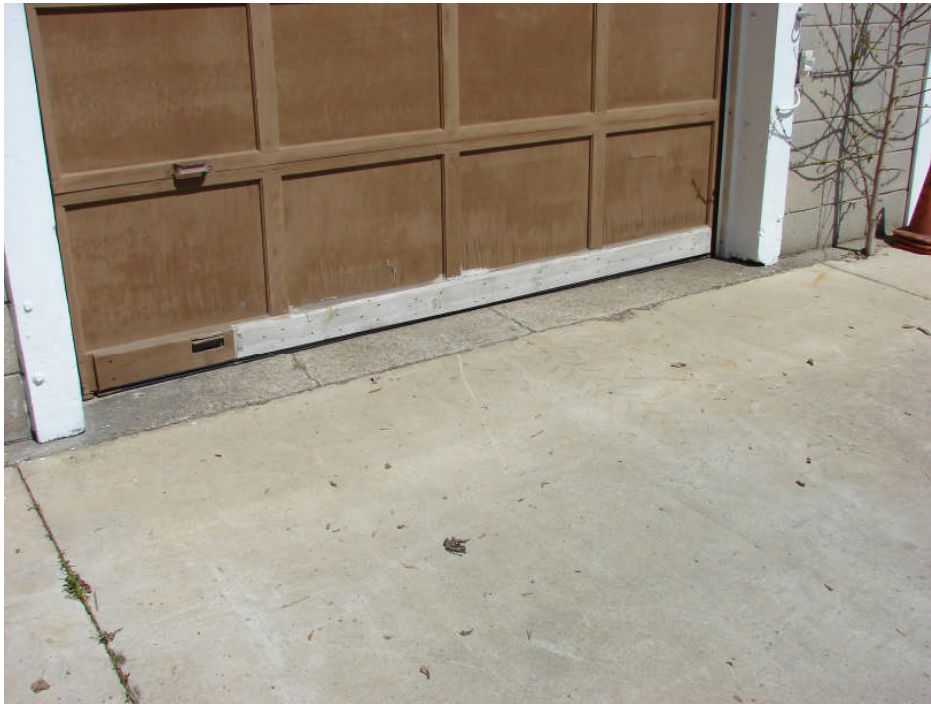
**Photograph 5:** Garage Building south elevation – concrete slab-on-grade cracking at east overhead door, typical.

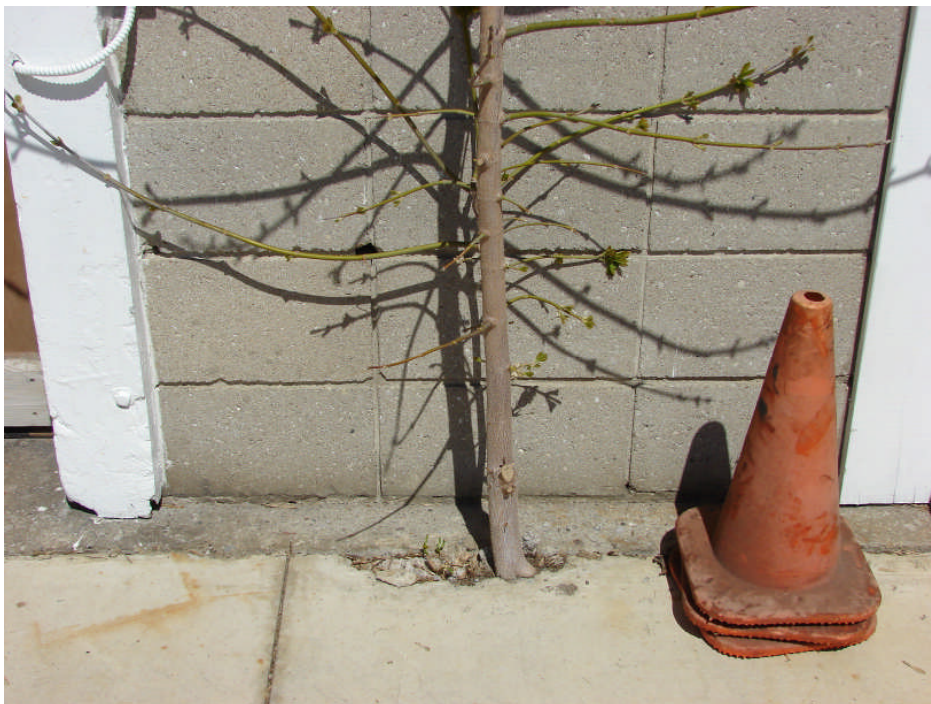
**Photograph 6:** Garage Building south elevation – vegetation growth through concrete slab-on-grade at east overhead door.

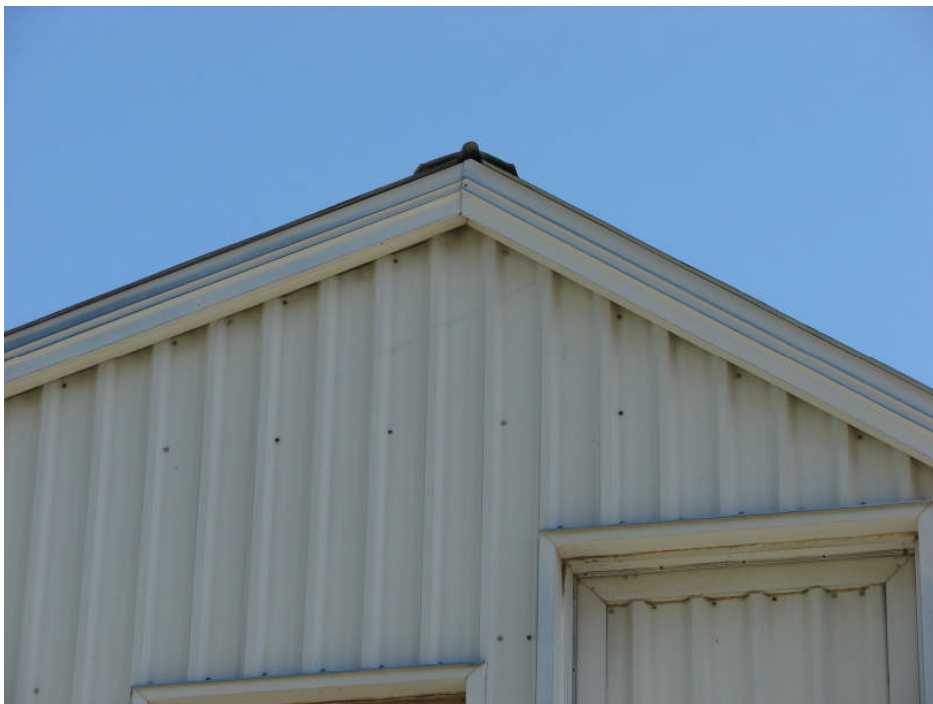
**Photograph 10:** Garage Building west elevation – missing ridge end cover at west side of metal roof, typical.

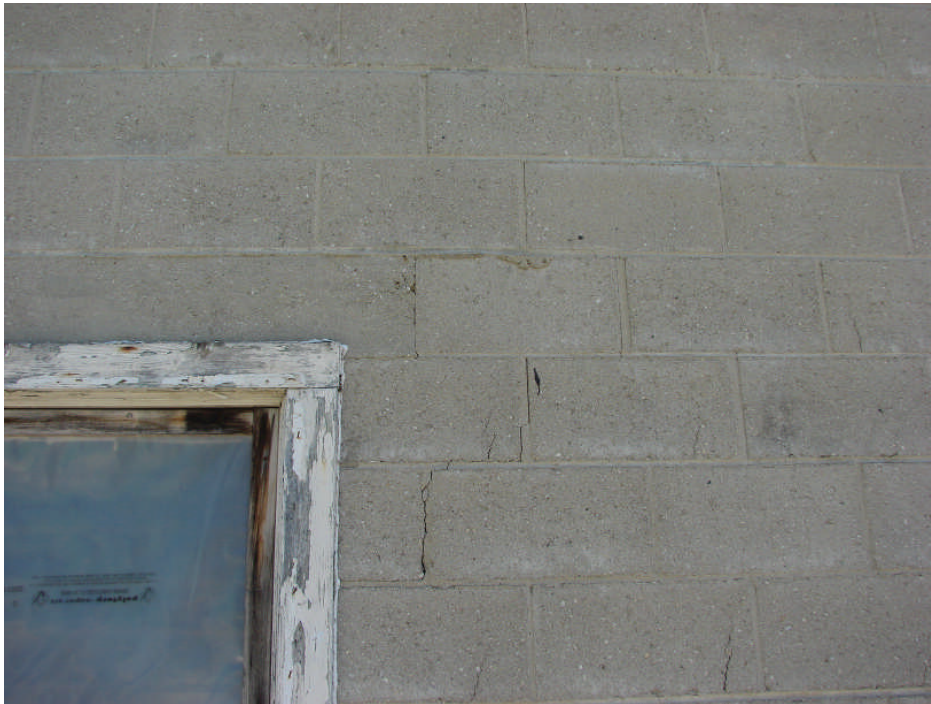
**Photograph 15:** Garage Building west elevation – concrete block wall step cracking above south end of south window, typical.

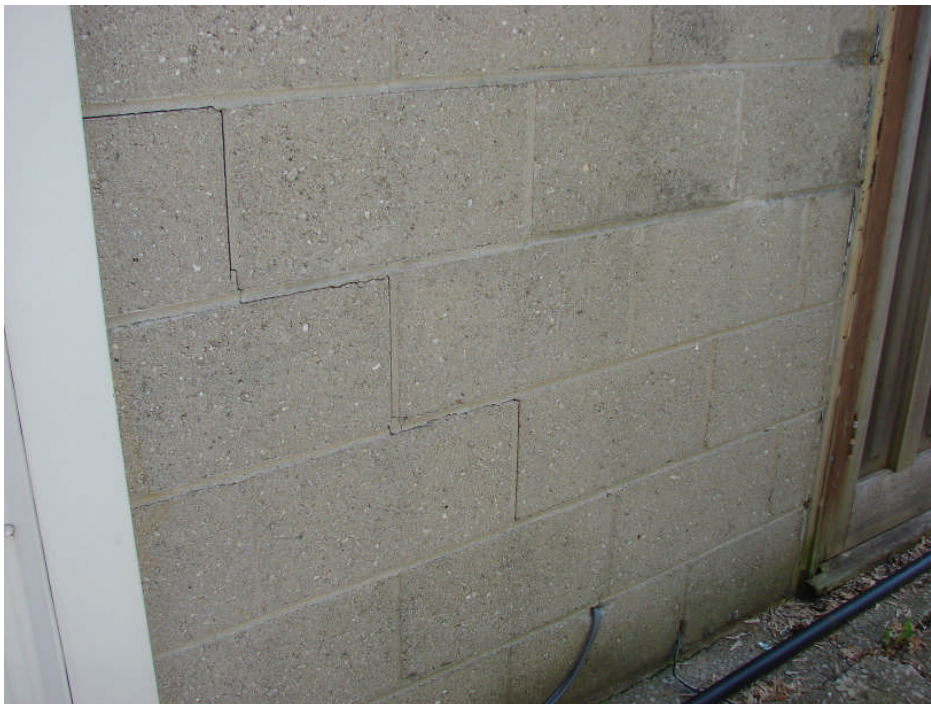
**Photograph 16:** Garage Building west elevation – concrete block wall step cracking between door and north gate, typical.

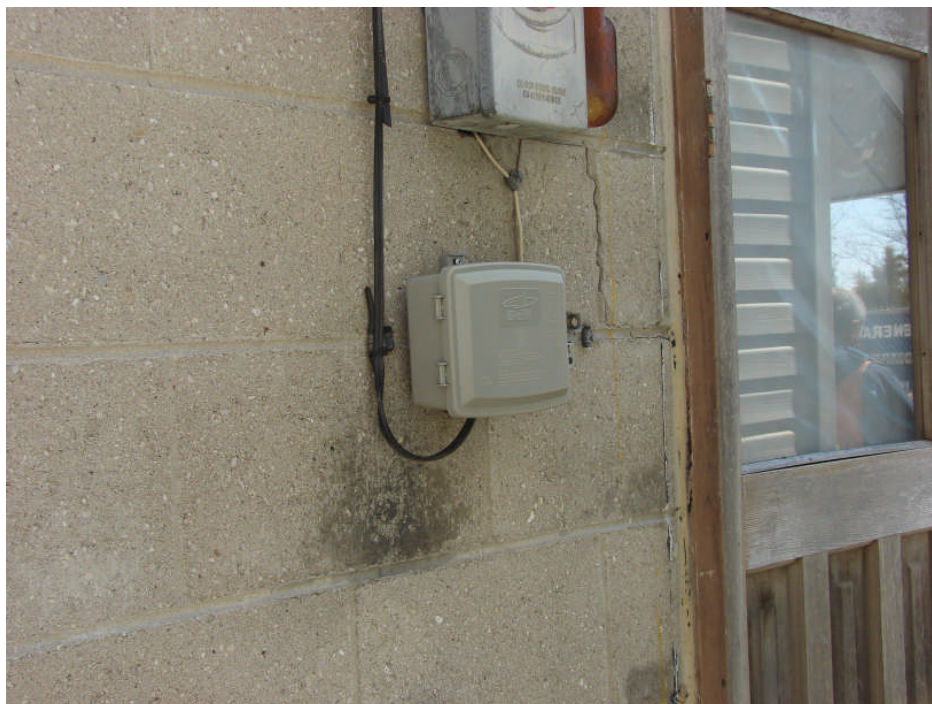
**Photograph 17:** Garage Building west elevation – concrete block wall step cracking near door on north side, typical.

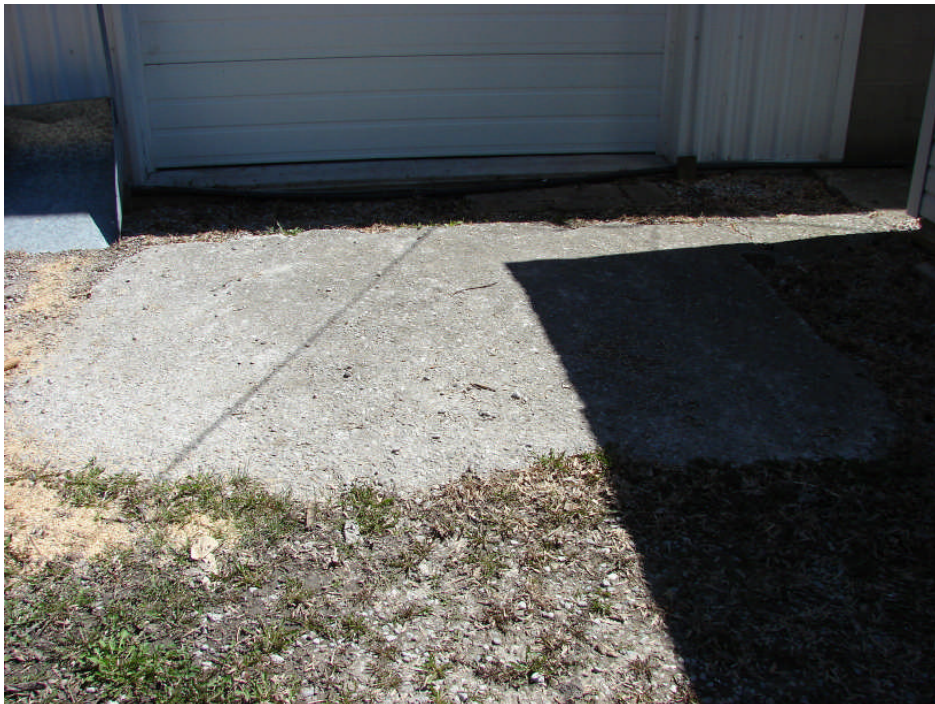
**Photograph 20:** Garage Building west elevation – extensive deterioration of concrete slab-on-grade with severe surface spalling, typical.

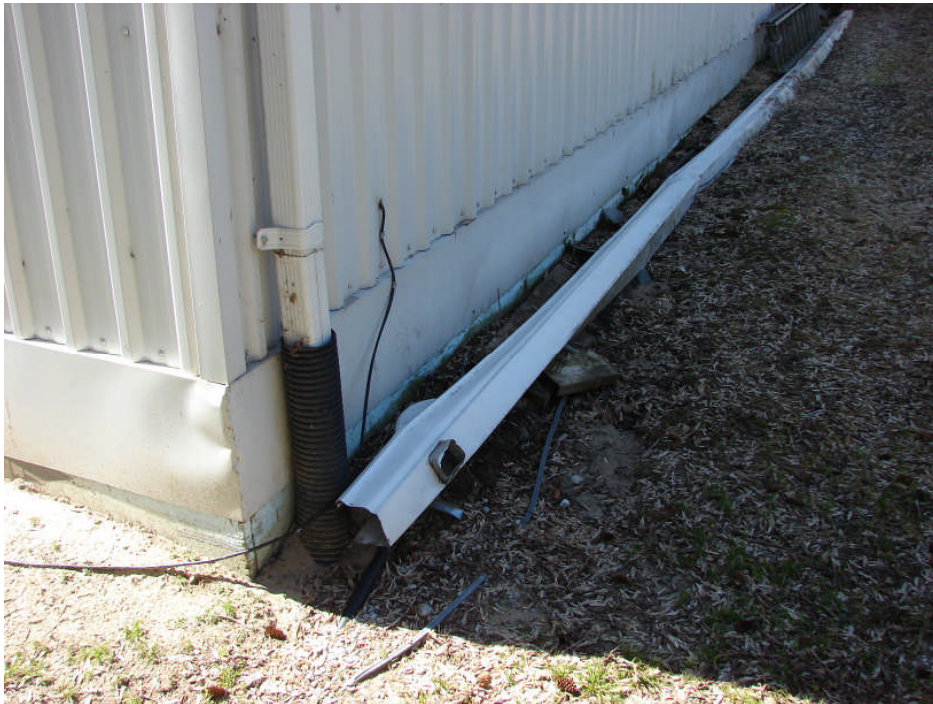
**Photograph 23:** Garage Building north elevation – damaged eavestrough resting on ground.

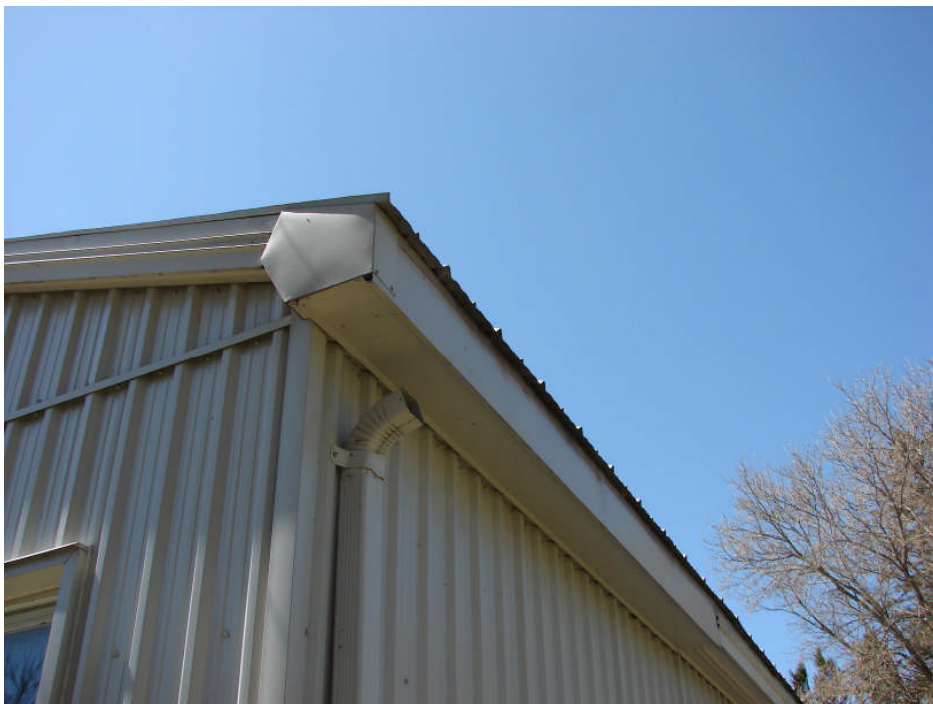
**Photograph 24:** Garage Building north elevation – missing rainwater gutter.

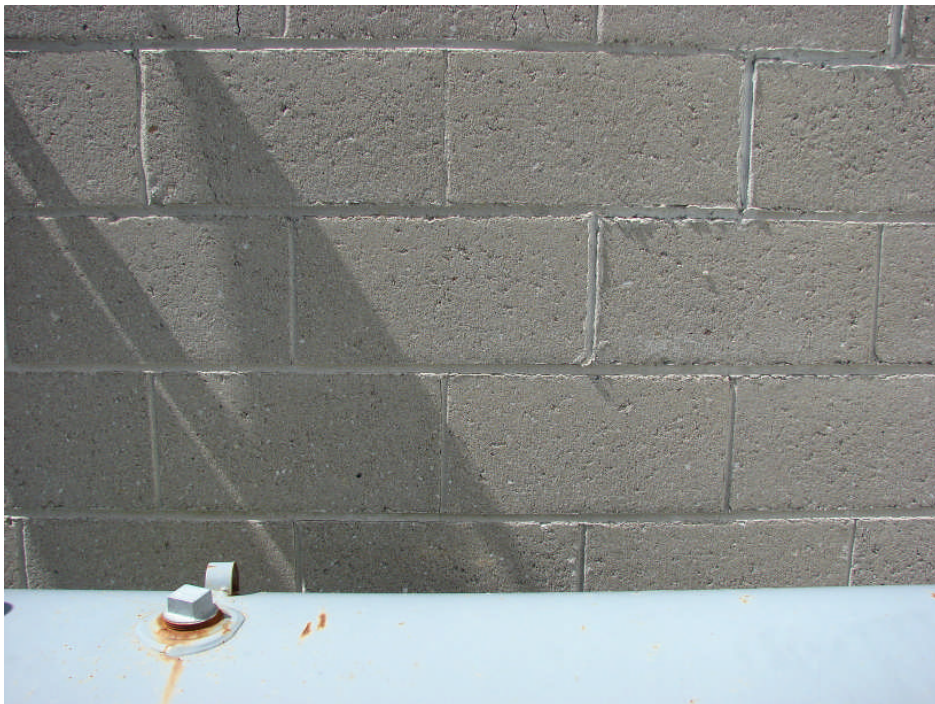
**Photograph 26:** Garage Building east elevation (north part) – concrete block wall step cracking near oil tank, typical.

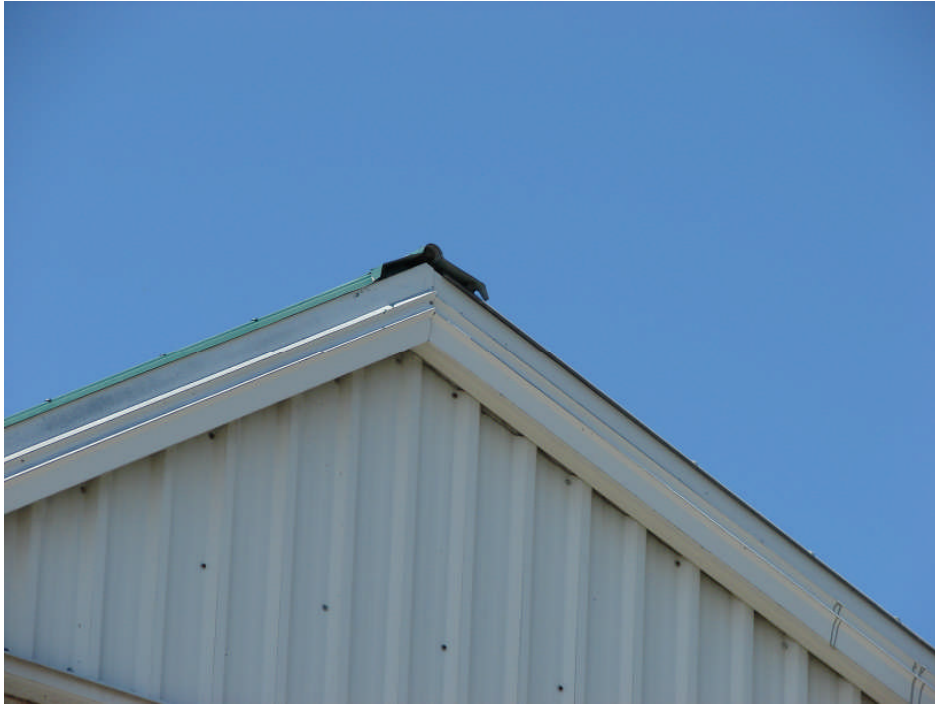
**Photograph 29:** Garage Building west elevation – missing ridge end cover at east side of metal roof, typical.

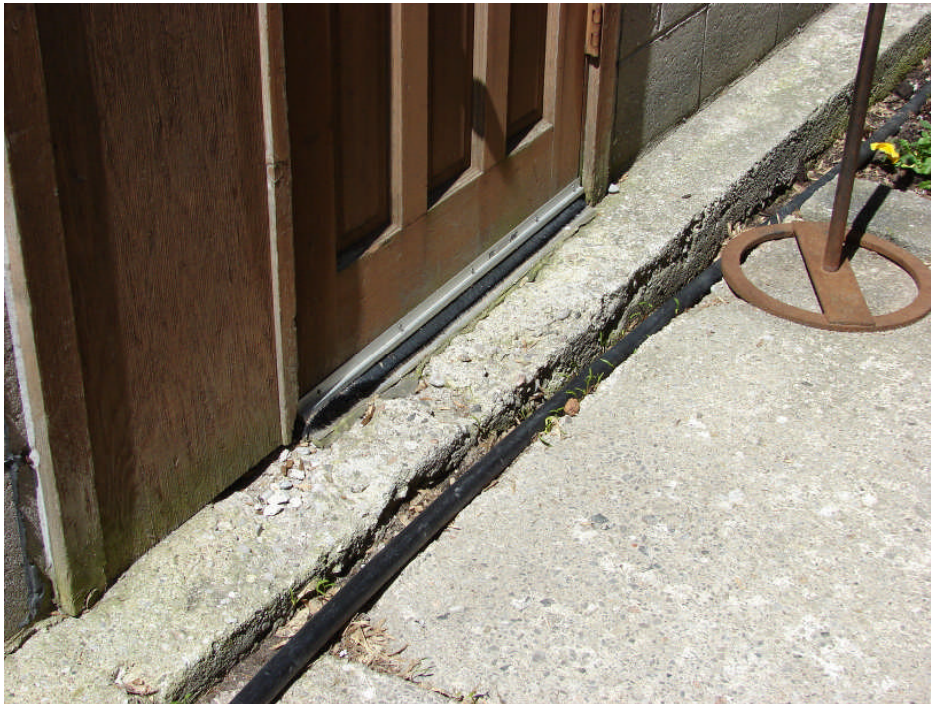
**Photograph 31:** Garage Building east elevation (south part) – severely deteriorated and breaking concrete door threshold, typical.

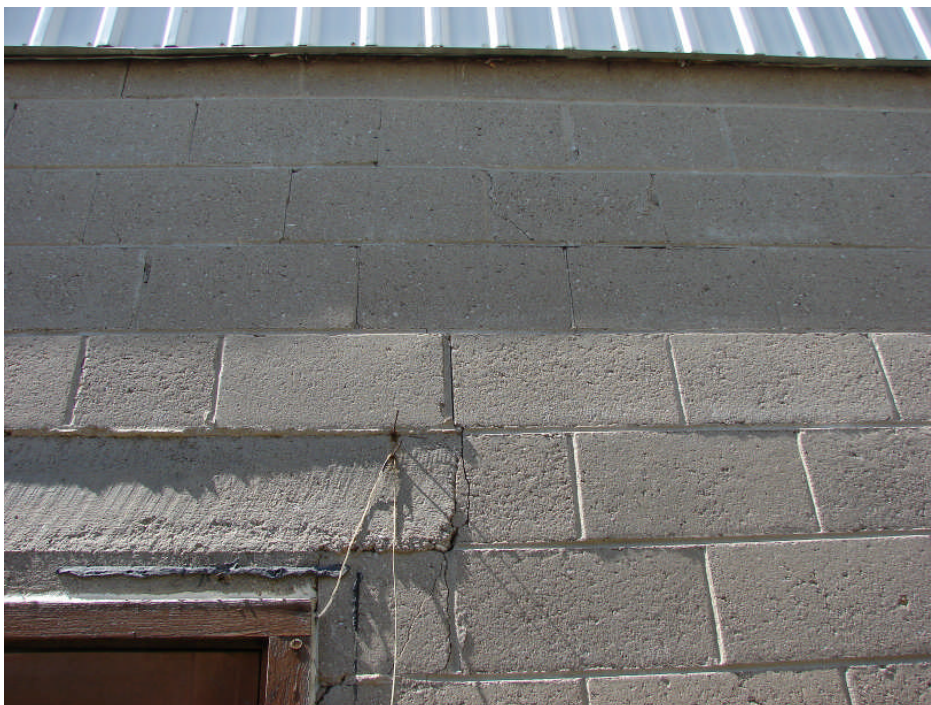
**Photograph 32:** Garage Building east elevation (south part) – concrete block wall step cracking at door lintel, typical.
