**CONDITION SURVEY REPORT  
3892 HIGHWAY 26 - DRAINAGE DITCH IMPROVEMENT  
AGREEMENT NO. 2013-E-0039  
TOWN OF EDENVALE, ONTARIO  
FOR  
MINISTRY OF TRANSPORTATION**

PML Ref.: 14TF007  
Index No.: 017CSR  
GEOCRES No.: 31D-579  
September 16, 2014

**Condition Survey Report**  
**Highway 26 – Edenvale, 3892 Highway 26,**  
**Personal Residence and Detached Structures**  
**Agreement No. 2013-E-0039**  
**Edenvale, Ontario**

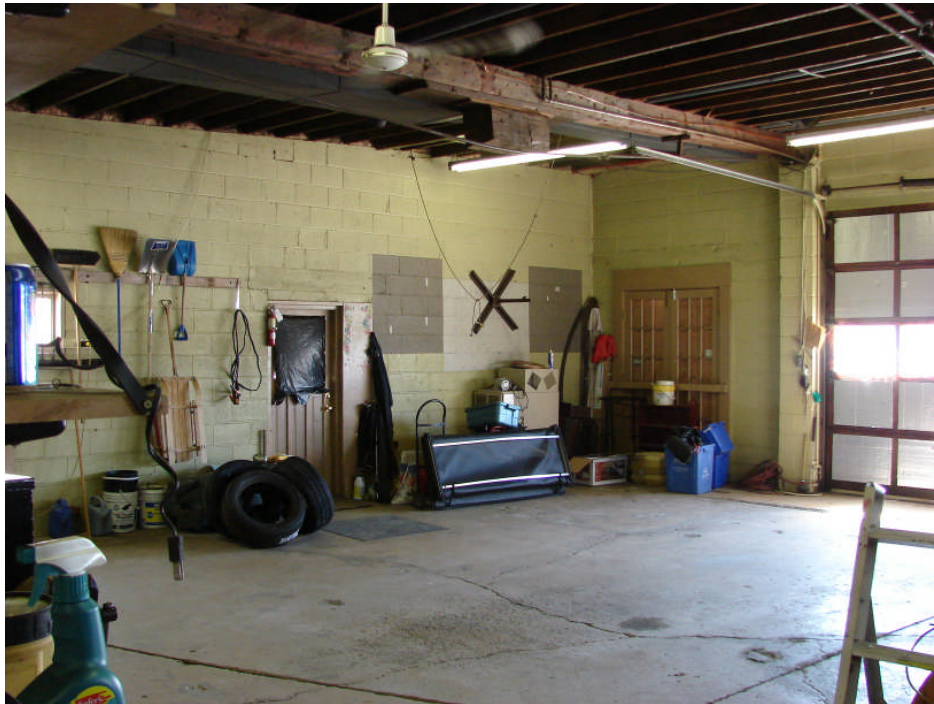
**Photograph 35:** Garage Building – unpainted concrete slab-on-grade cracking, typical.

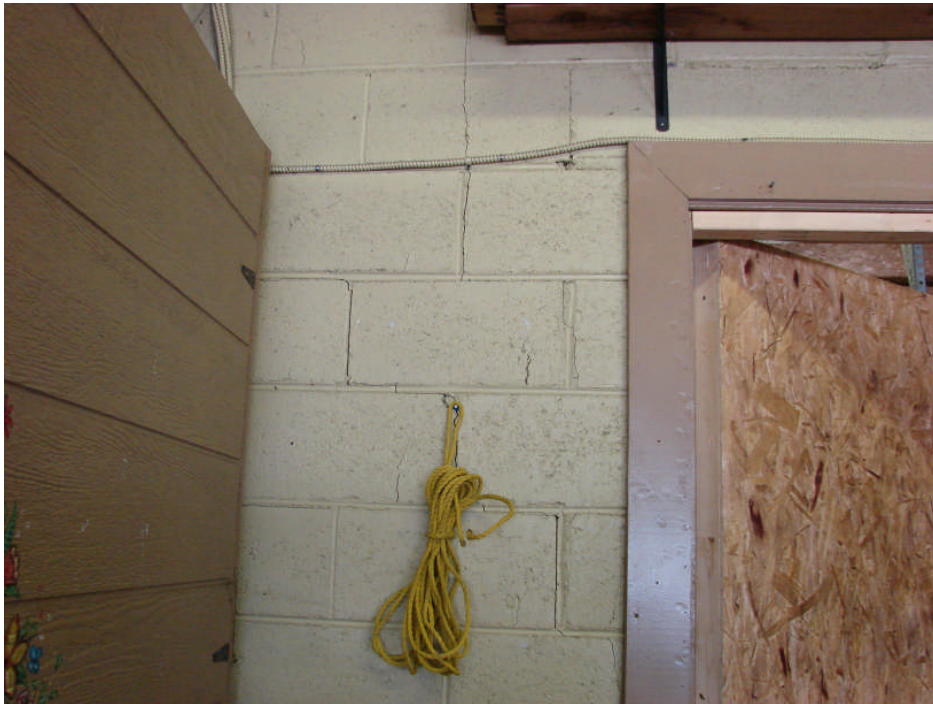
**Photograph 37:** Garage Building north wall – concrete block wall step cracking near west end, typical.

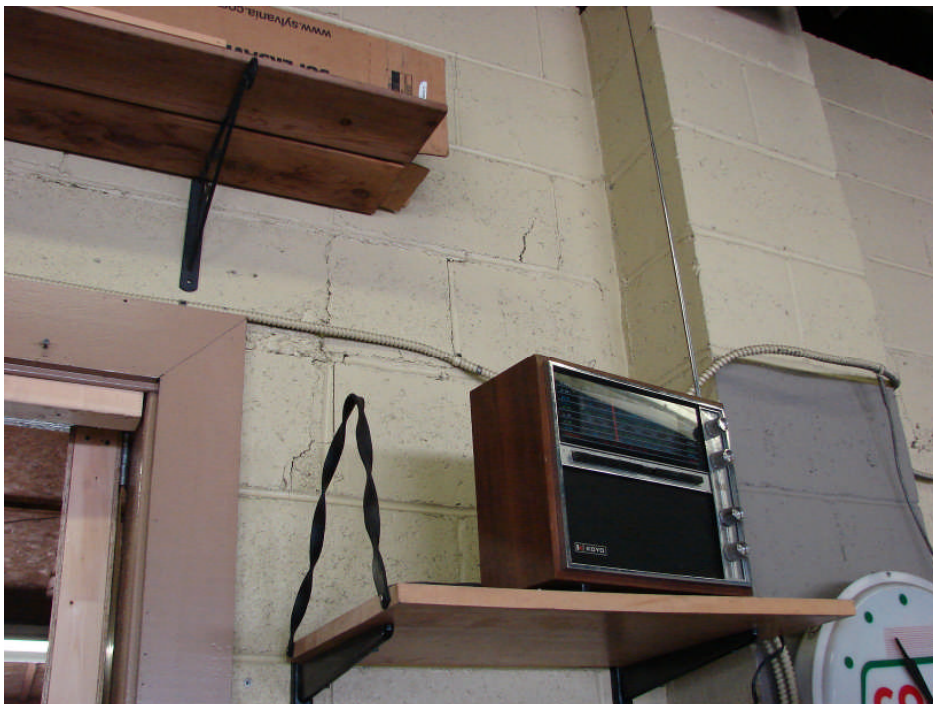
**Photograph 38:** Garage Building north wall – concrete block wall step cracking on east side of door, typical.

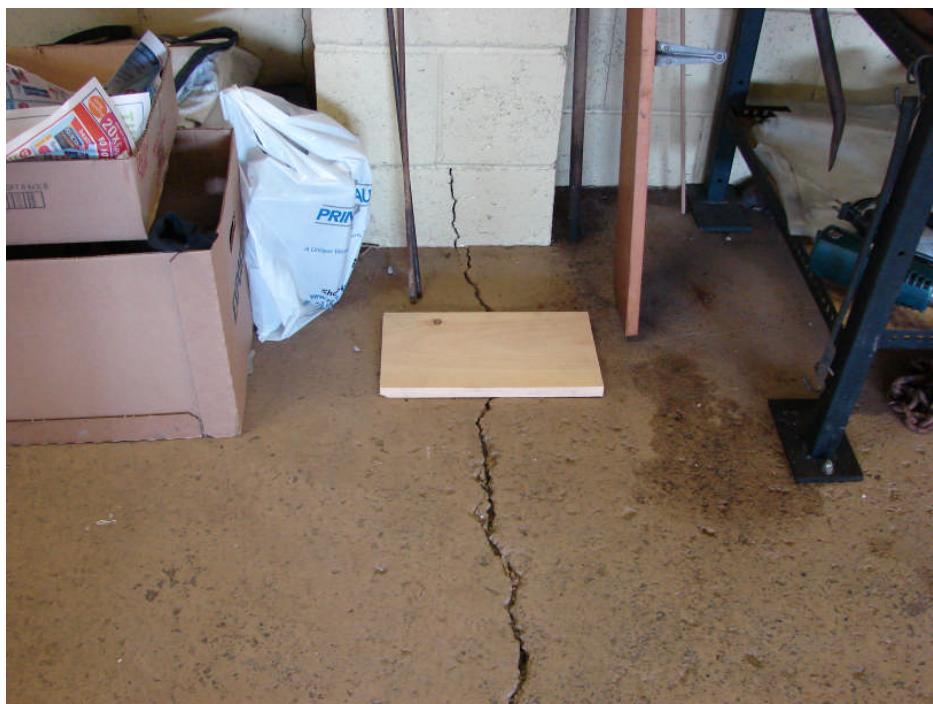
**Photograph 40:** Garage Building north wall – continued wall and slab cracks at east concrete block pier, typical.

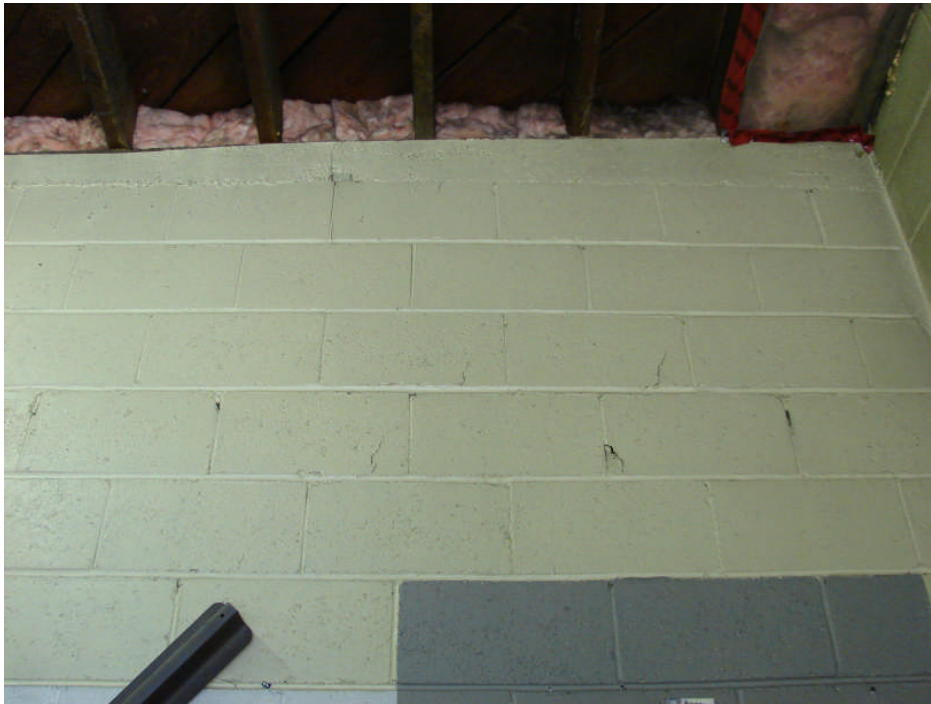
**Photograph 47:** Garage Building east wall – concrete block wall step cracking at south end, typical.

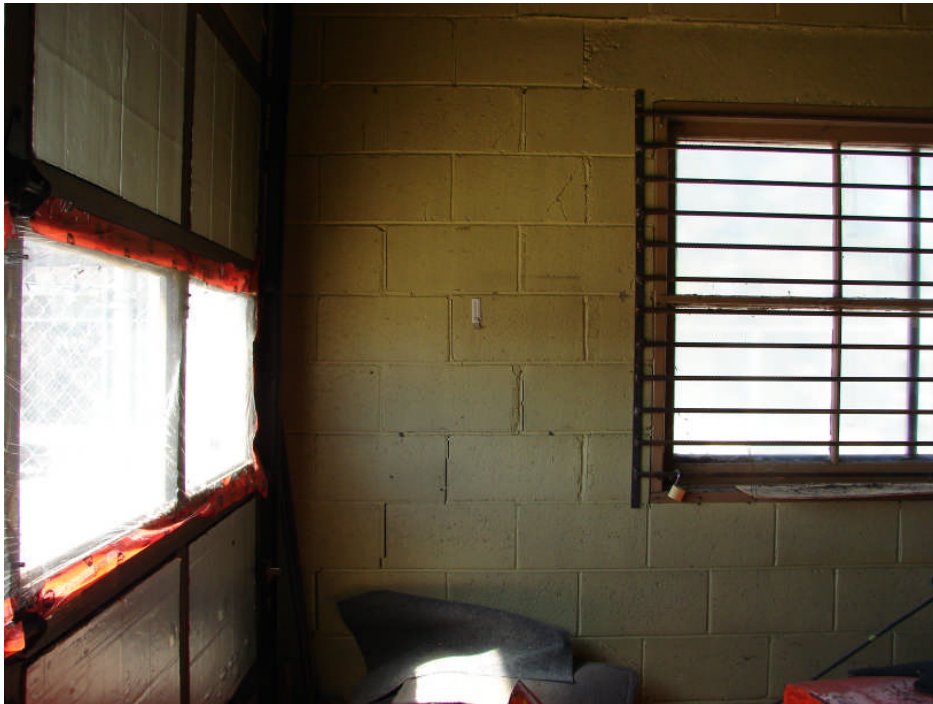
**Photograph 49:** Garage Building west wall – concrete block wall step cracking at south end, typical.

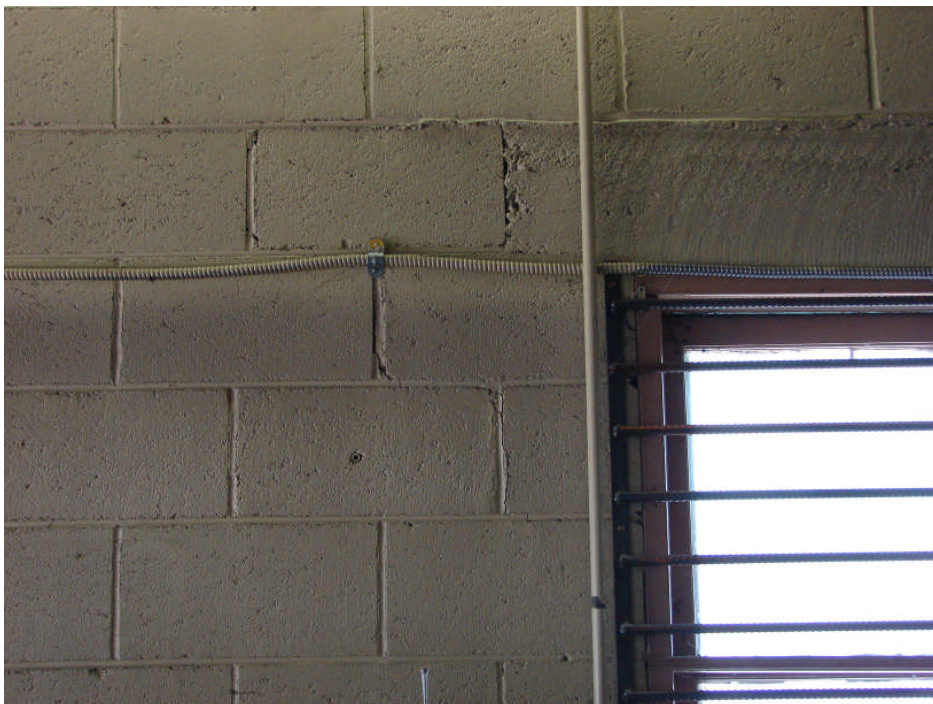
**Photograph 50:** Garage Building west wall – concrete block wall step cracking at south end of north window, typical.

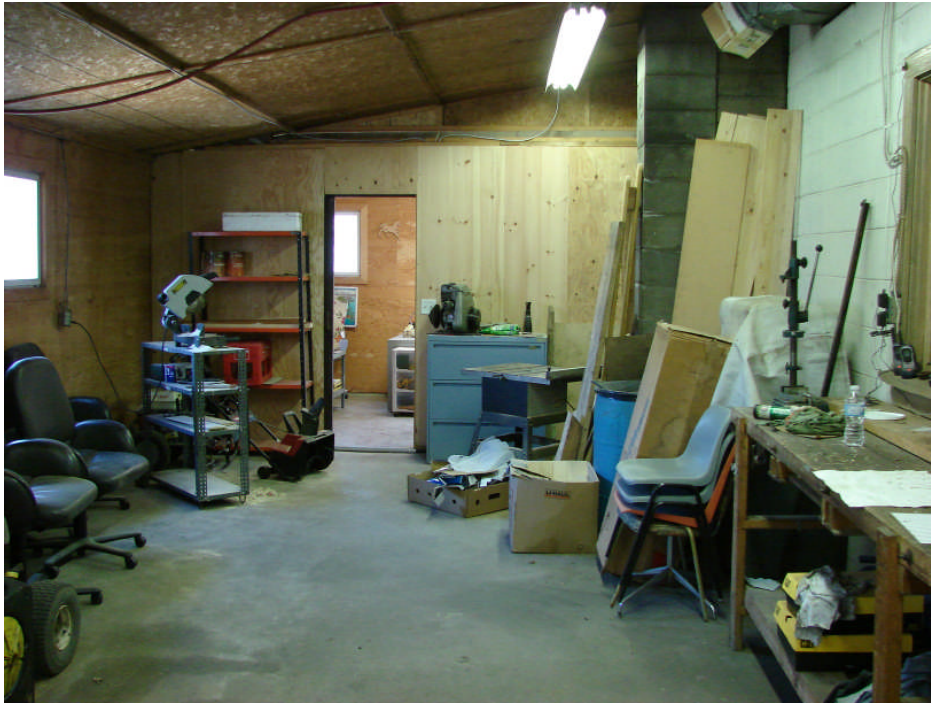
**Photograph 55:** Garage Building rear workshop – plywood wall cladding conceals the main structure.

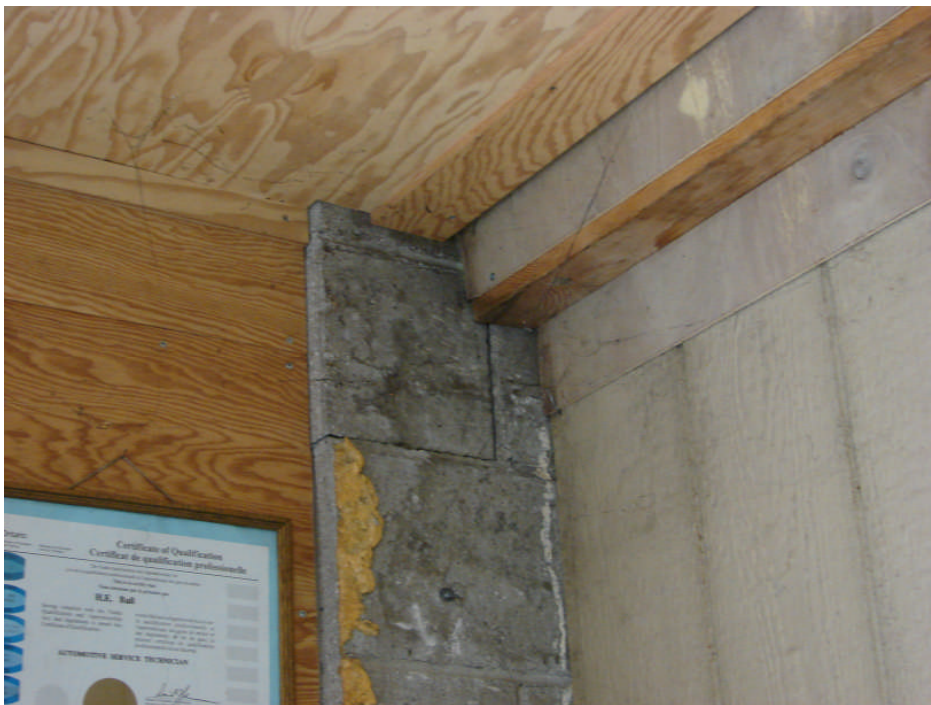
**Photograph 56:** Garage Building rear workshop – office southwest corner wall cracks.

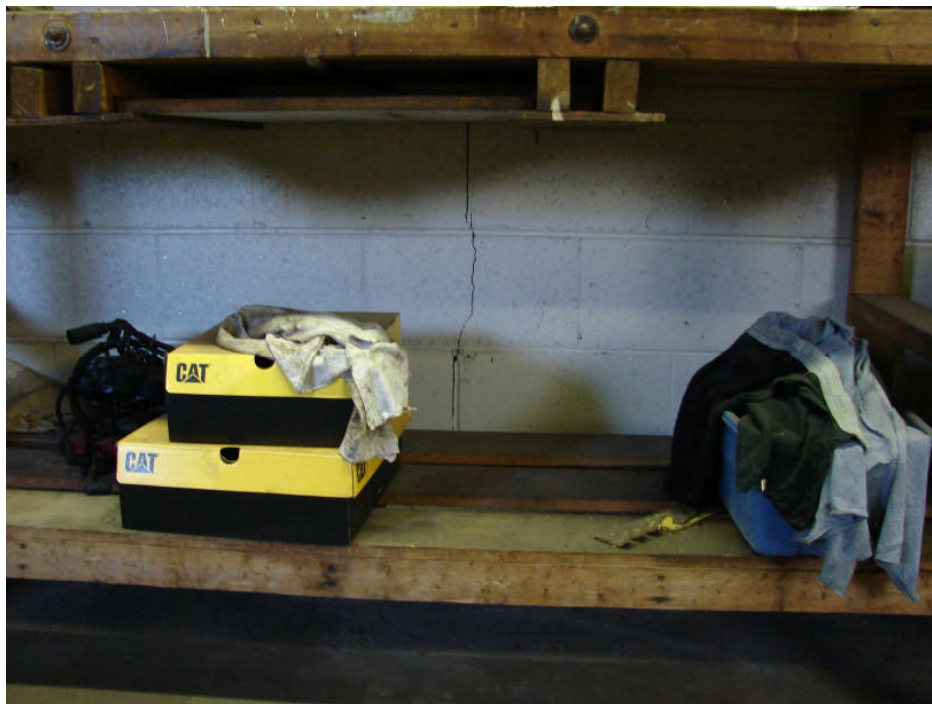
**Photograph 57:** Garage Building rear workshop south wall – wall step cracking below wall openings, typical.

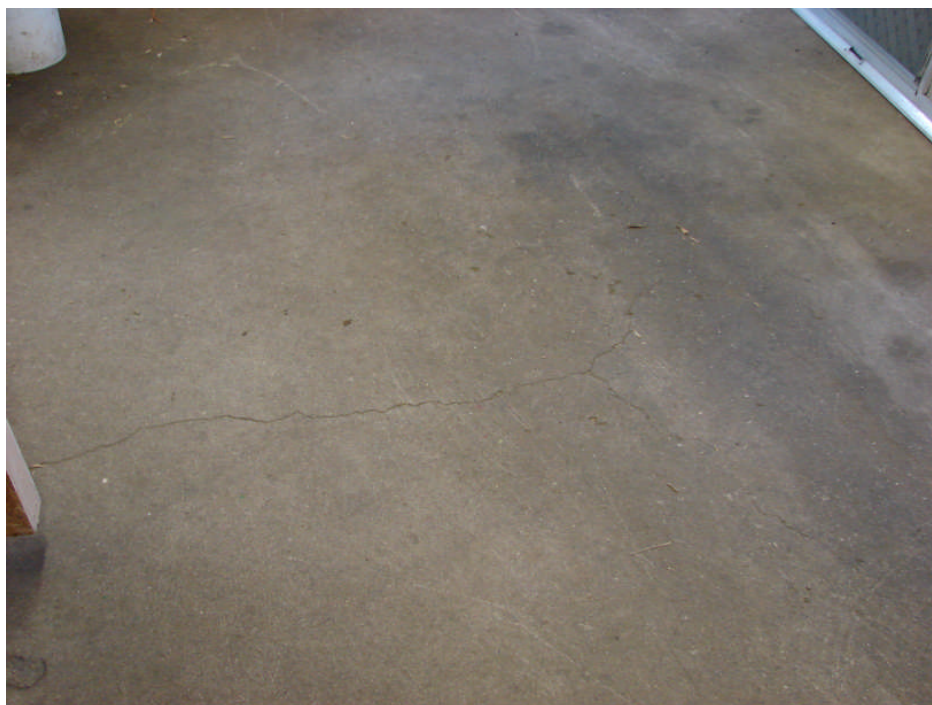
**Photograph 58:** Garage Building rear workshop - unpainted concrete slab-on-grade with minor cracks, typical.

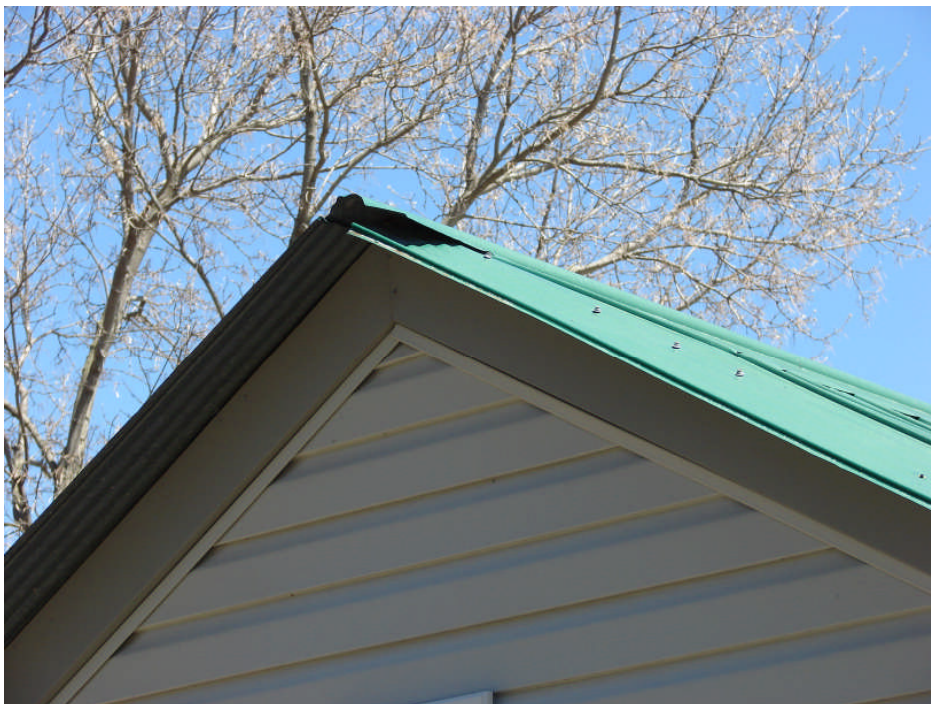
**Photograph 4:** Other Structures Storage Building - roof ridge missing end cap at west end, typical.

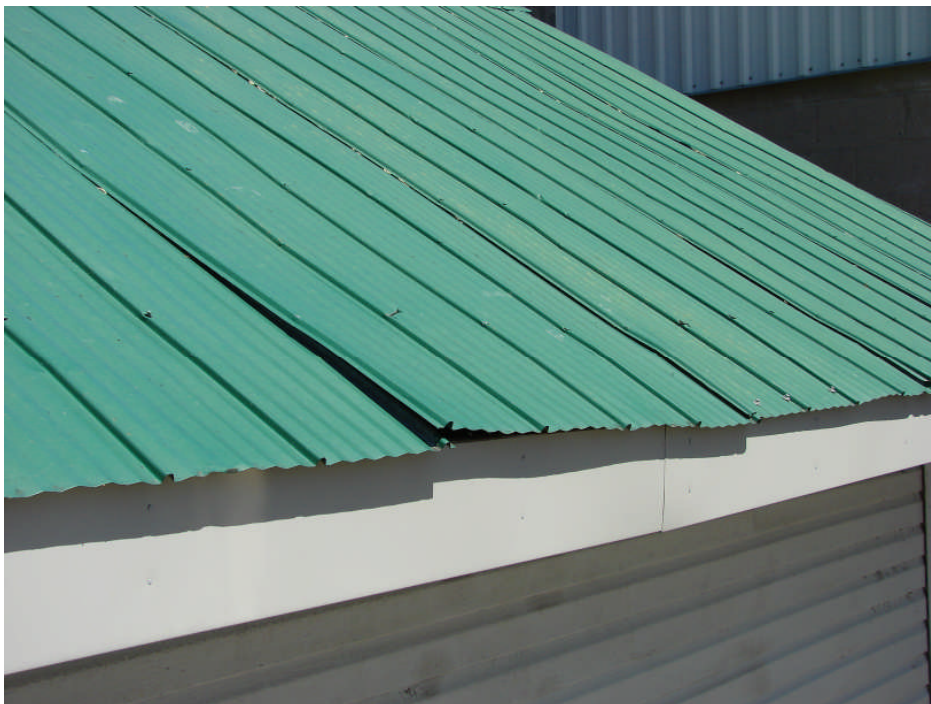
**Photograph 6:** Other Structures Storage Building – loose metal roof panels missing fasteners, typical.

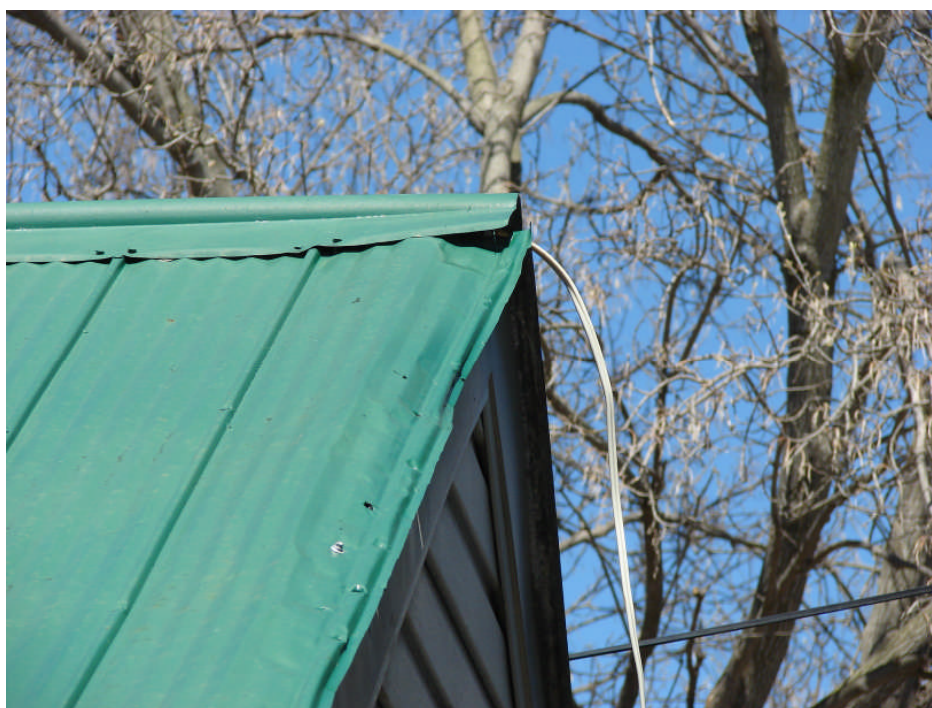
**Photograph 8:** Other Structures Storage Building - roof ridge missing end cap at east end, typical.

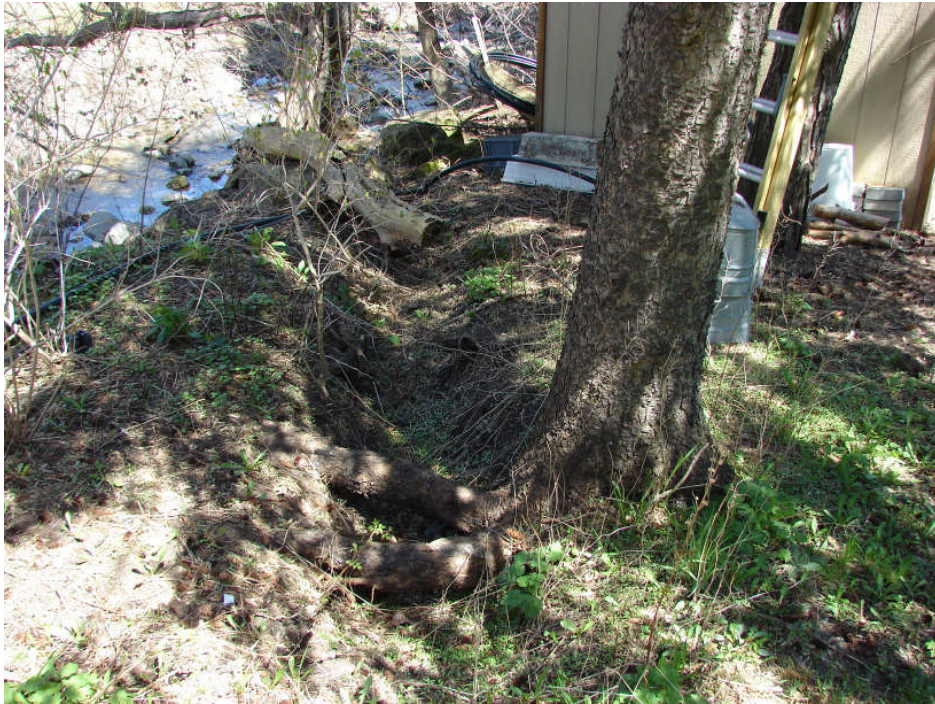
**Photograph 13:** Site Works – general view along south side of drainage ditch near residence looking east, with extensive soil erosion, typical.

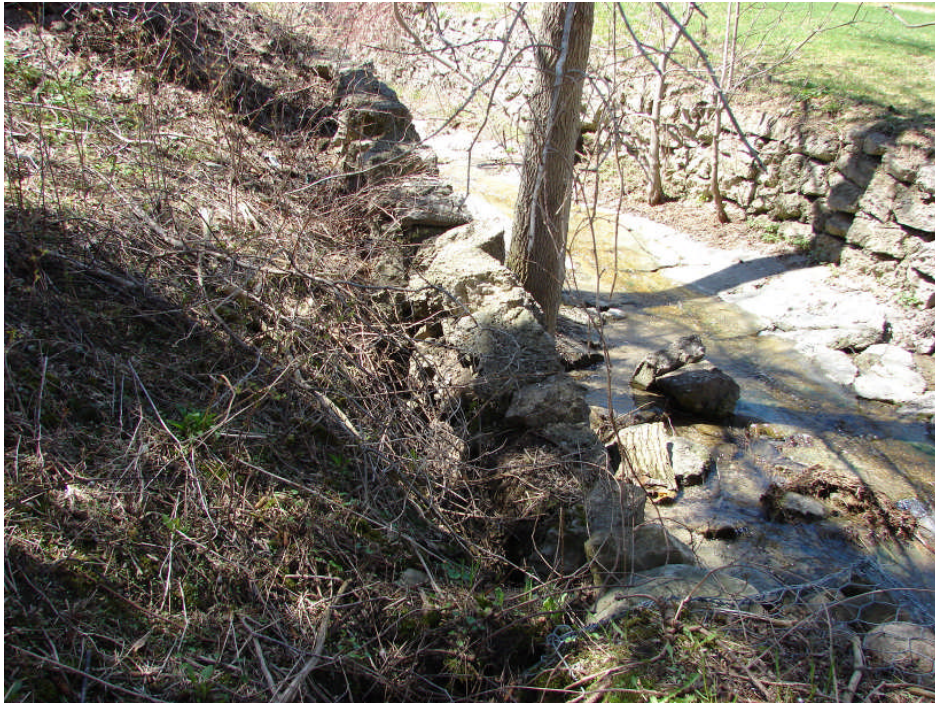
**Photograph 15:** Site Works – general view along south side of drainage ditch near residence looking west, with extensive soil erosion, typical.

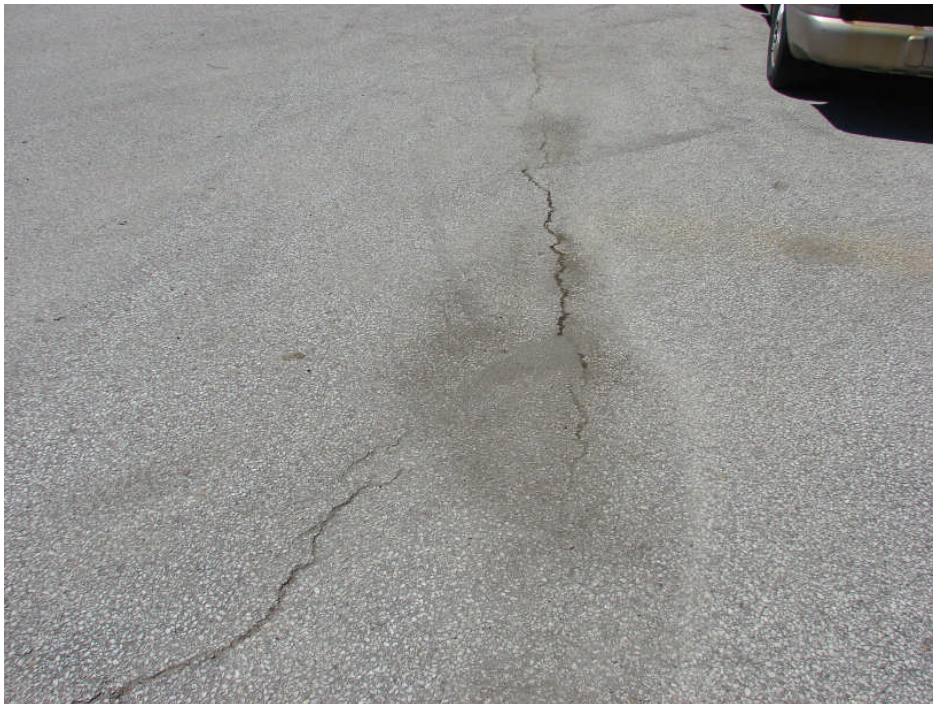
**Photograph 22:** Site Works – cracking of asphalt pavement along Highway 26 near entrance, typical.

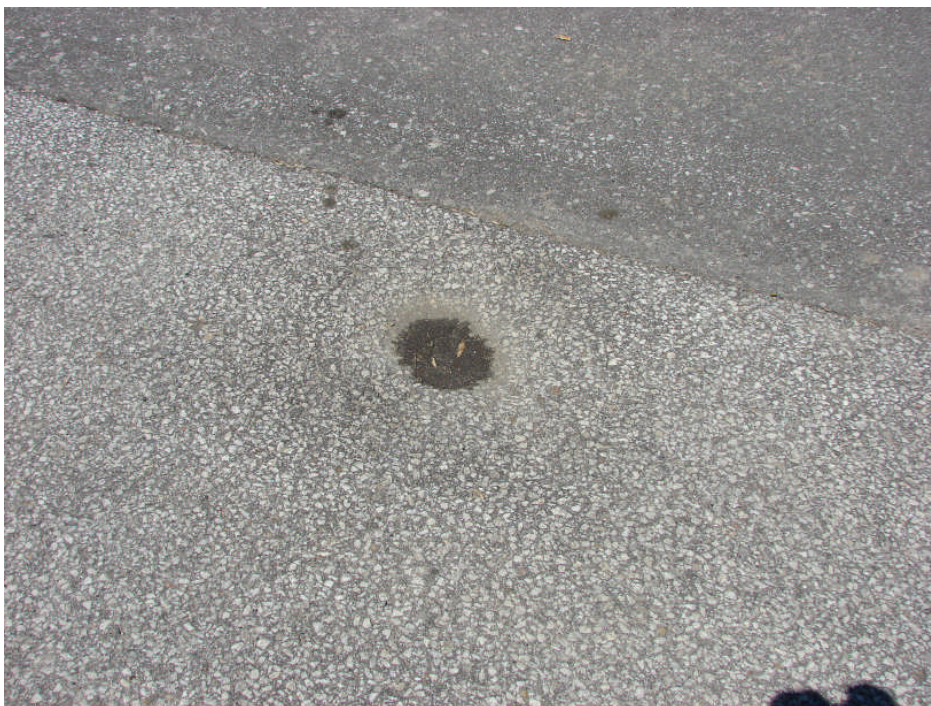
**Photograph 23:** Site Works – hole in the asphalt pavement near the large asphalt patch/repair.

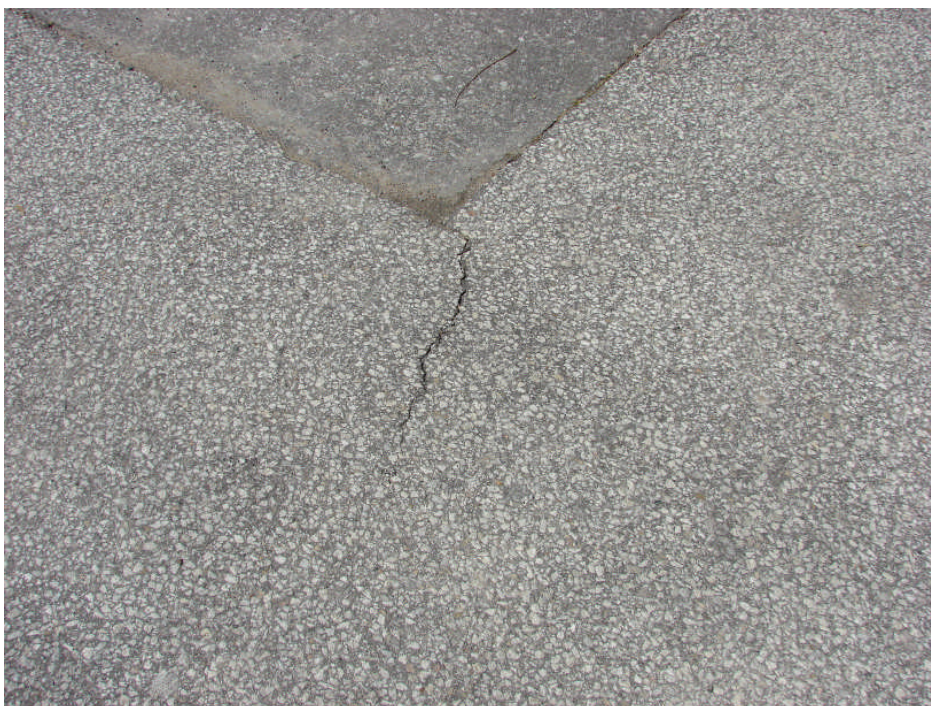
**Photograph 24:** Site Works – cracking of asphalt pavement adjacent the large asphalt patch/repair.

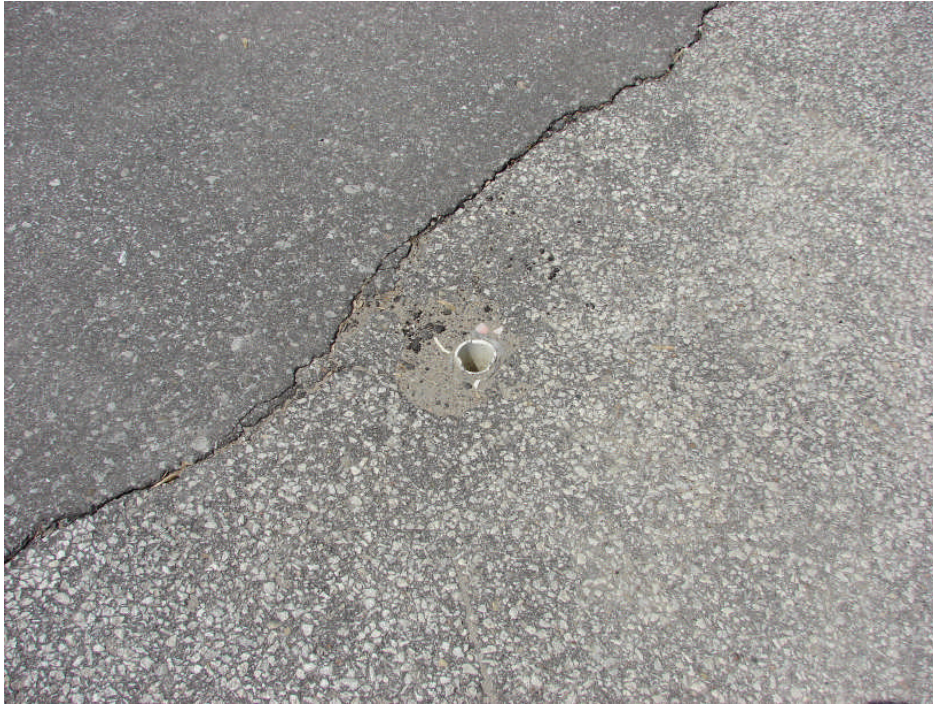
**Photograph 25:** Site Works – hole in the asphalt pavement near the large asphalt patch/repair.

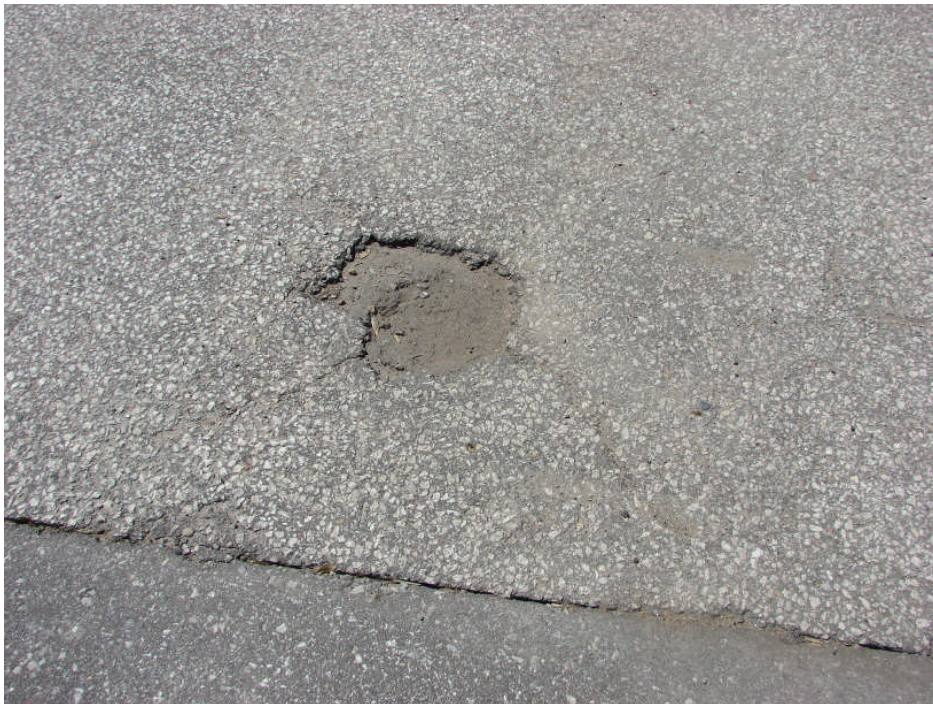
**Photograph 26:** Site Works – hole in the asphalt pavement and cracking near the large asphalt patch/repair.

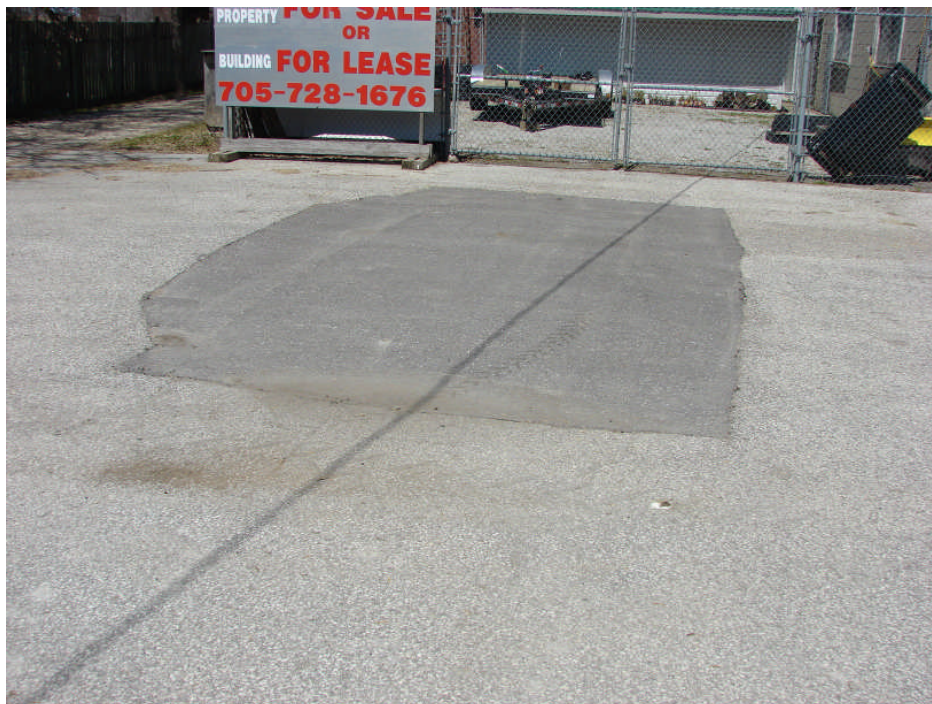
**Photograph 27:** Site Works – small asphalt patch/repair in southeast of the garage building.

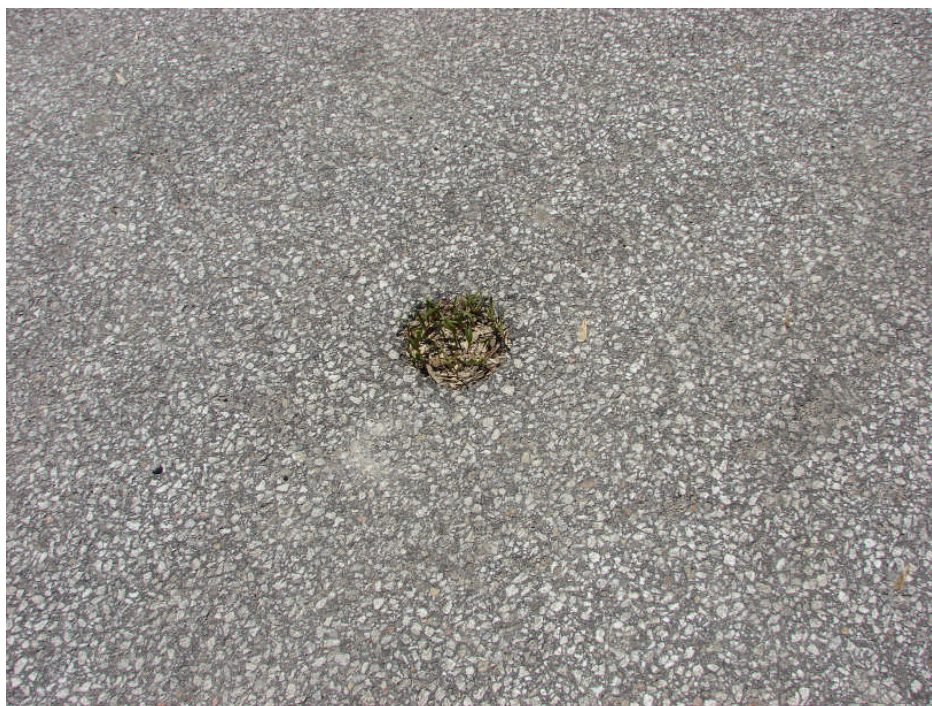
**Photograph 28:** Site Works – hole in the asphalt pavement near the small asphalt patch/repair.

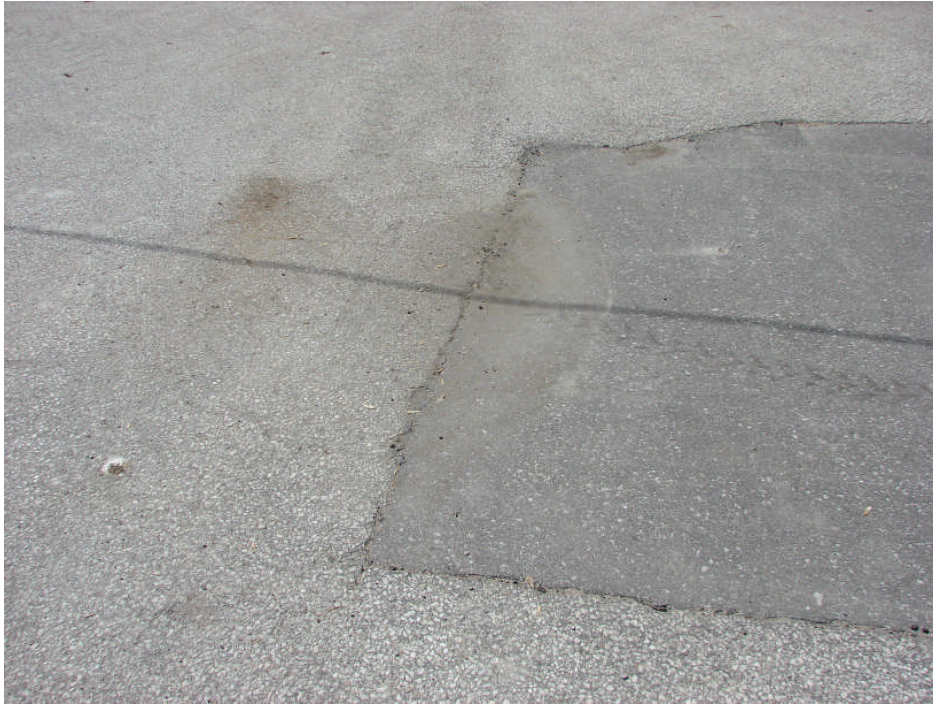
**Photograph 29:** Site Works – minor settlement and water ponding staining on the south side of the small asphalt patch/repair.

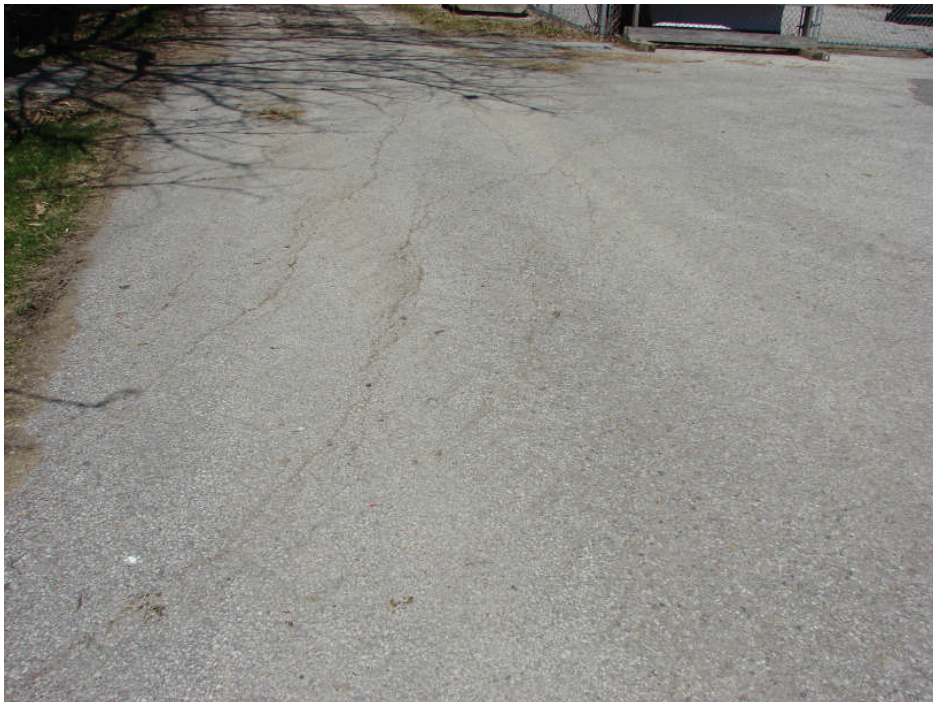
**Photograph 30:** Site Works – extensive cracking and some alligator cracking of asphalt pavement at the west end.

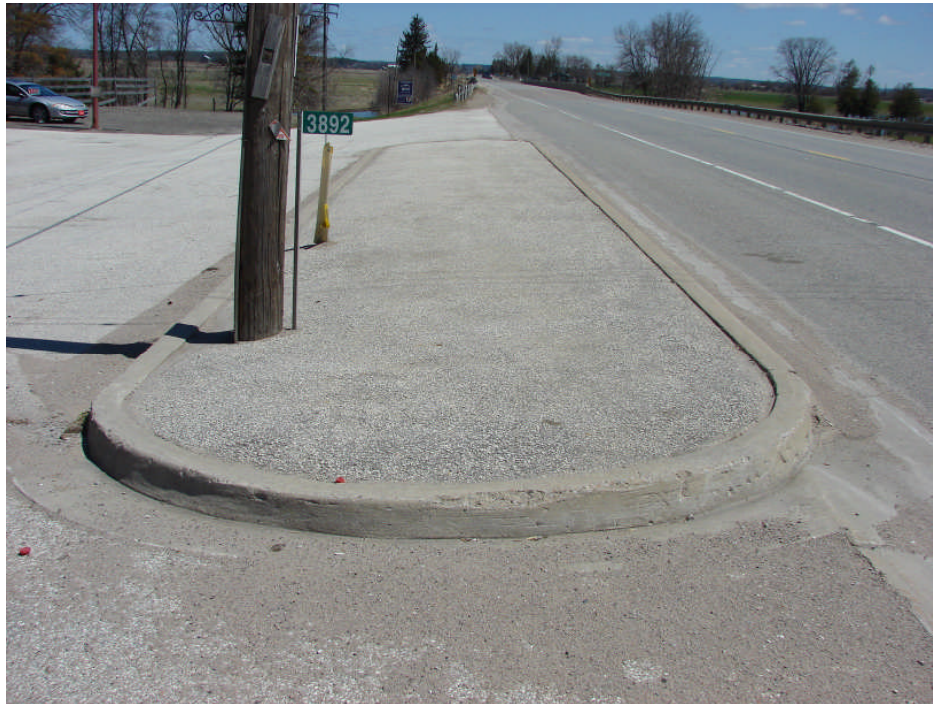
**Photograph 31:** Site Works – cracking of concrete curb including scuff marks and impact damage at boulevard island, typical.

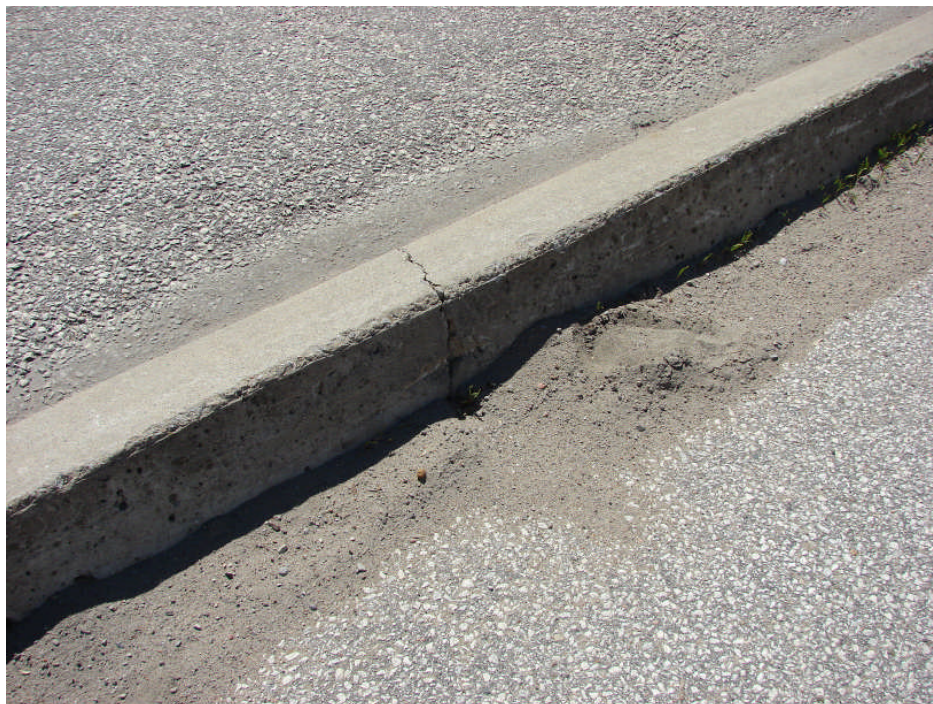
**Photograph 32:** Site Works – cracking of concrete curb including scuff marks and impact damage at boulevard island, typical.

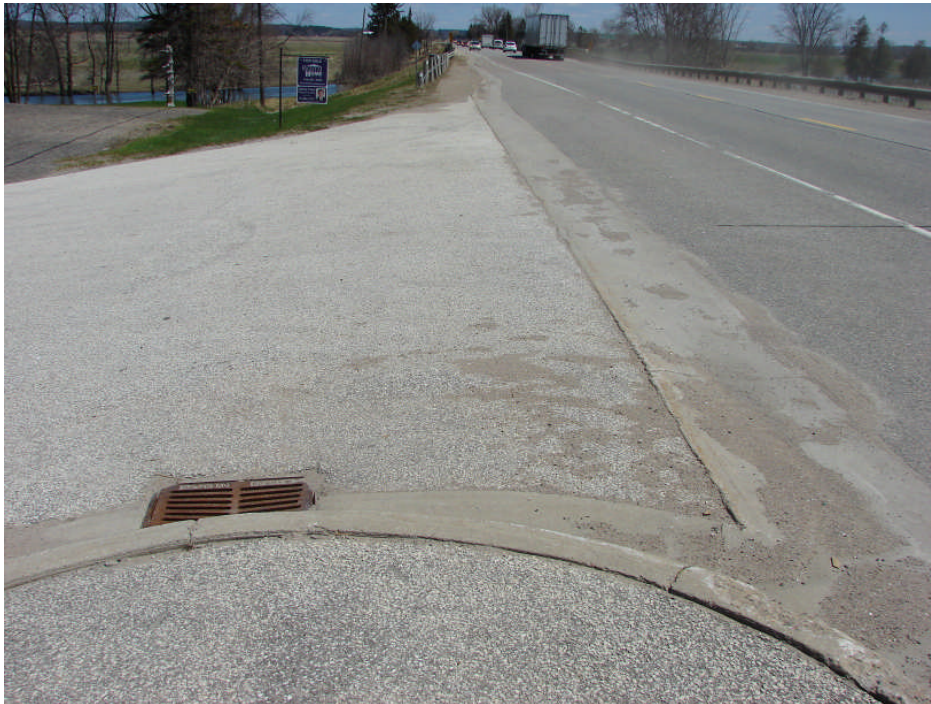
**Photograph 33:** Site Works – cracking of concrete curb including scuff marks and impact damage at boulevard island, typical.

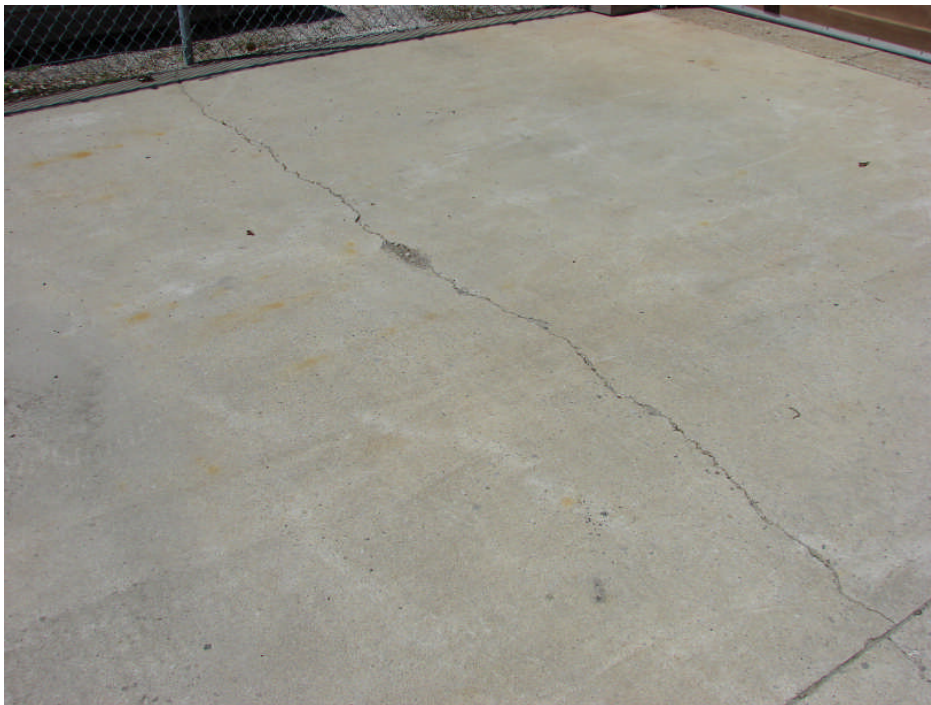
**Photograph 34:** Site Works – cracking of concrete slab-on-grade pad south of the west overhead door to the garage building, typical.

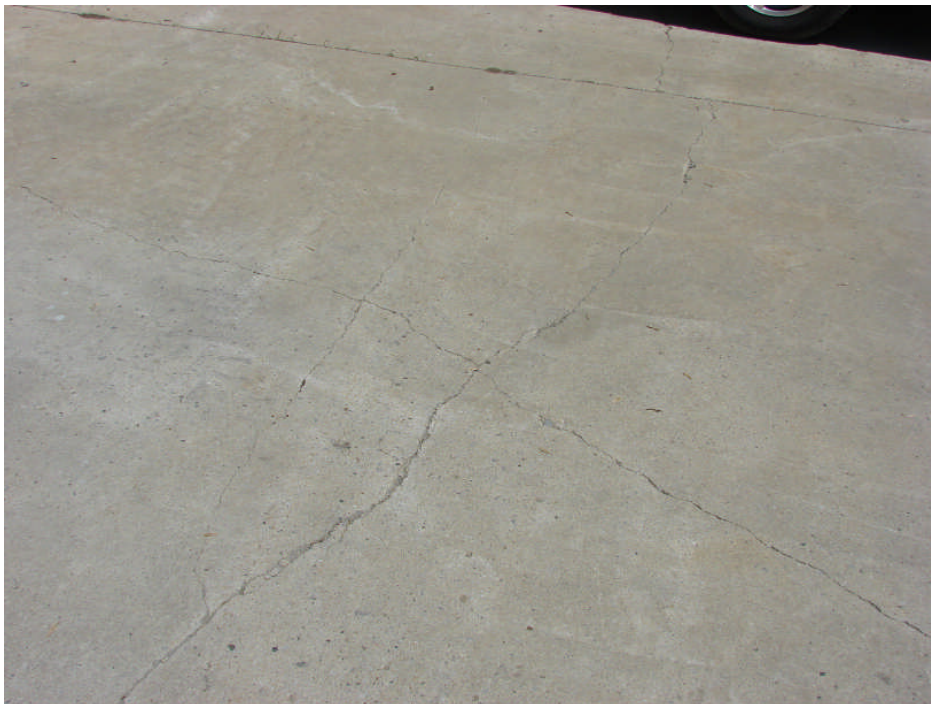
**Photograph 35:** Site Works – cracking of concrete slab-on-grade pad south of the east overhead door to the garage building, typical.

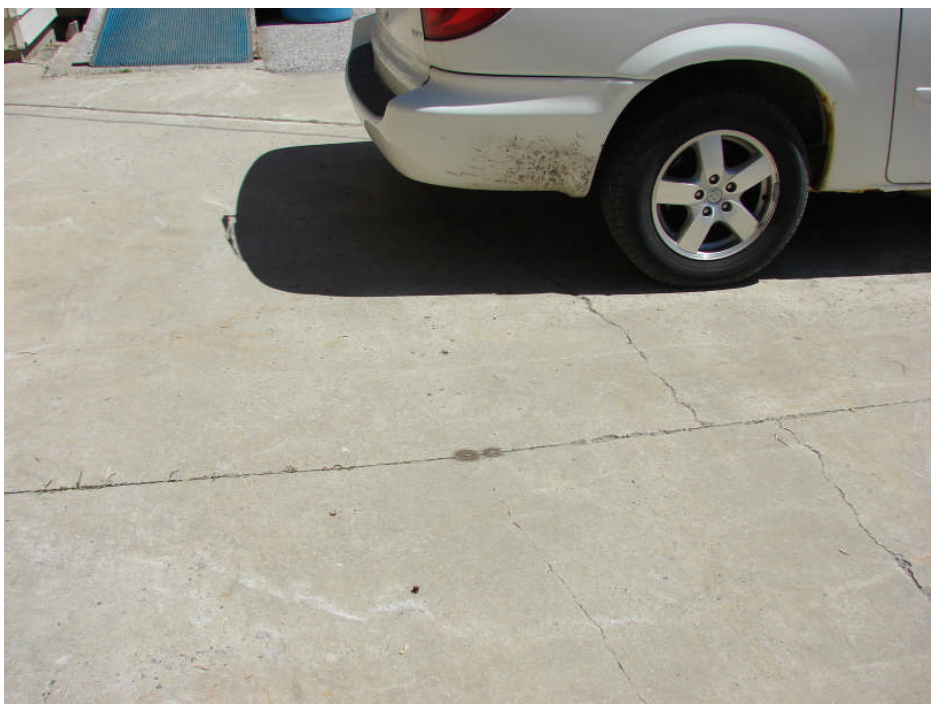
**Photograph 36:** Site Works – cracking of concrete slab-on-grade pad south of the east overhead door to the garage building, typical.

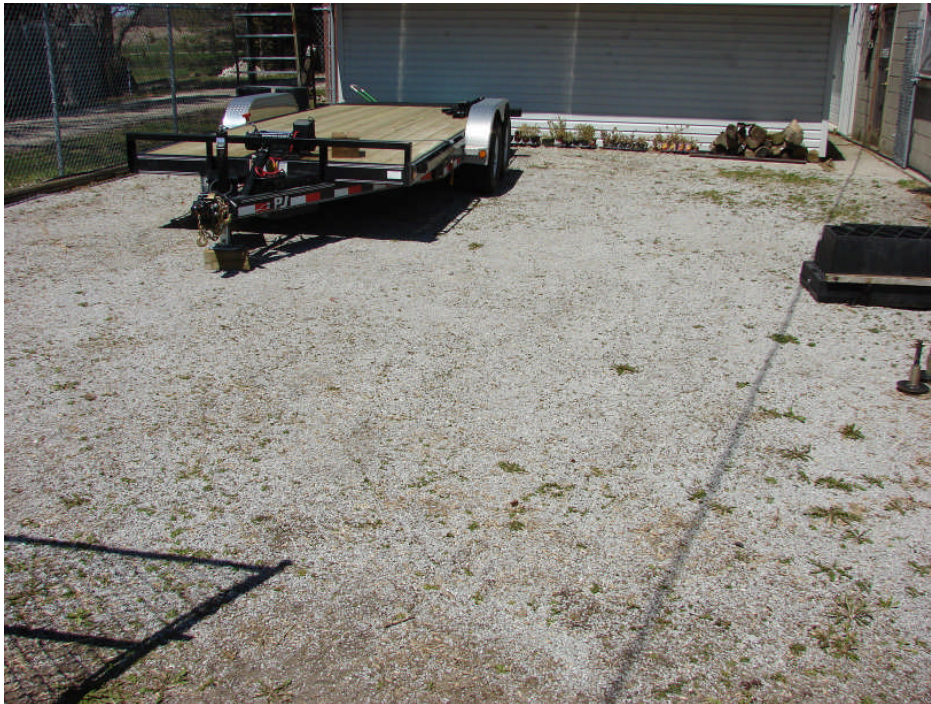
**Photograph 37:** Site Works – granular surface at fenced storage area near west side of property.

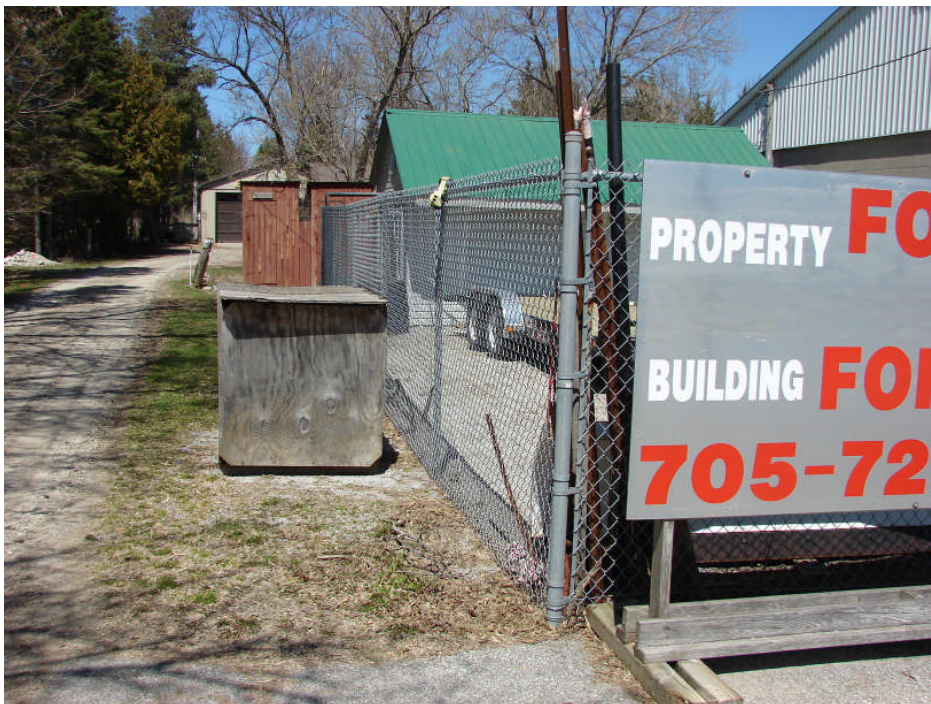
**Photograph 38:** Site Works - chain-link fence at storage area near west side of property appears to be in good condition.
