**CONDITION SURVEY REPORT  
3892 HIGHWAY 26 - DRAINAGE DITCH IMPROVEMENT  
AGREEMENT NO. 2013-E-0039  
TOWN OF EDENVALE, ONTARIO  
FOR  
MINISTRY OF TRANSPORTATION**

PML Ref.: 14TF007  
Index No.: 017CSR  
GEOCRES No.: 31D-579  
September 16, 2014

**Condition Survey Report**  
**Highway 26 – Edenvale, 3892 Highway 26,**  
**Personal Residence and Detached Structures**  
**Agreement No. 2013-E-0039**  
**Edenvale, Ontario**

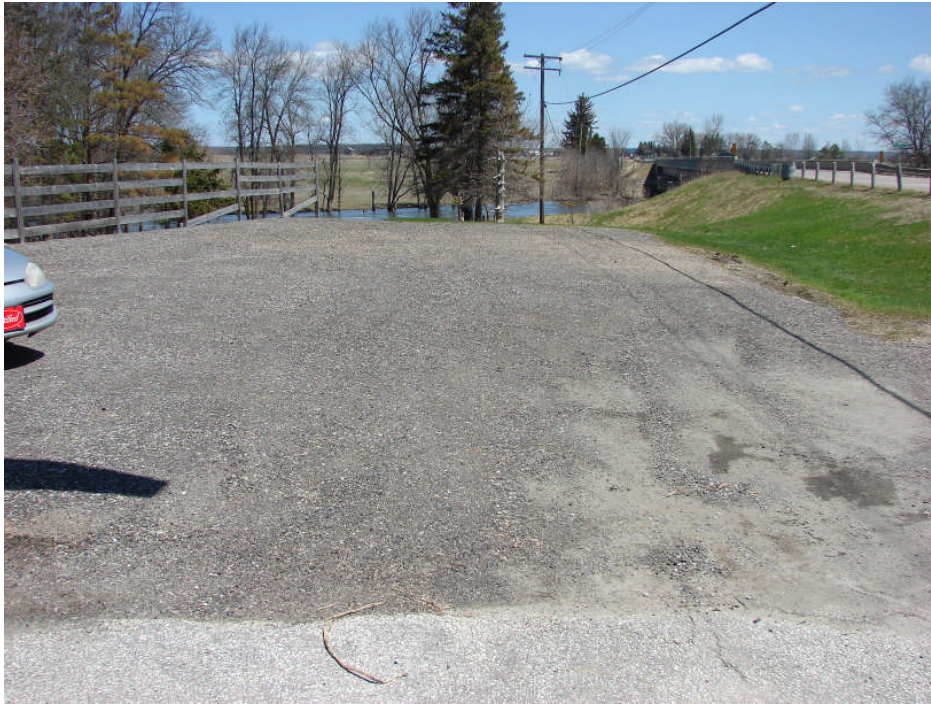
**Photograph 39:** Site Works – recycled granular material at parking area near east end of property adjacent residence.

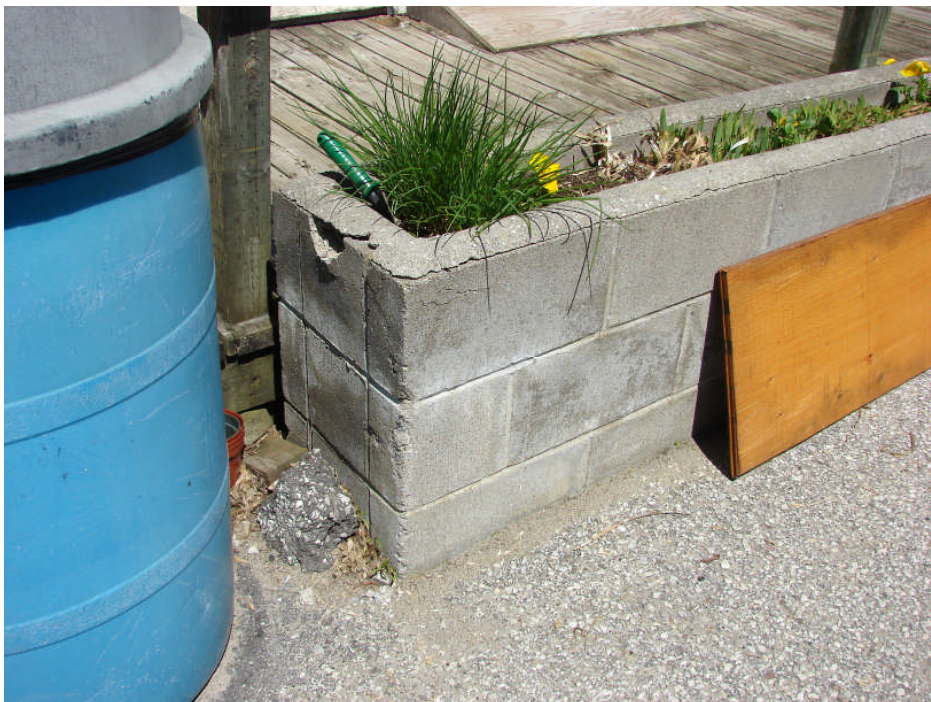
**Photograph 40:** Site Works – concrete block joint cracking at planter box including loose and cracking grout coping along south building elevation, typical.

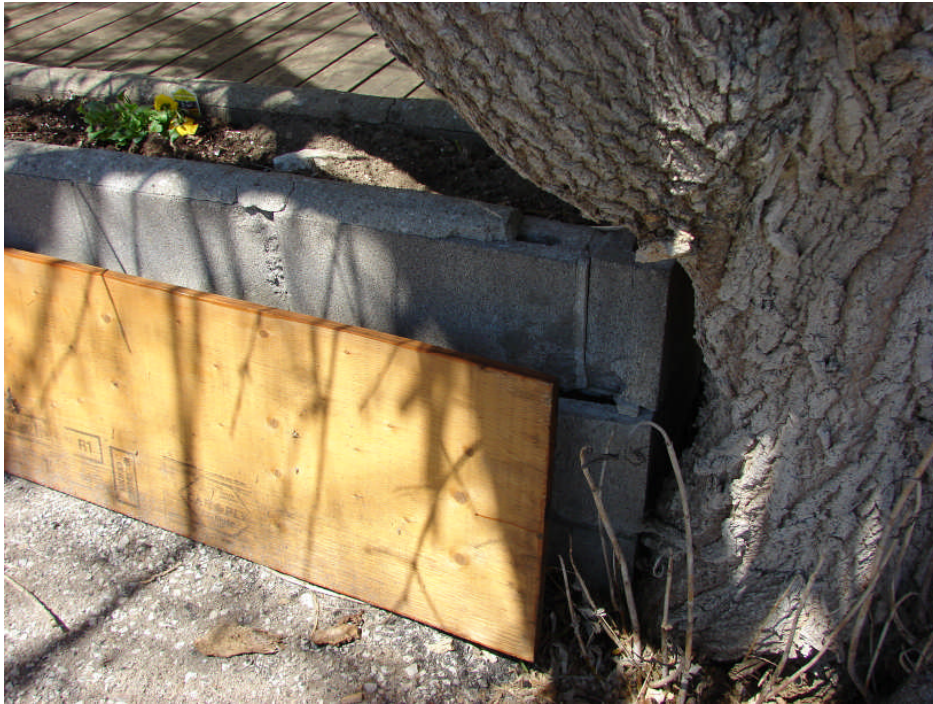
**Photograph 41:** Site Works – concrete block joint cracking at planter box including loose and cracking grout coping along south building elevation, typical.

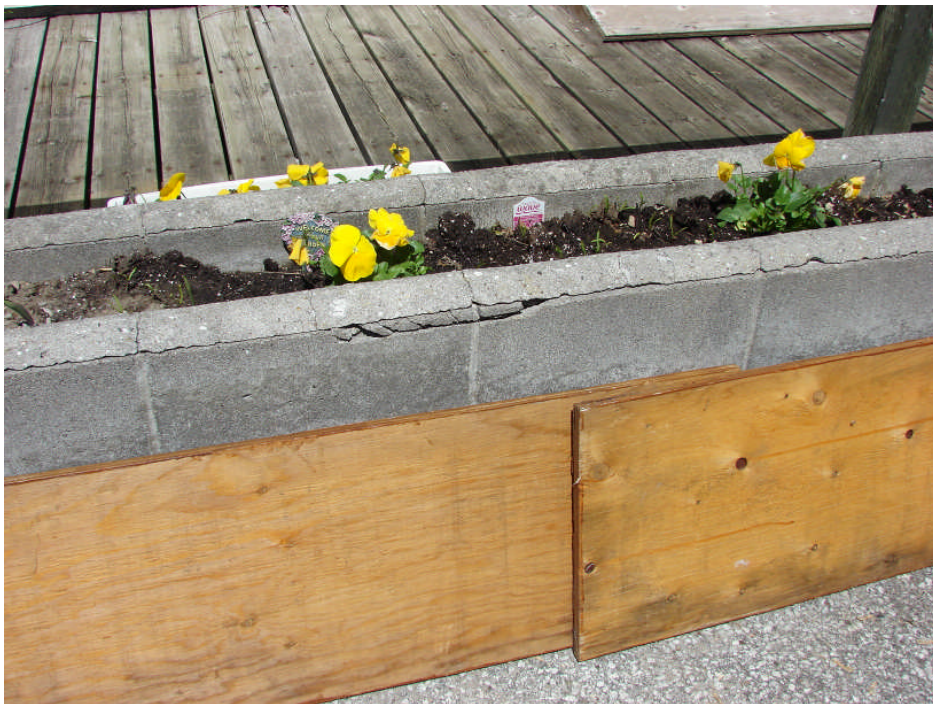
**Photograph 42:** Site Works – concrete block joint cracking at planter box including loose and cracking grout coping along south building elevation, typical.
